# Present status of JSNS mercury target

Katsuhiro Haga, Hiroyuki Kogawa, Takashi Wakui,  
**Takahsi Naoe**, Eiichi Wakai, Hiroshi Takada

J-PARC Center, JAEA

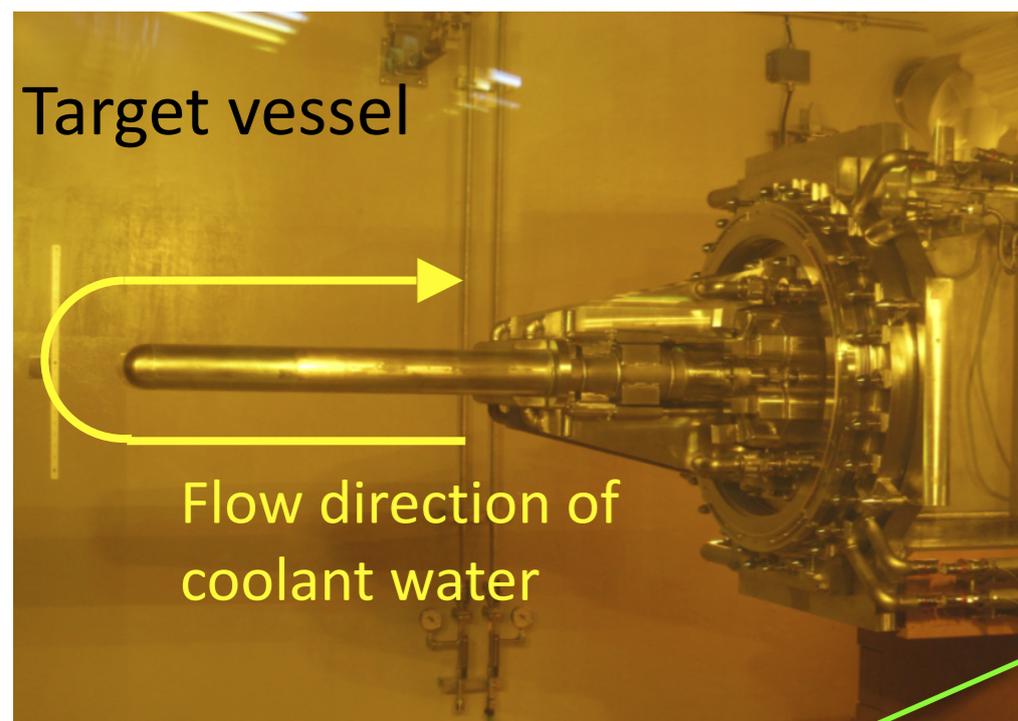
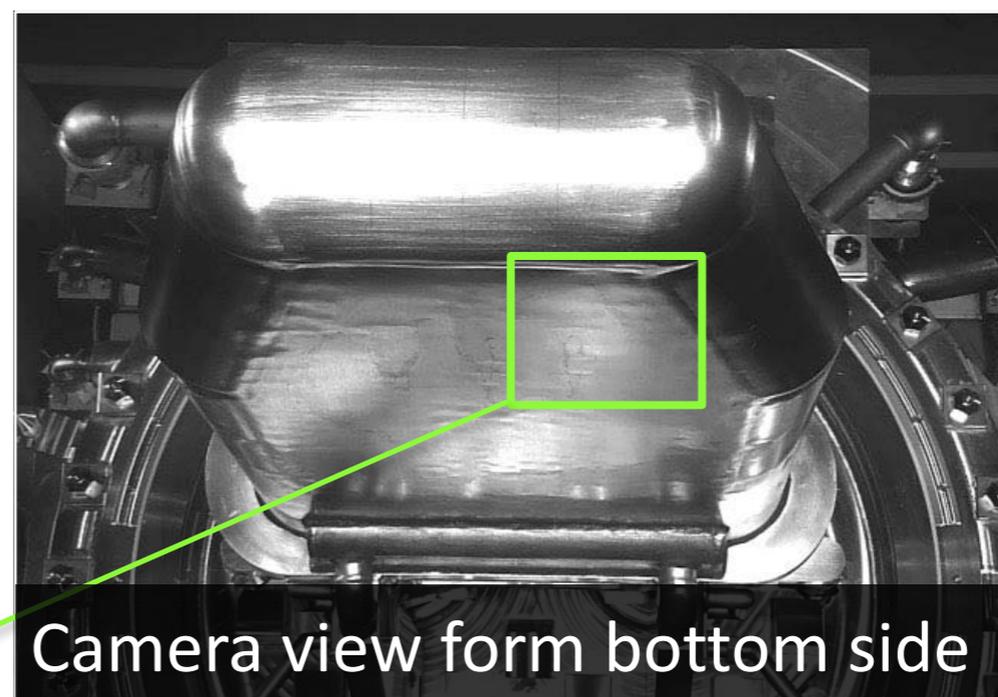
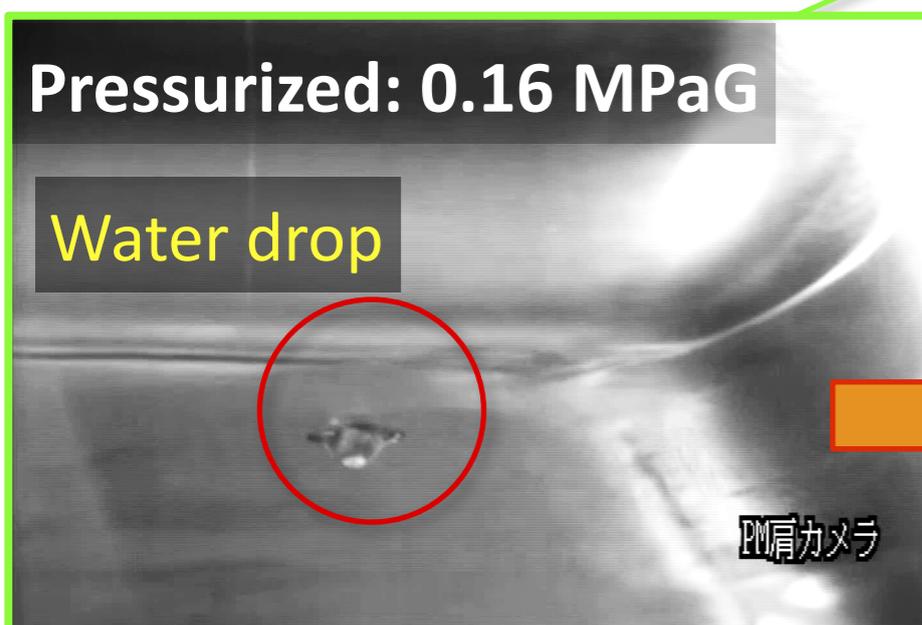
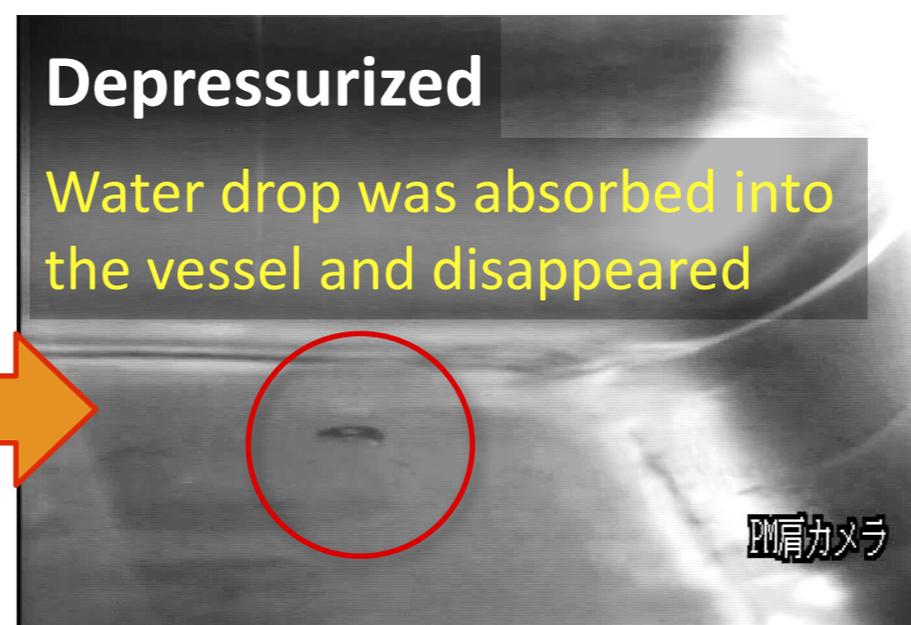
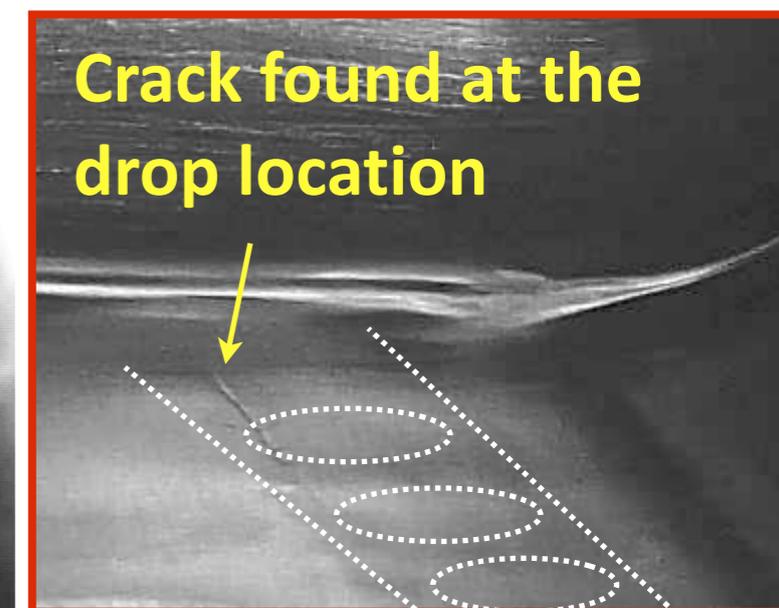
- Observation of target surface by video camera
- Pressurizing water shroud with helium gas (0.16 MPaG)
- A water drop found on the bottom side surface (**Determined leak location**)
- Crack caused by welding defect was found on leak location

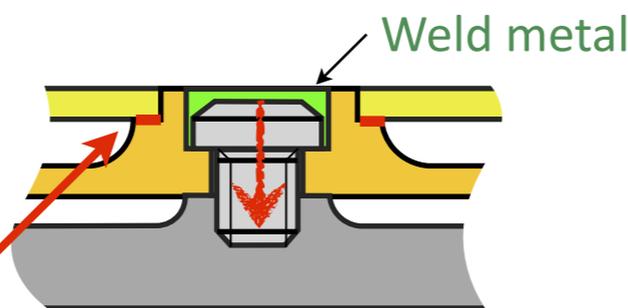
**Diffusion bonded interface was detached by thermal deformation**

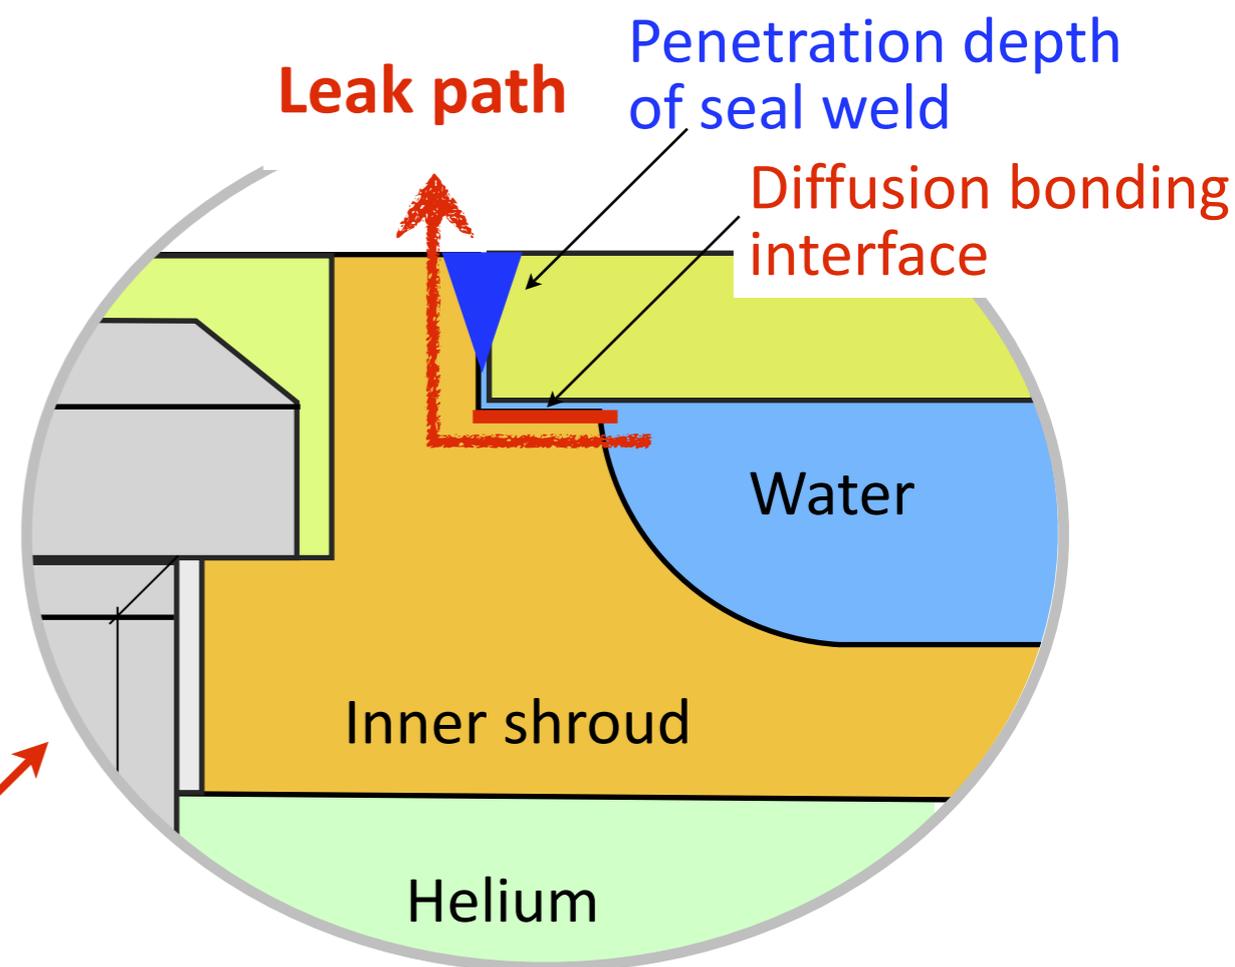
**Seal welding of thin penetration depth (<1.5 mm) was failed by repeated thermal stress**

- Crack propagated through the seal welded part between inner and outer shroud
- Total number of thermal cycles due to beam trip for 5th target is ca. 2500
- Structural design, that allowed the seal welding without groove, was attributed to the water leak

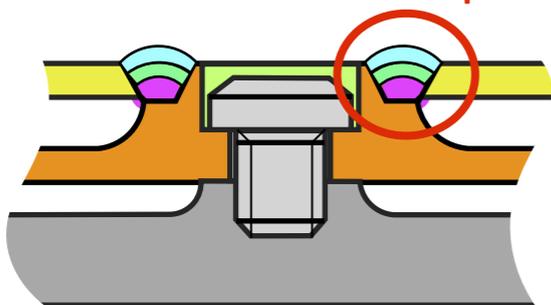
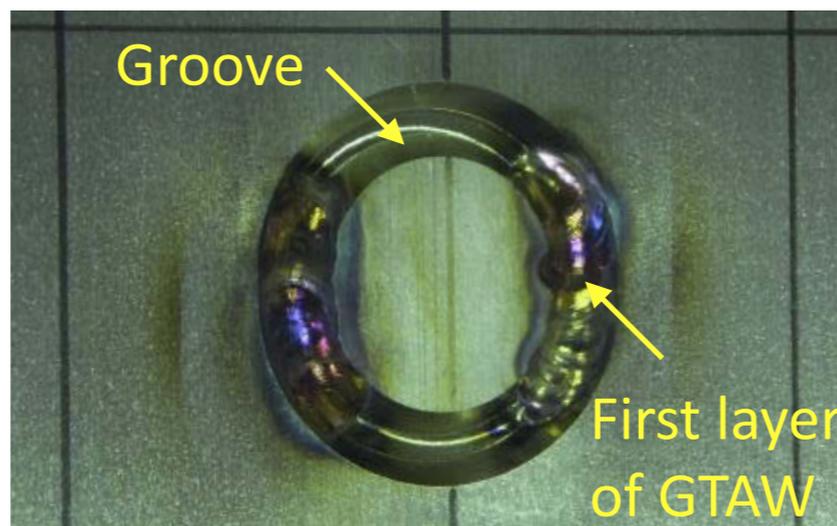
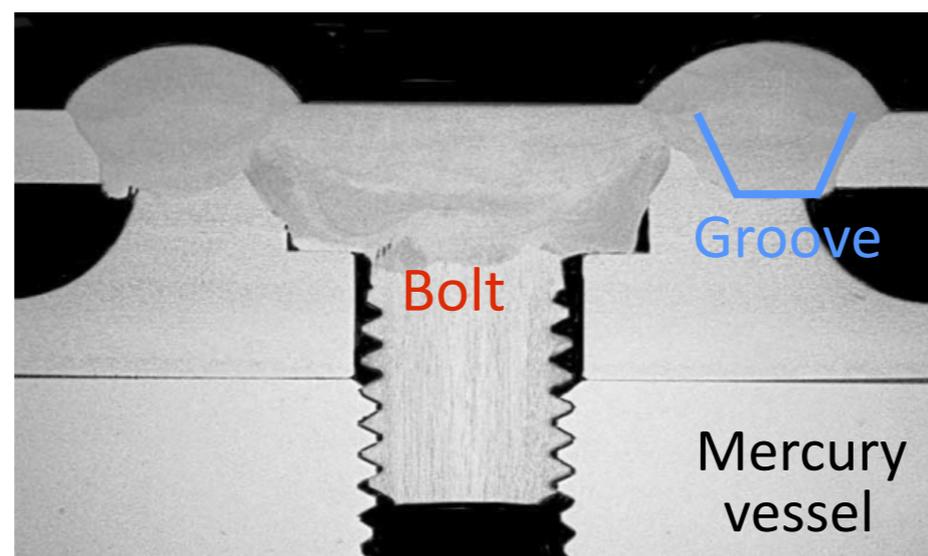
*Cross section of mock-up specimen*

- Spare target (7th target) which is the same design with 5th target was repaired to eliminate seal welding without groove
- 167 portion of around bolts were repaired and beam operation with repaired 7th target was started from Oct. 2015
- **7th target was failed two weeks after restarting operation at 500 kW**

## Repair welding (leave a weld bead) 3 path

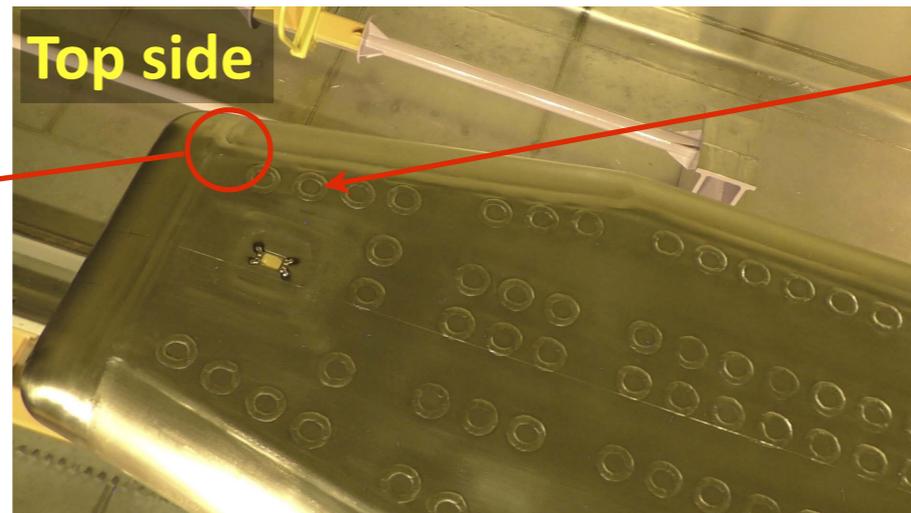
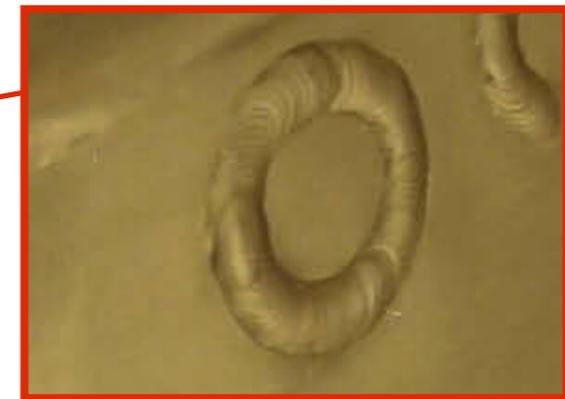
Repaired point of around bolt

***No-visible change was found from outside inspection***

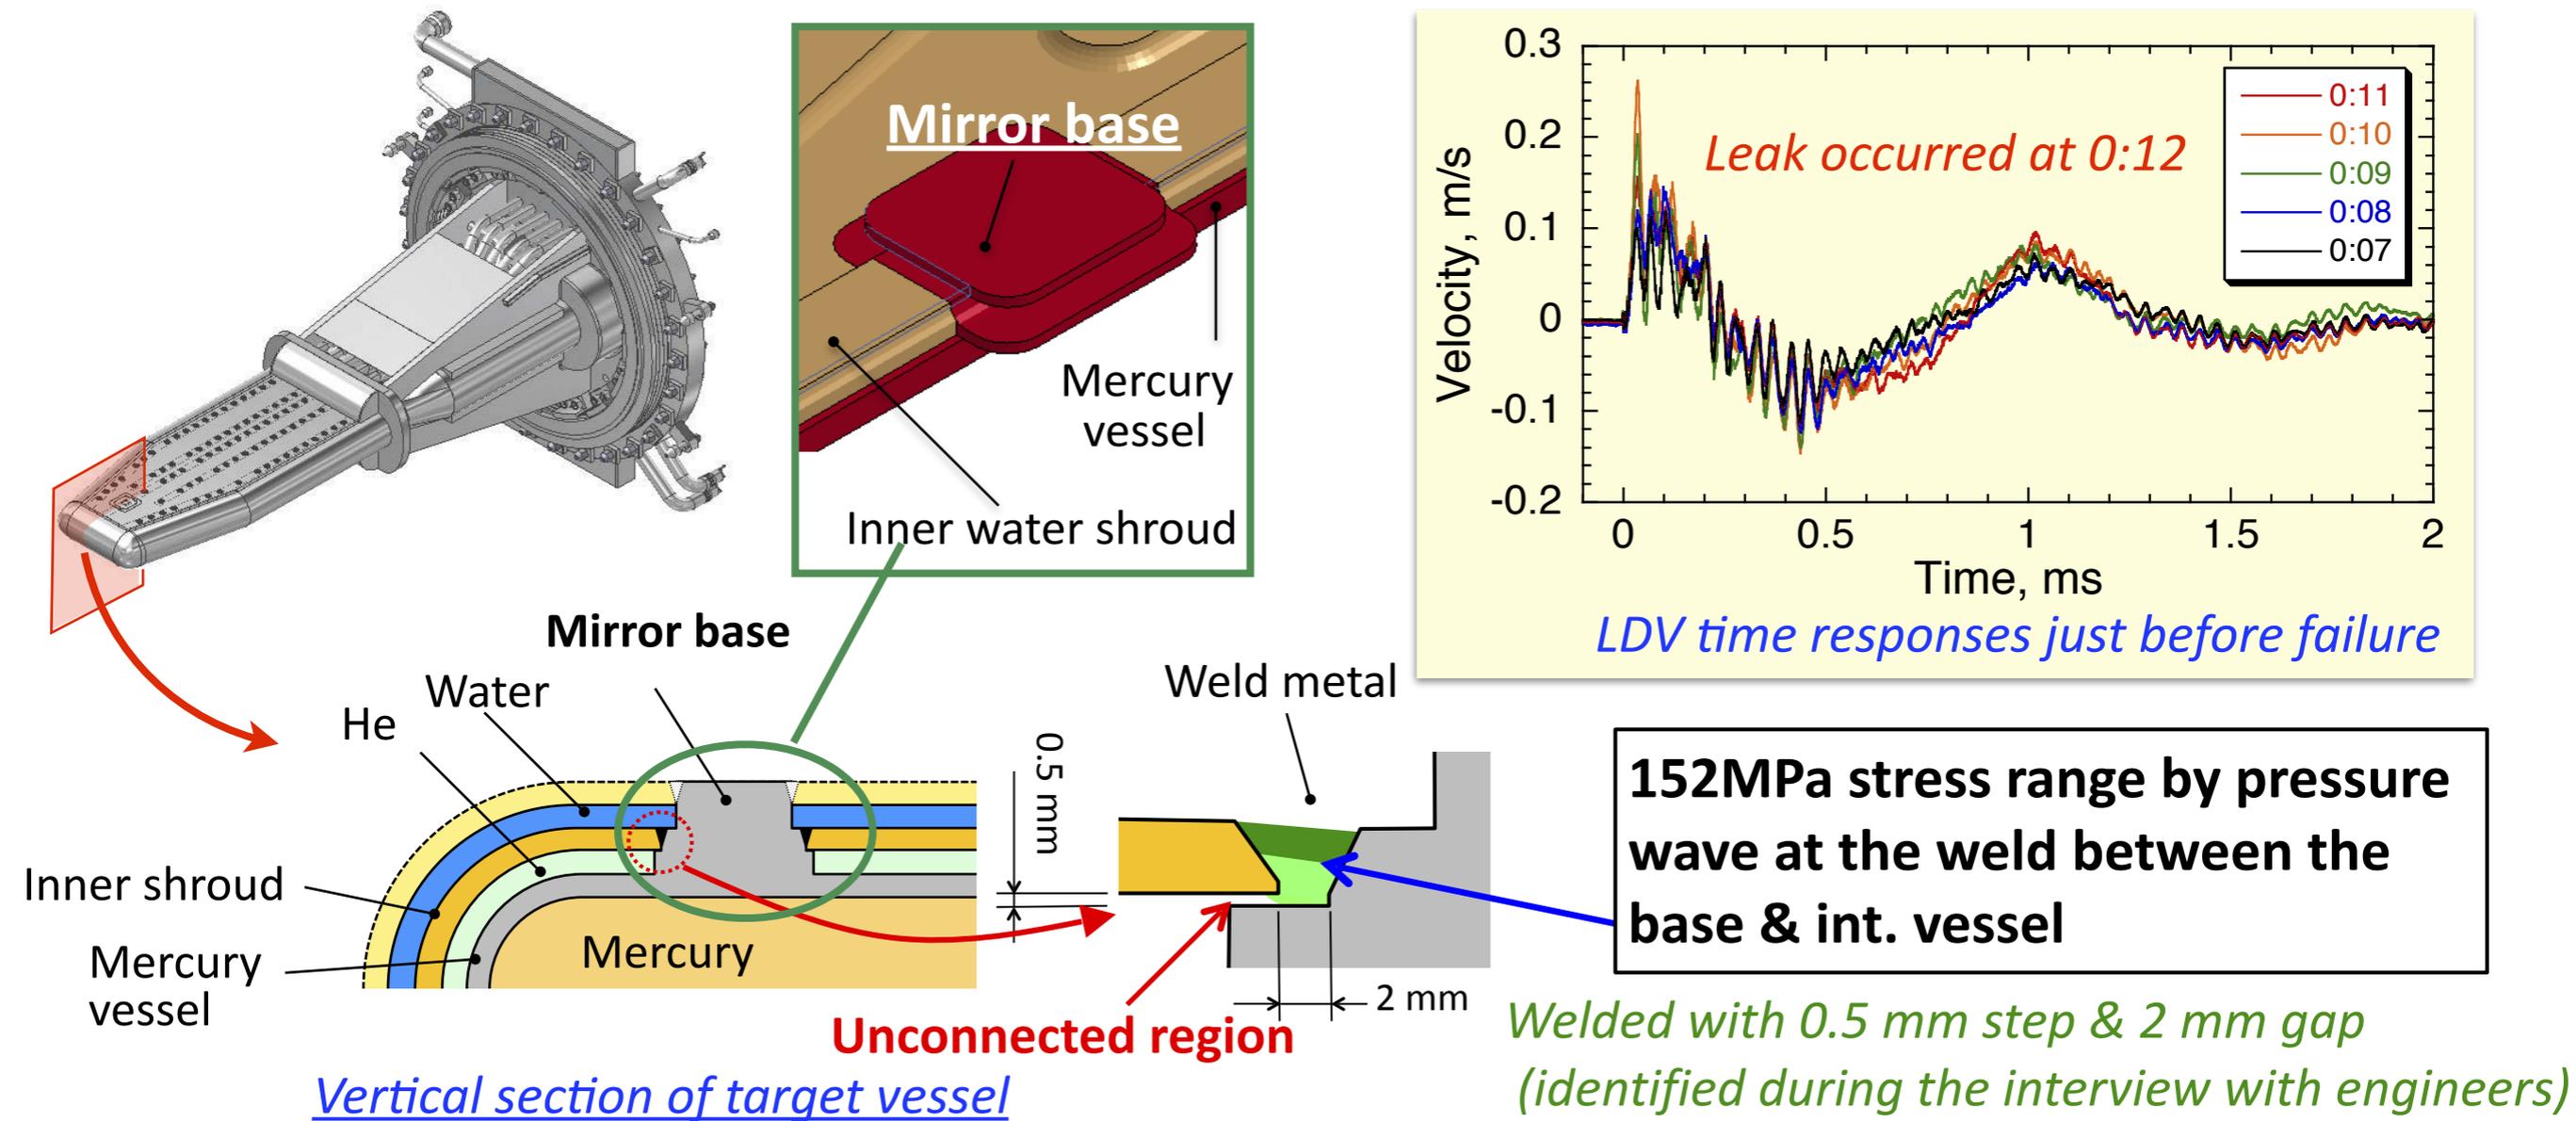
- Monolithic structure around mirror for LDV system seems to be leak location
- Welding defect (unconnected region) acts as notch for propagating fatigue crack by pressure waves and thermal stress
- But we did not find any change in LDV signals just before failure

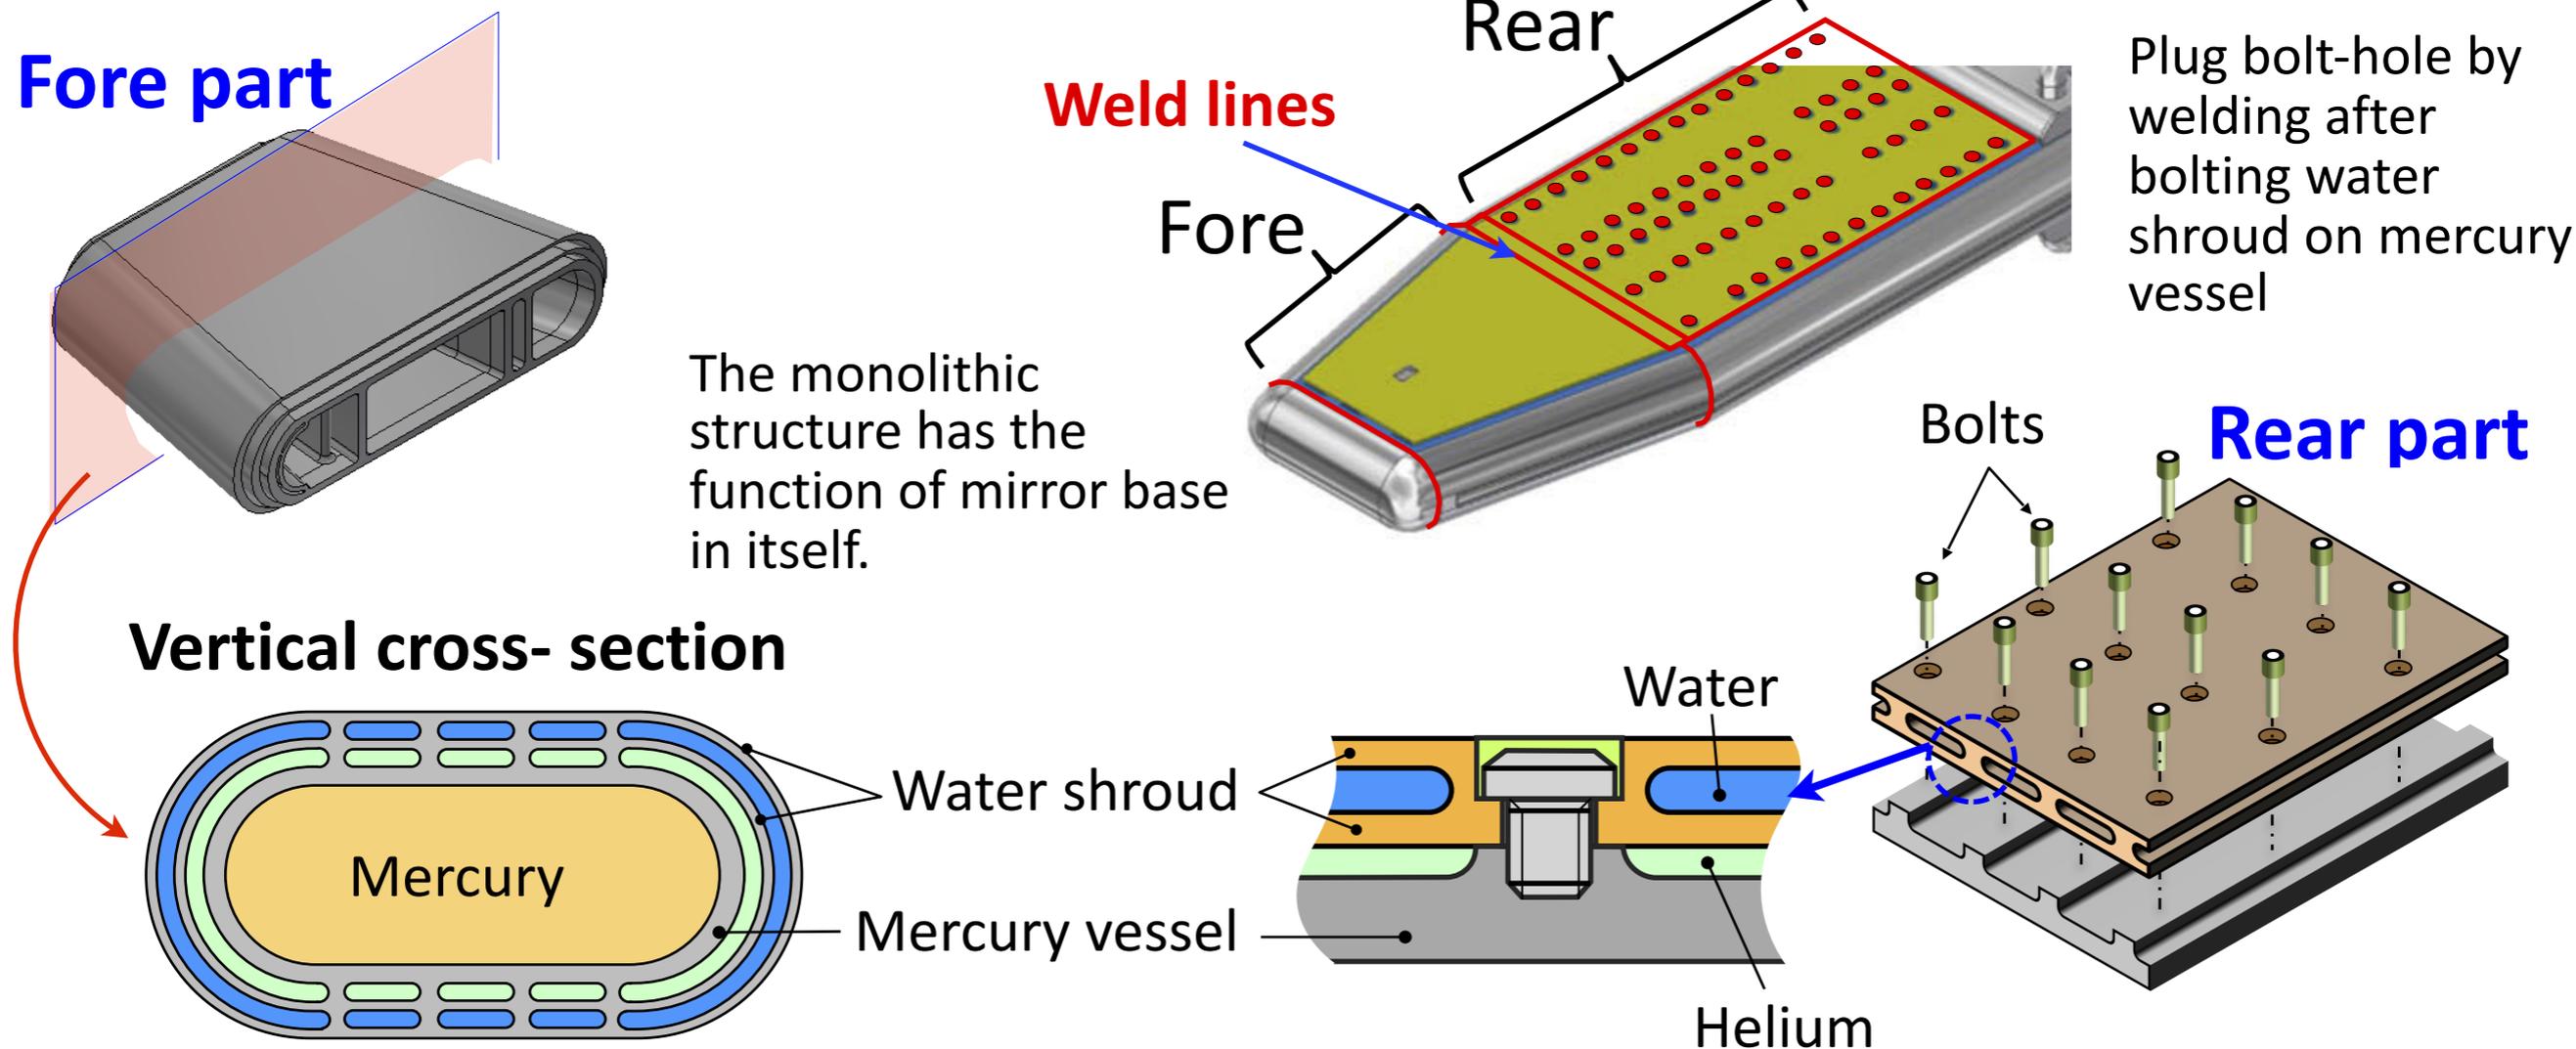
- Lack of penetration depth for seal welding led leakage of water (5th target)  
Fatigue crack was propagated thermal cycles by beam trip from weld defect
- Monolithic structure of LDV mirror base seemed to be induce un-welded region which acts as notch, and fatigue crack propagated by pressure waves

**Wire EDM was applied to reduce welding line and to eliminate diffusion bonding**

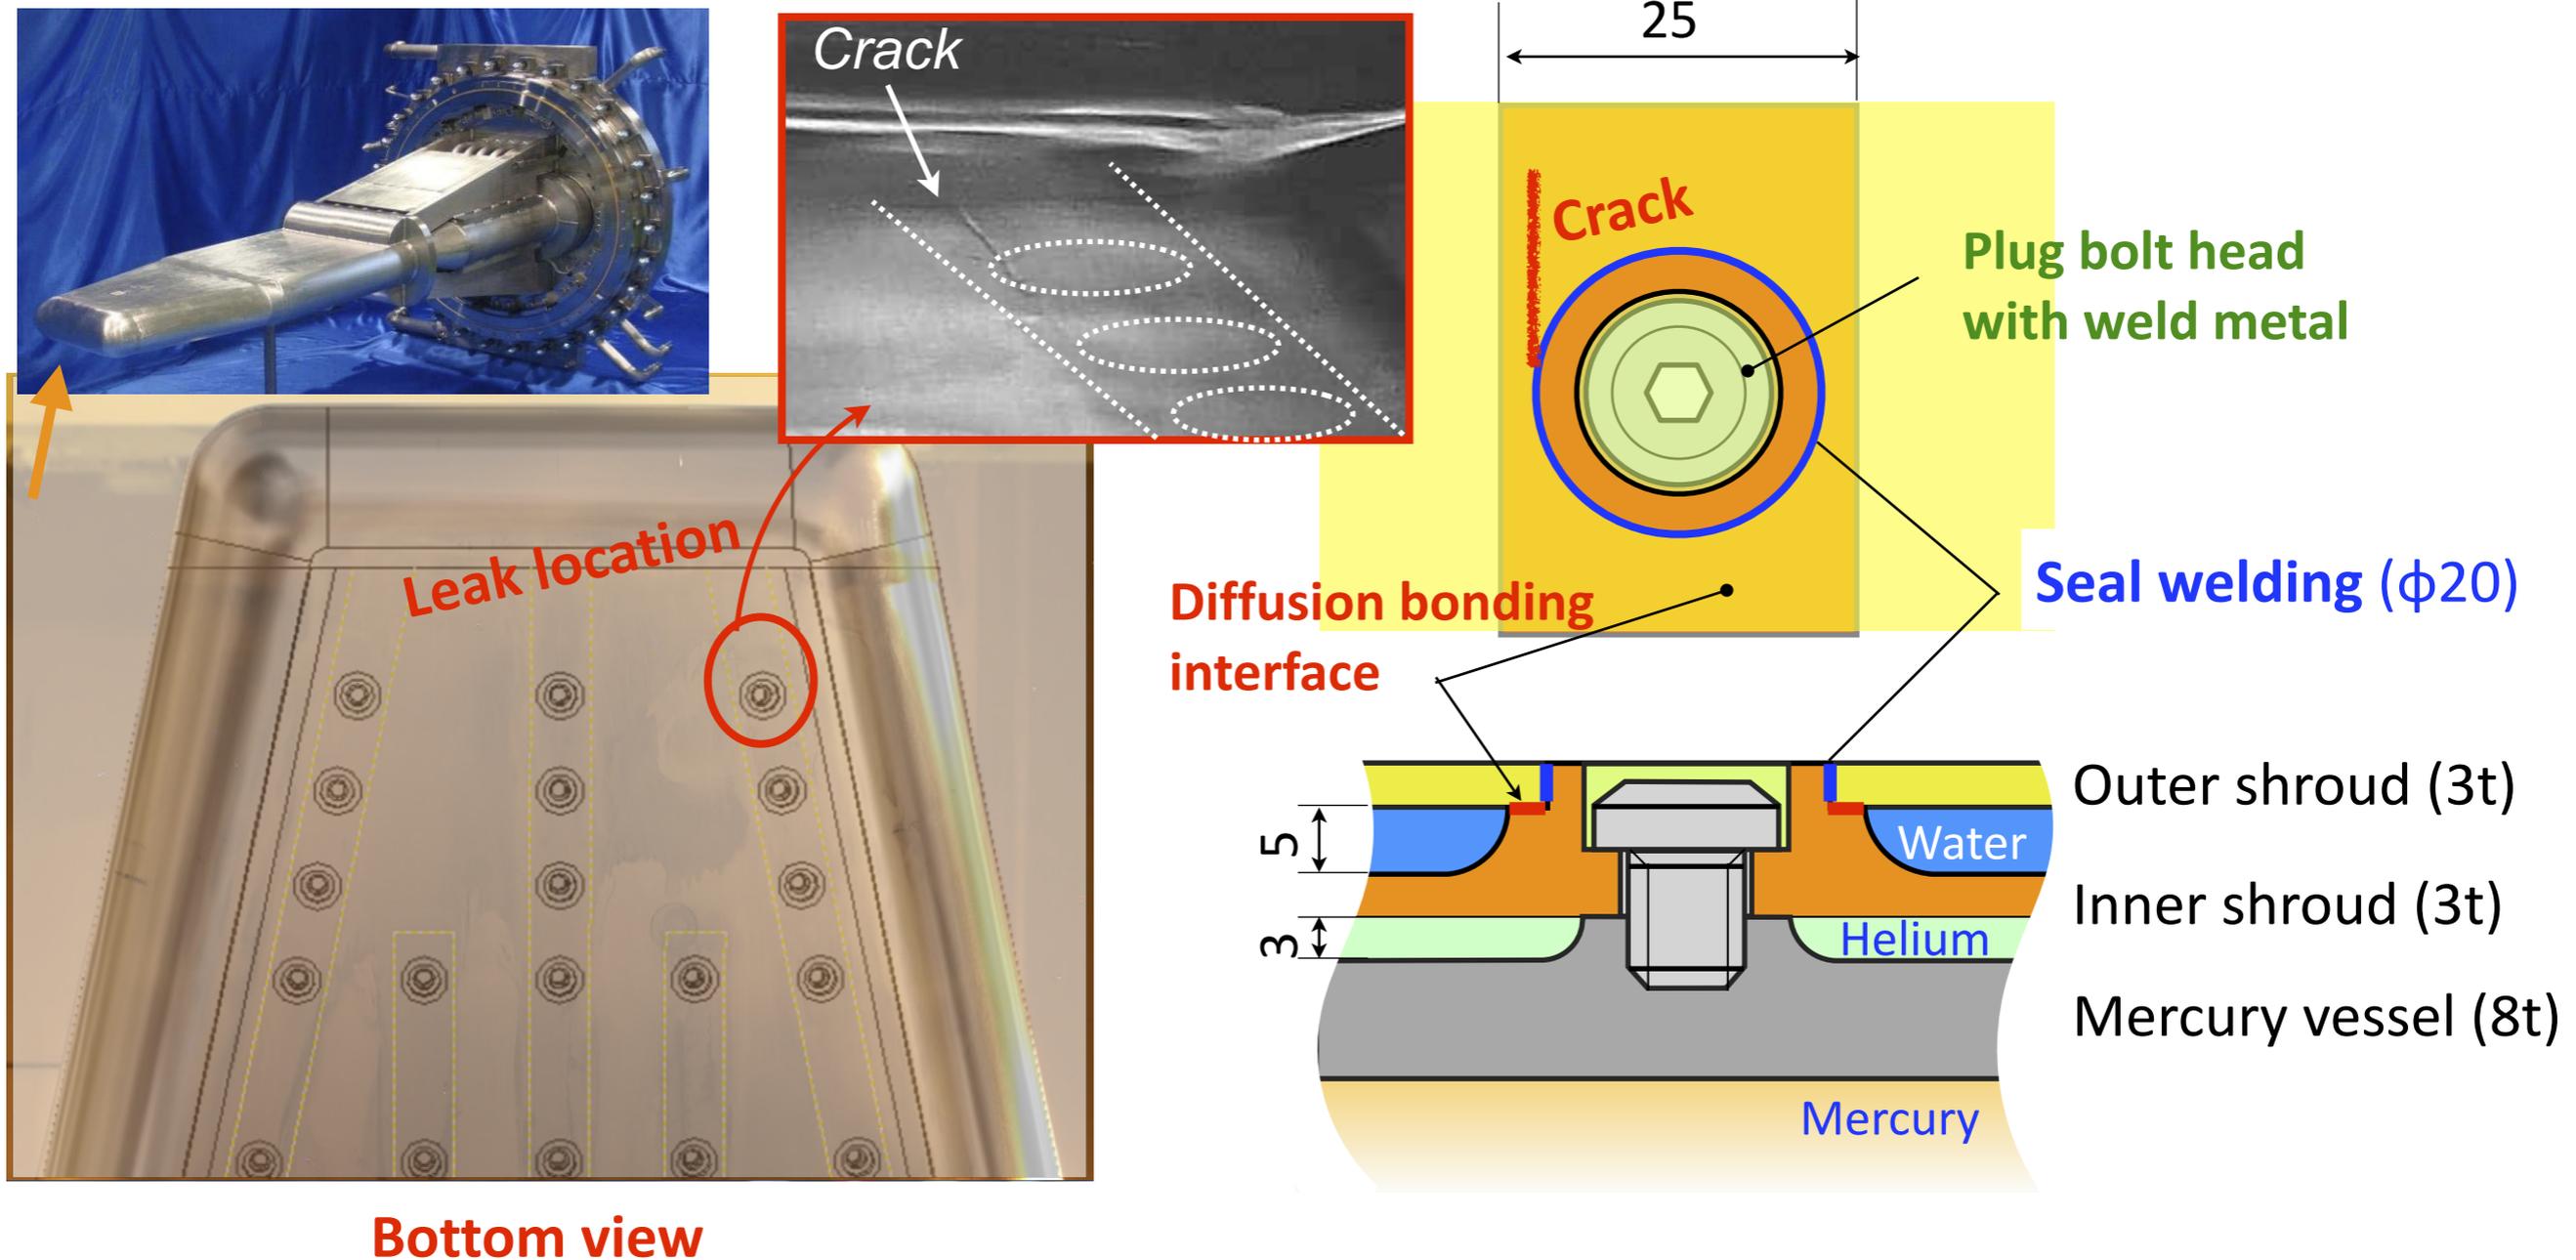
- Crack propagated through the seal welded part between inner and outer shroud
- Seal welding without groove was performed by GTAW to satisfy only seal performance
- Penetration depth is less than 1.5 mm (Structural strength is not expected)

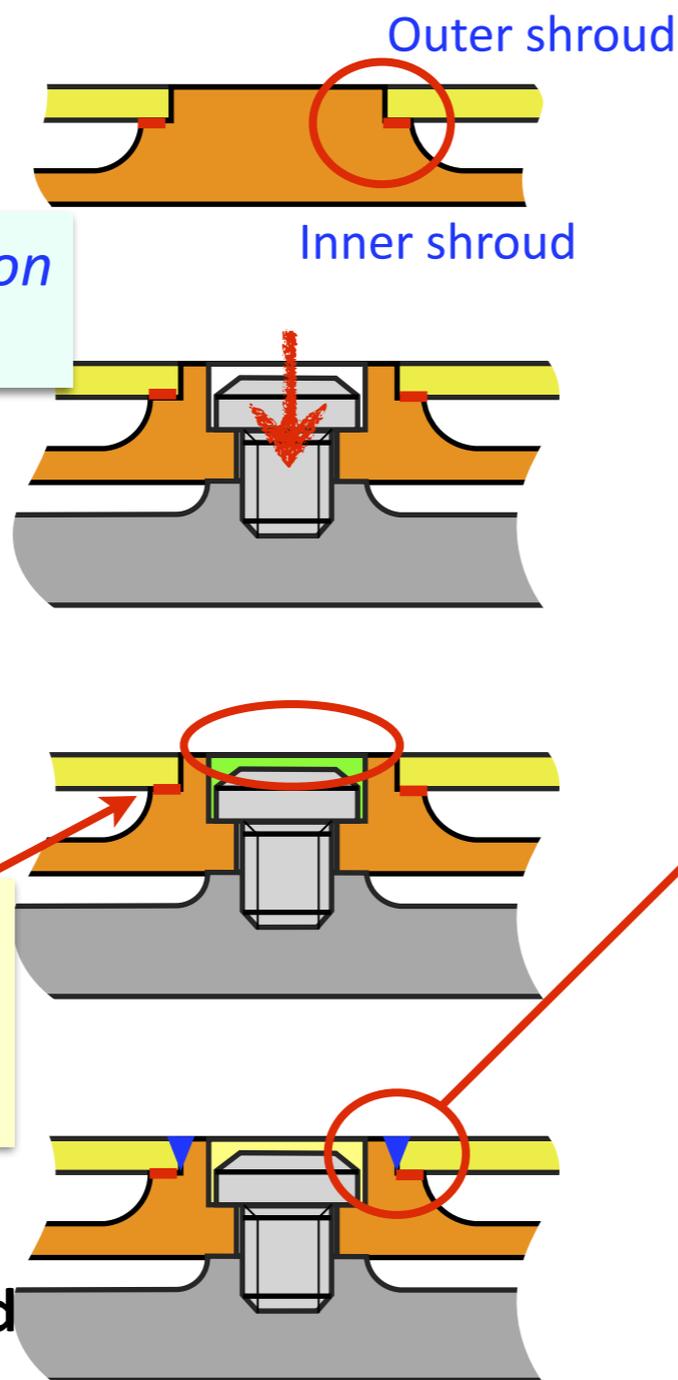
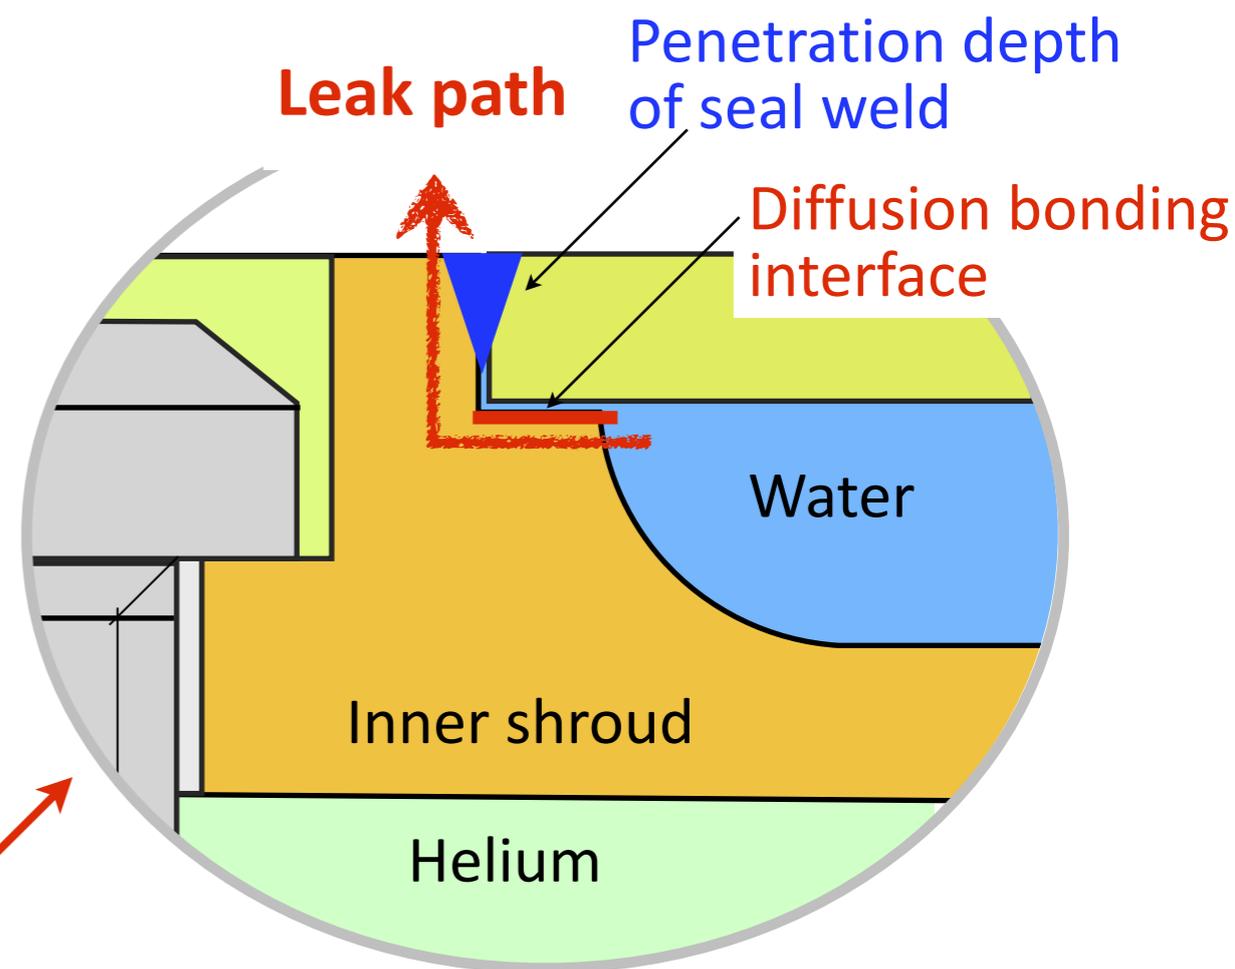
Seal welding of thin penetration depth was failed by repeated thermal stress

- Total number of thermal cycles due to beam trip for 5th target is ca. 2500
- Structural design, that allowed the seal welding without groove, was attributed to the water leak

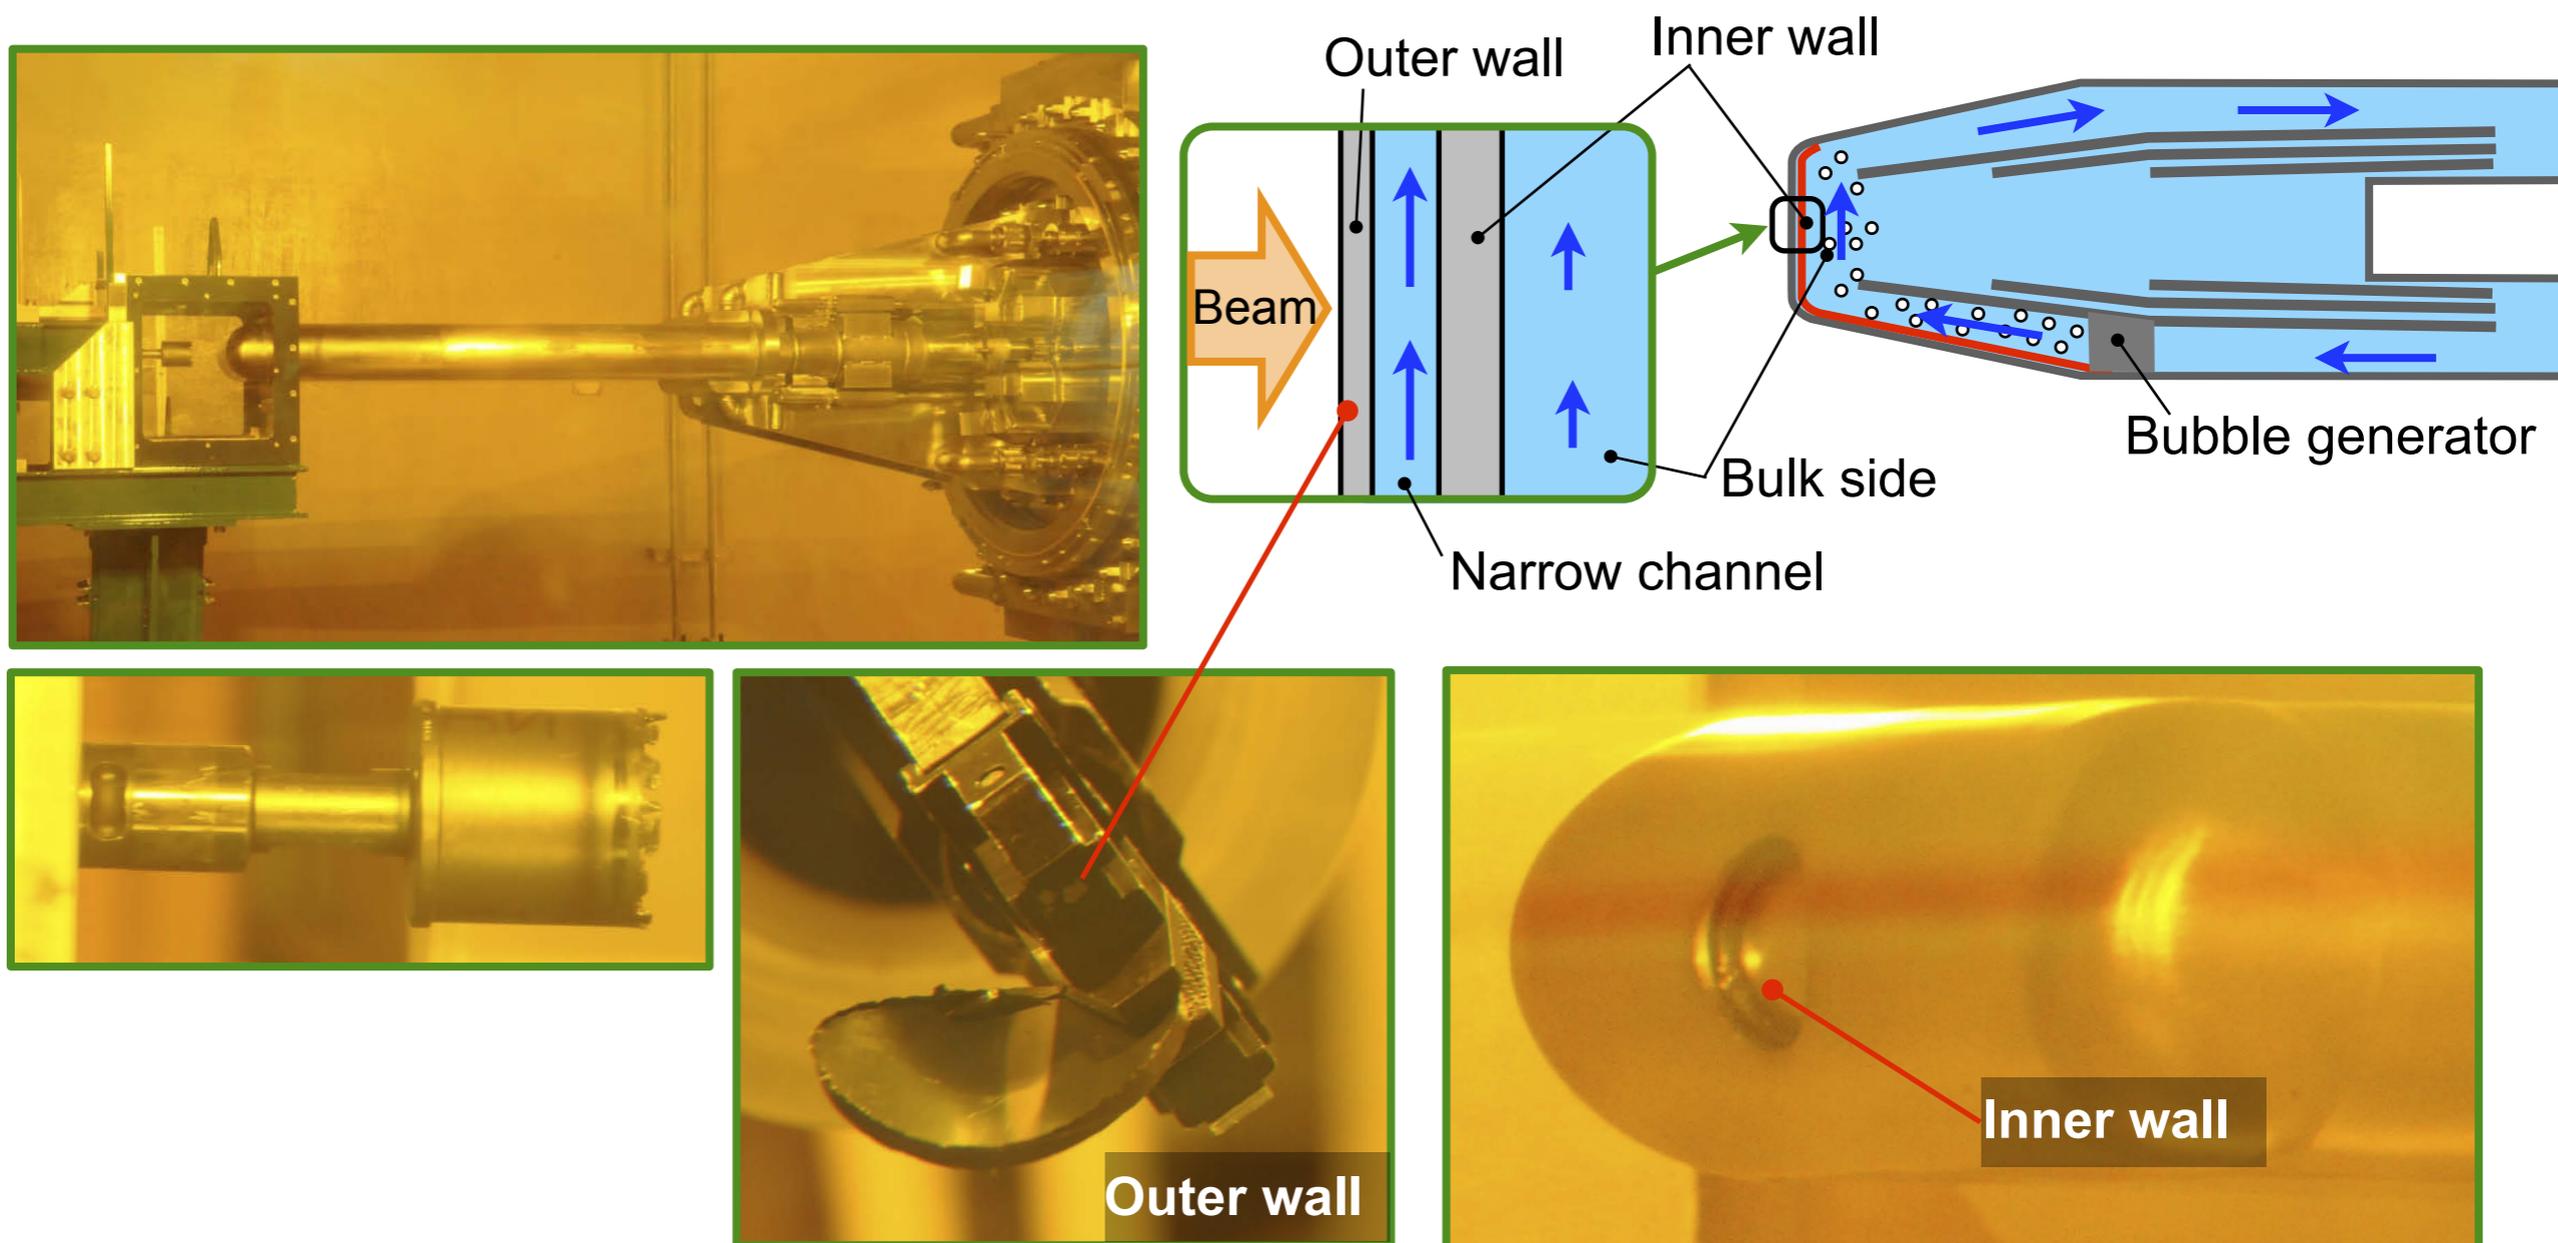
- Beam window of failed target vessel was cut to observe cavitation damage inside mercury vessel
- Cavitation damage on narrow channel was measured by replica method
- Innermost surface of beam window could not cut due to broken of cutter
