Cavitation damage in double-walled mercury target vessel

**J-PARC Center,
Japan Atomic Energy Agency**

Cutting and inspection of 5th target

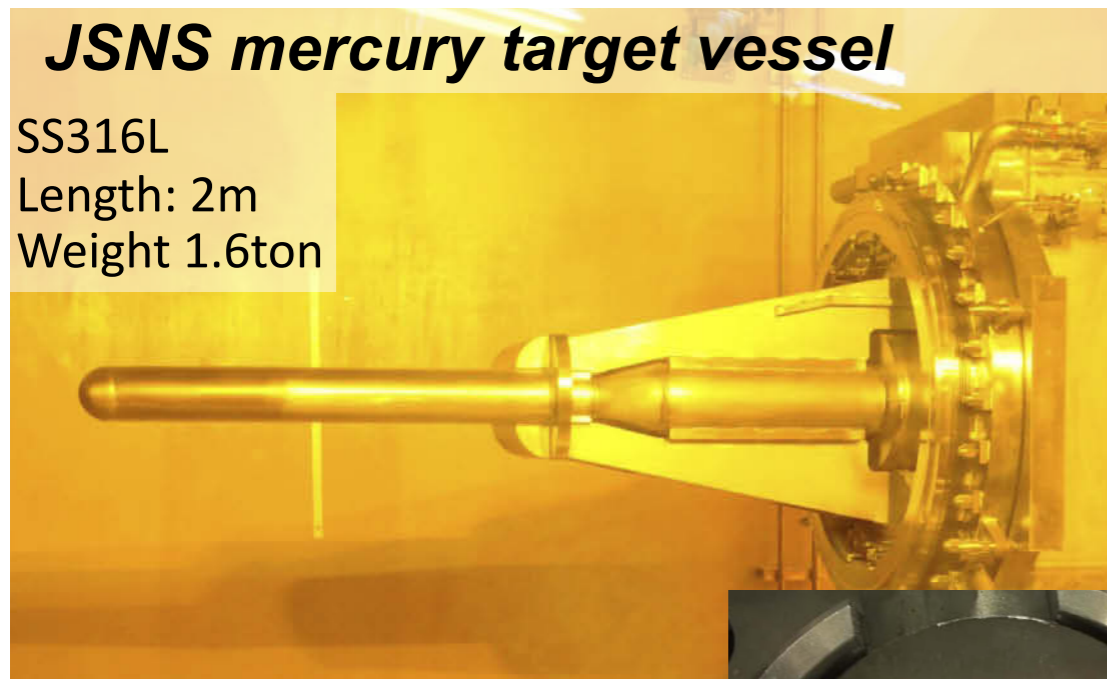
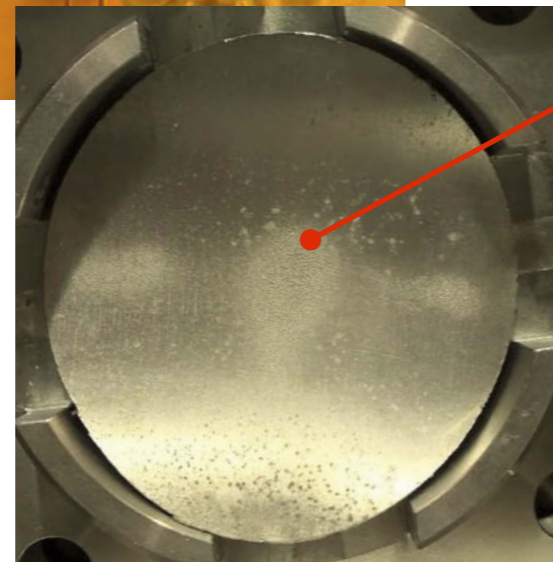
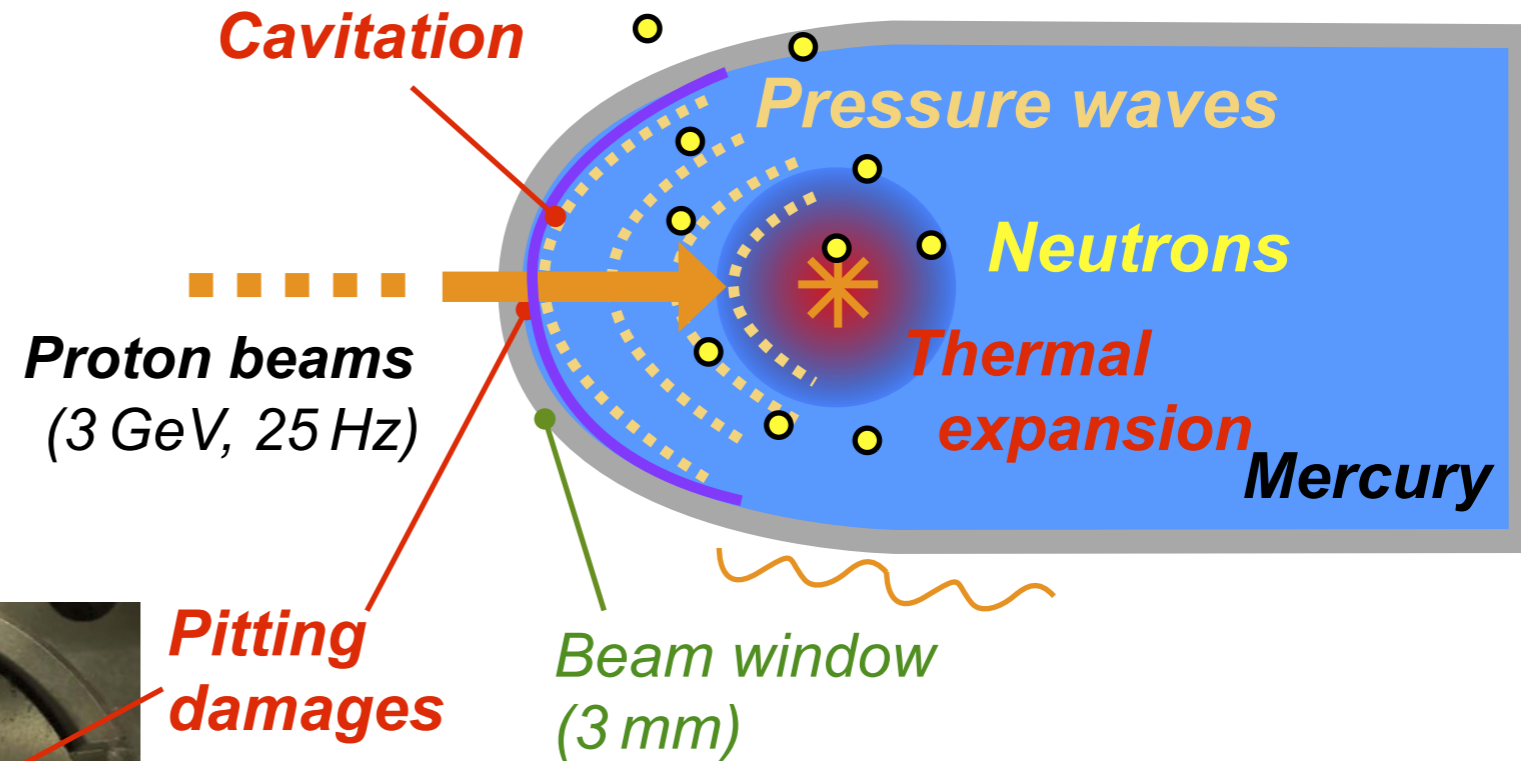
*Inside beam window of 1st JSNS target
475 MWh (200 kW at maximum)*

- Cavitation-induced erosion degrades structural integrity of the target vessel, e.g. mercury leakage and fatigue failure
 - Damage increases with the beam power
 - Cavitation damage mitigation is necessary under high power operation
- Designed lifetime of JSNS target is 2500 MWh (tentative dose limit 5 dpa)

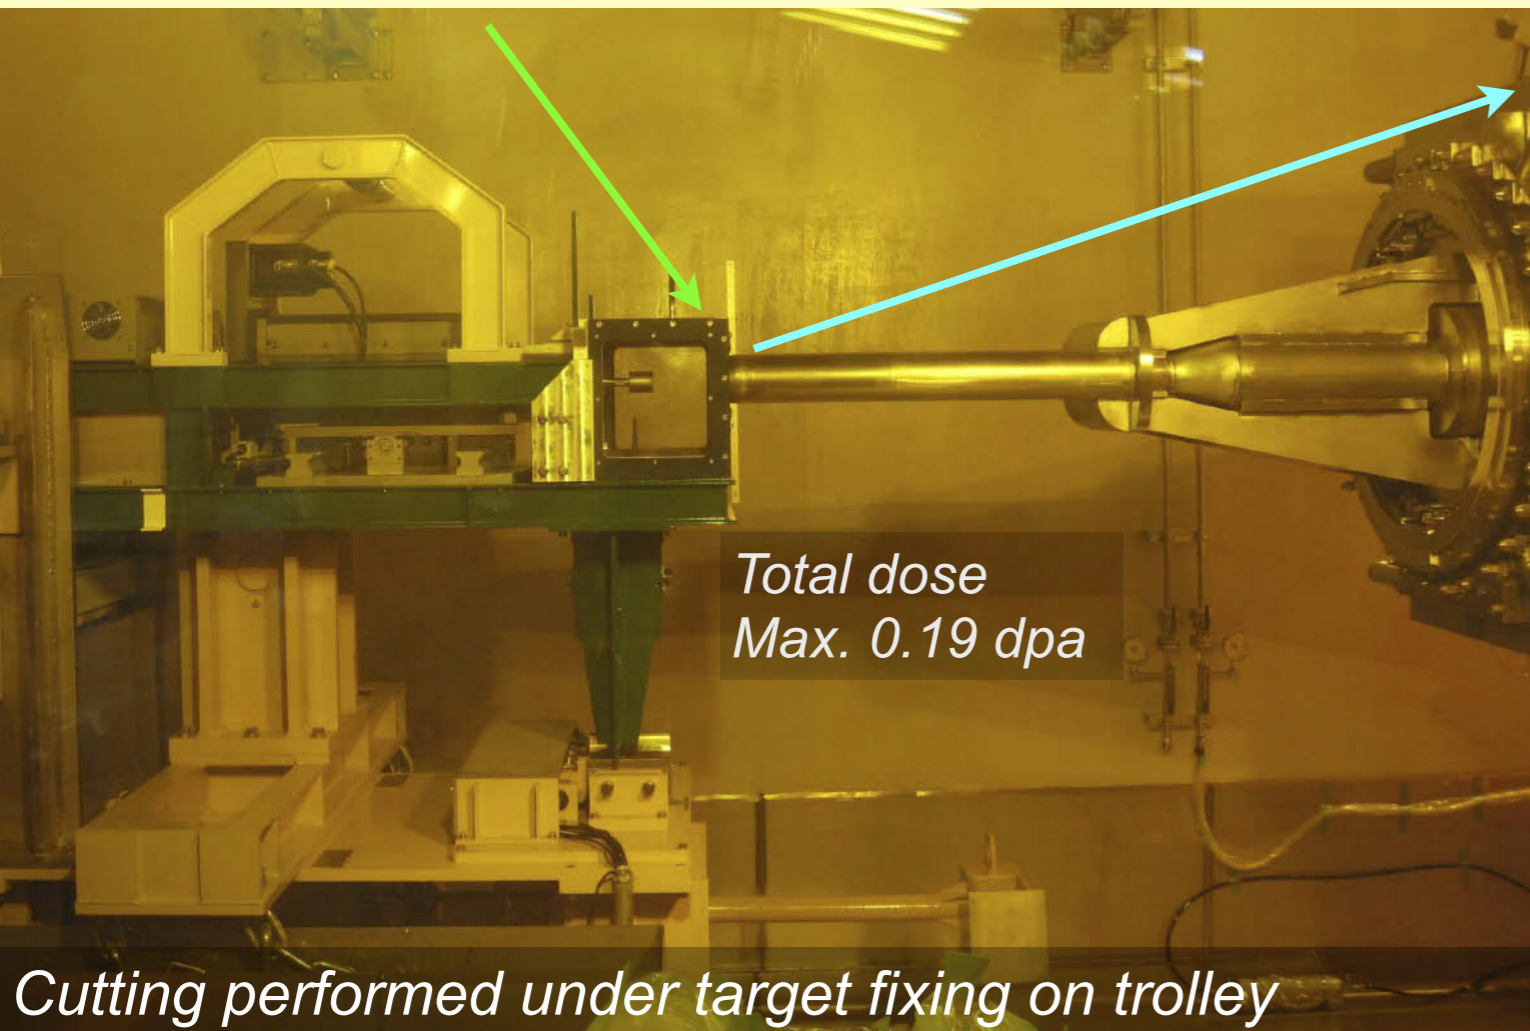
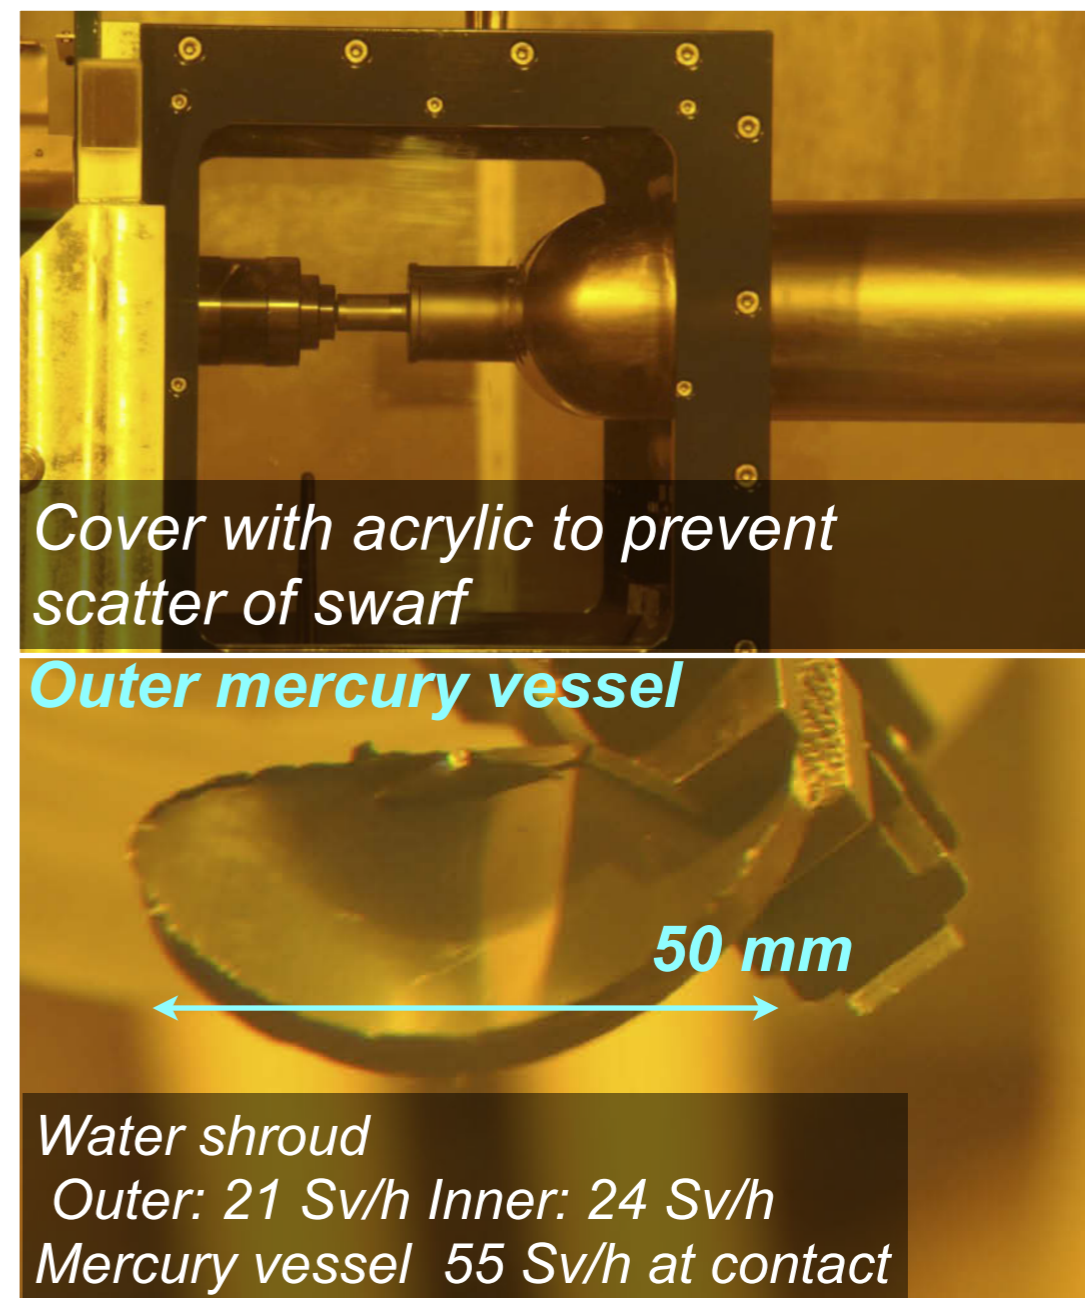
Measured dose rate at the center of beam window is 245 Sv/h at 680 MWh after 4 months cooling

- 5th target vessel was failed by water leak from water shroud
- Before replacing target to 7th target, beam window part was cut using annular cutter 50 mm in inner diameter to inspect inside damage
- Cut performed without any lubricant by full-remote handling

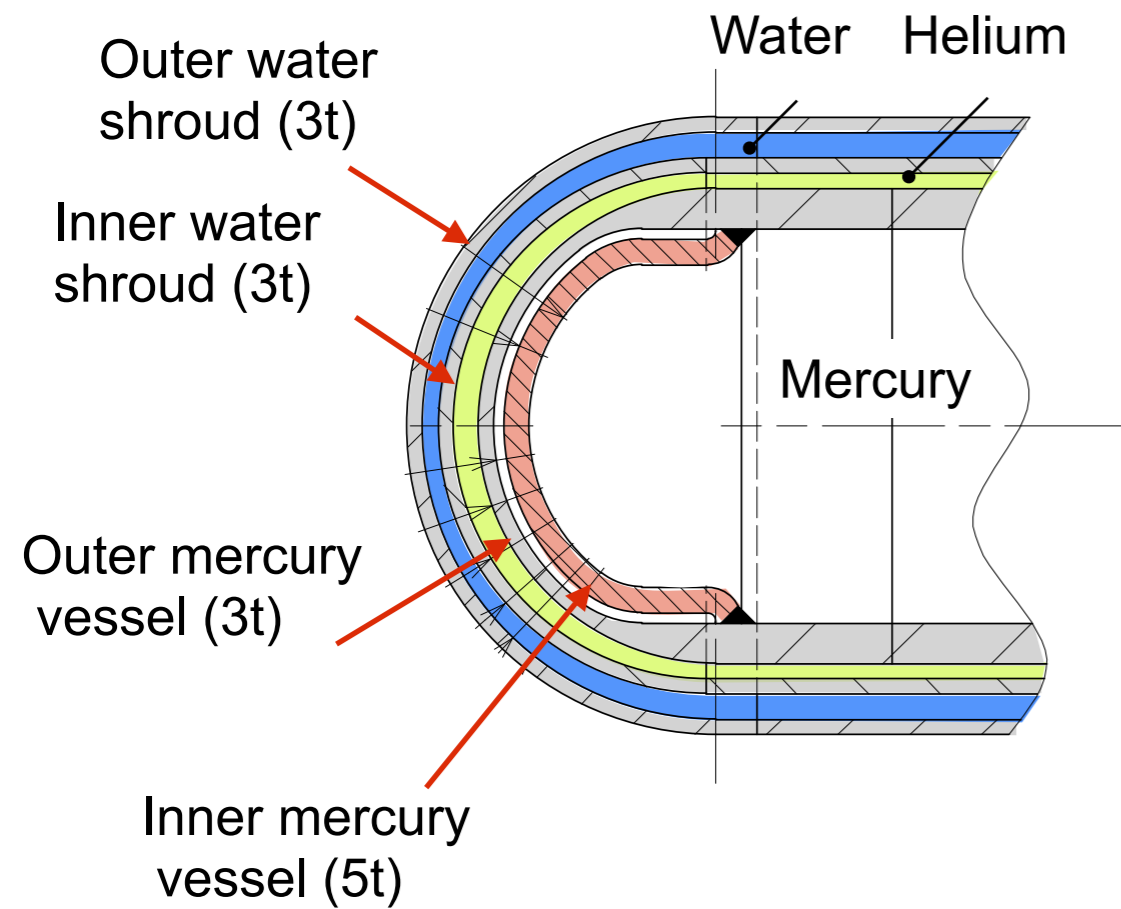
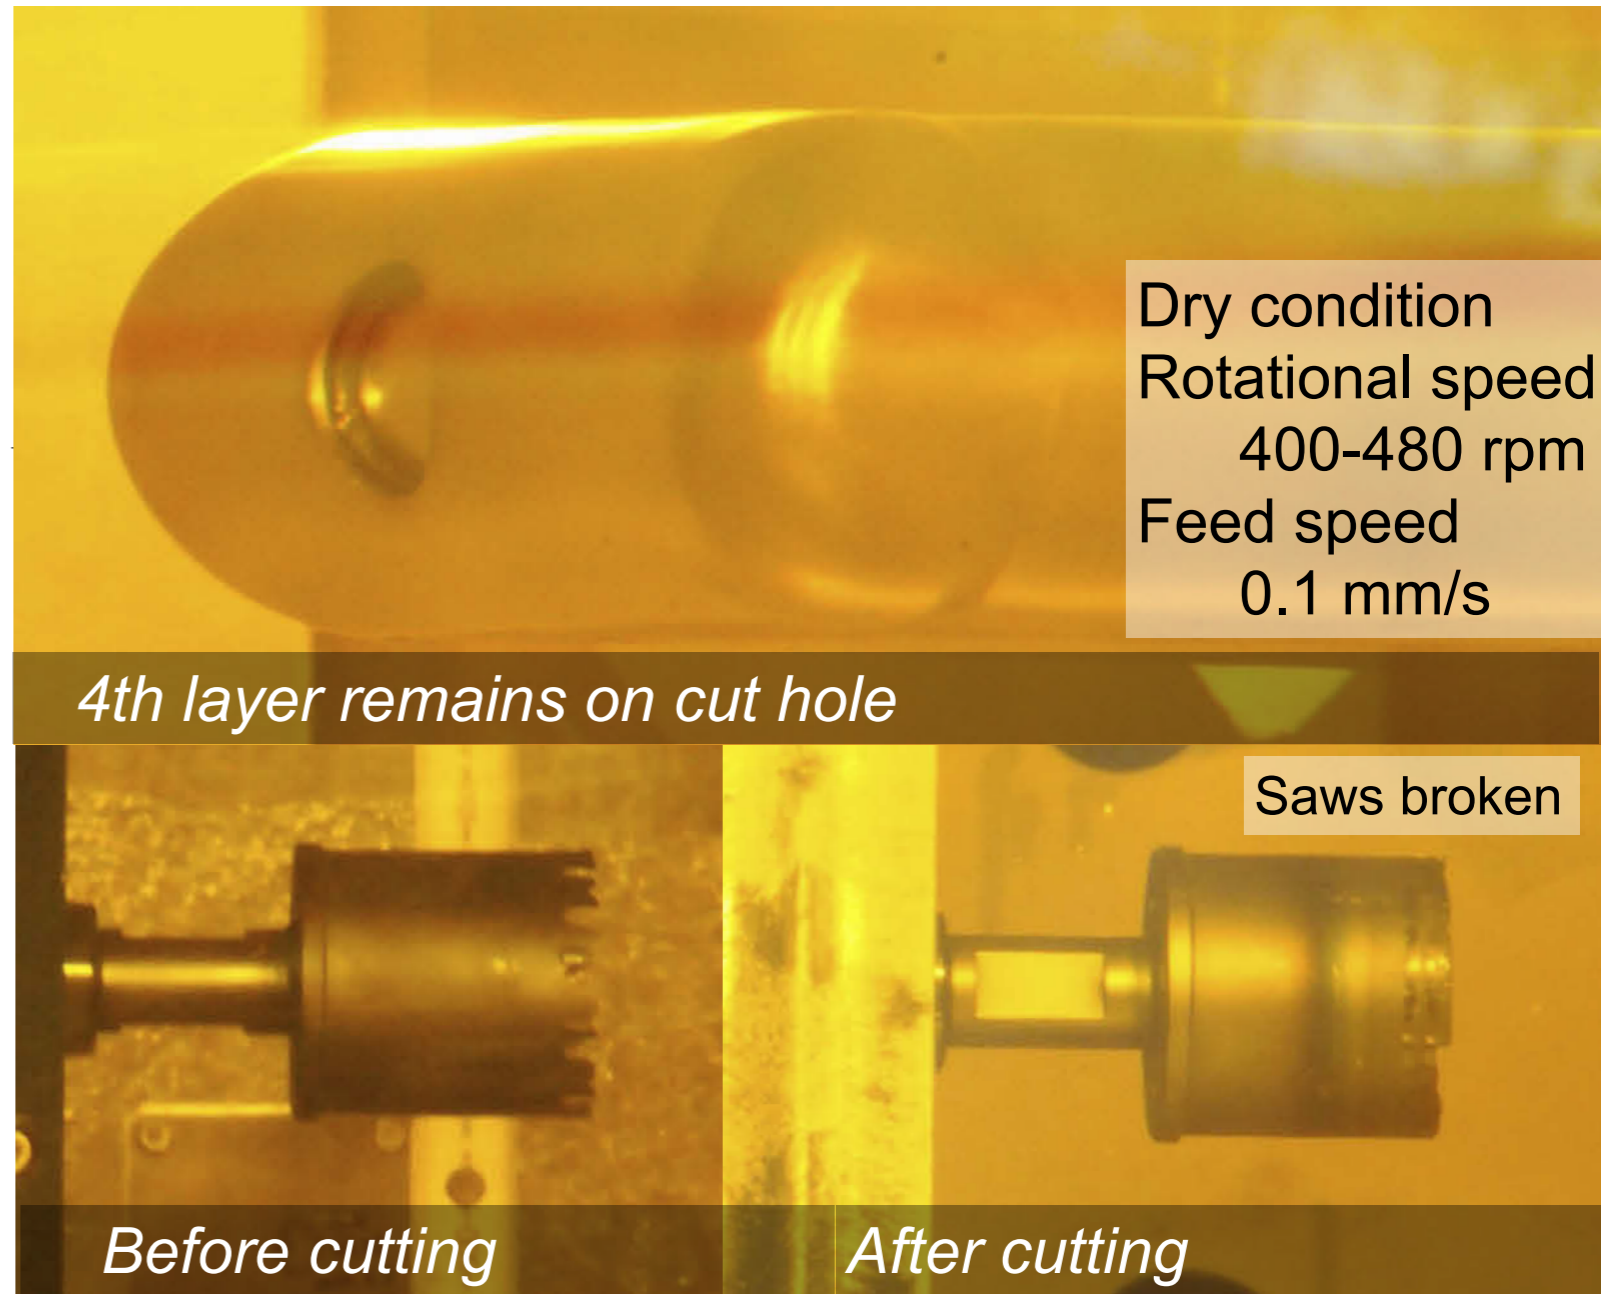
Vertical cross section of double walled target (5th target)

- 5th target (4 layers structure) was cut using annular cutter
- All prepared cutters (tip of saw) were broken by heat of dry cutting ($>500^{\circ}\text{C}$)
Need to reconsider cutting condition and material of saw (coating, etc.)
- Innermost layer of beam window is still remains on cut hole
The effect of gas microbubbles injection on cavitation damage was not confirmed

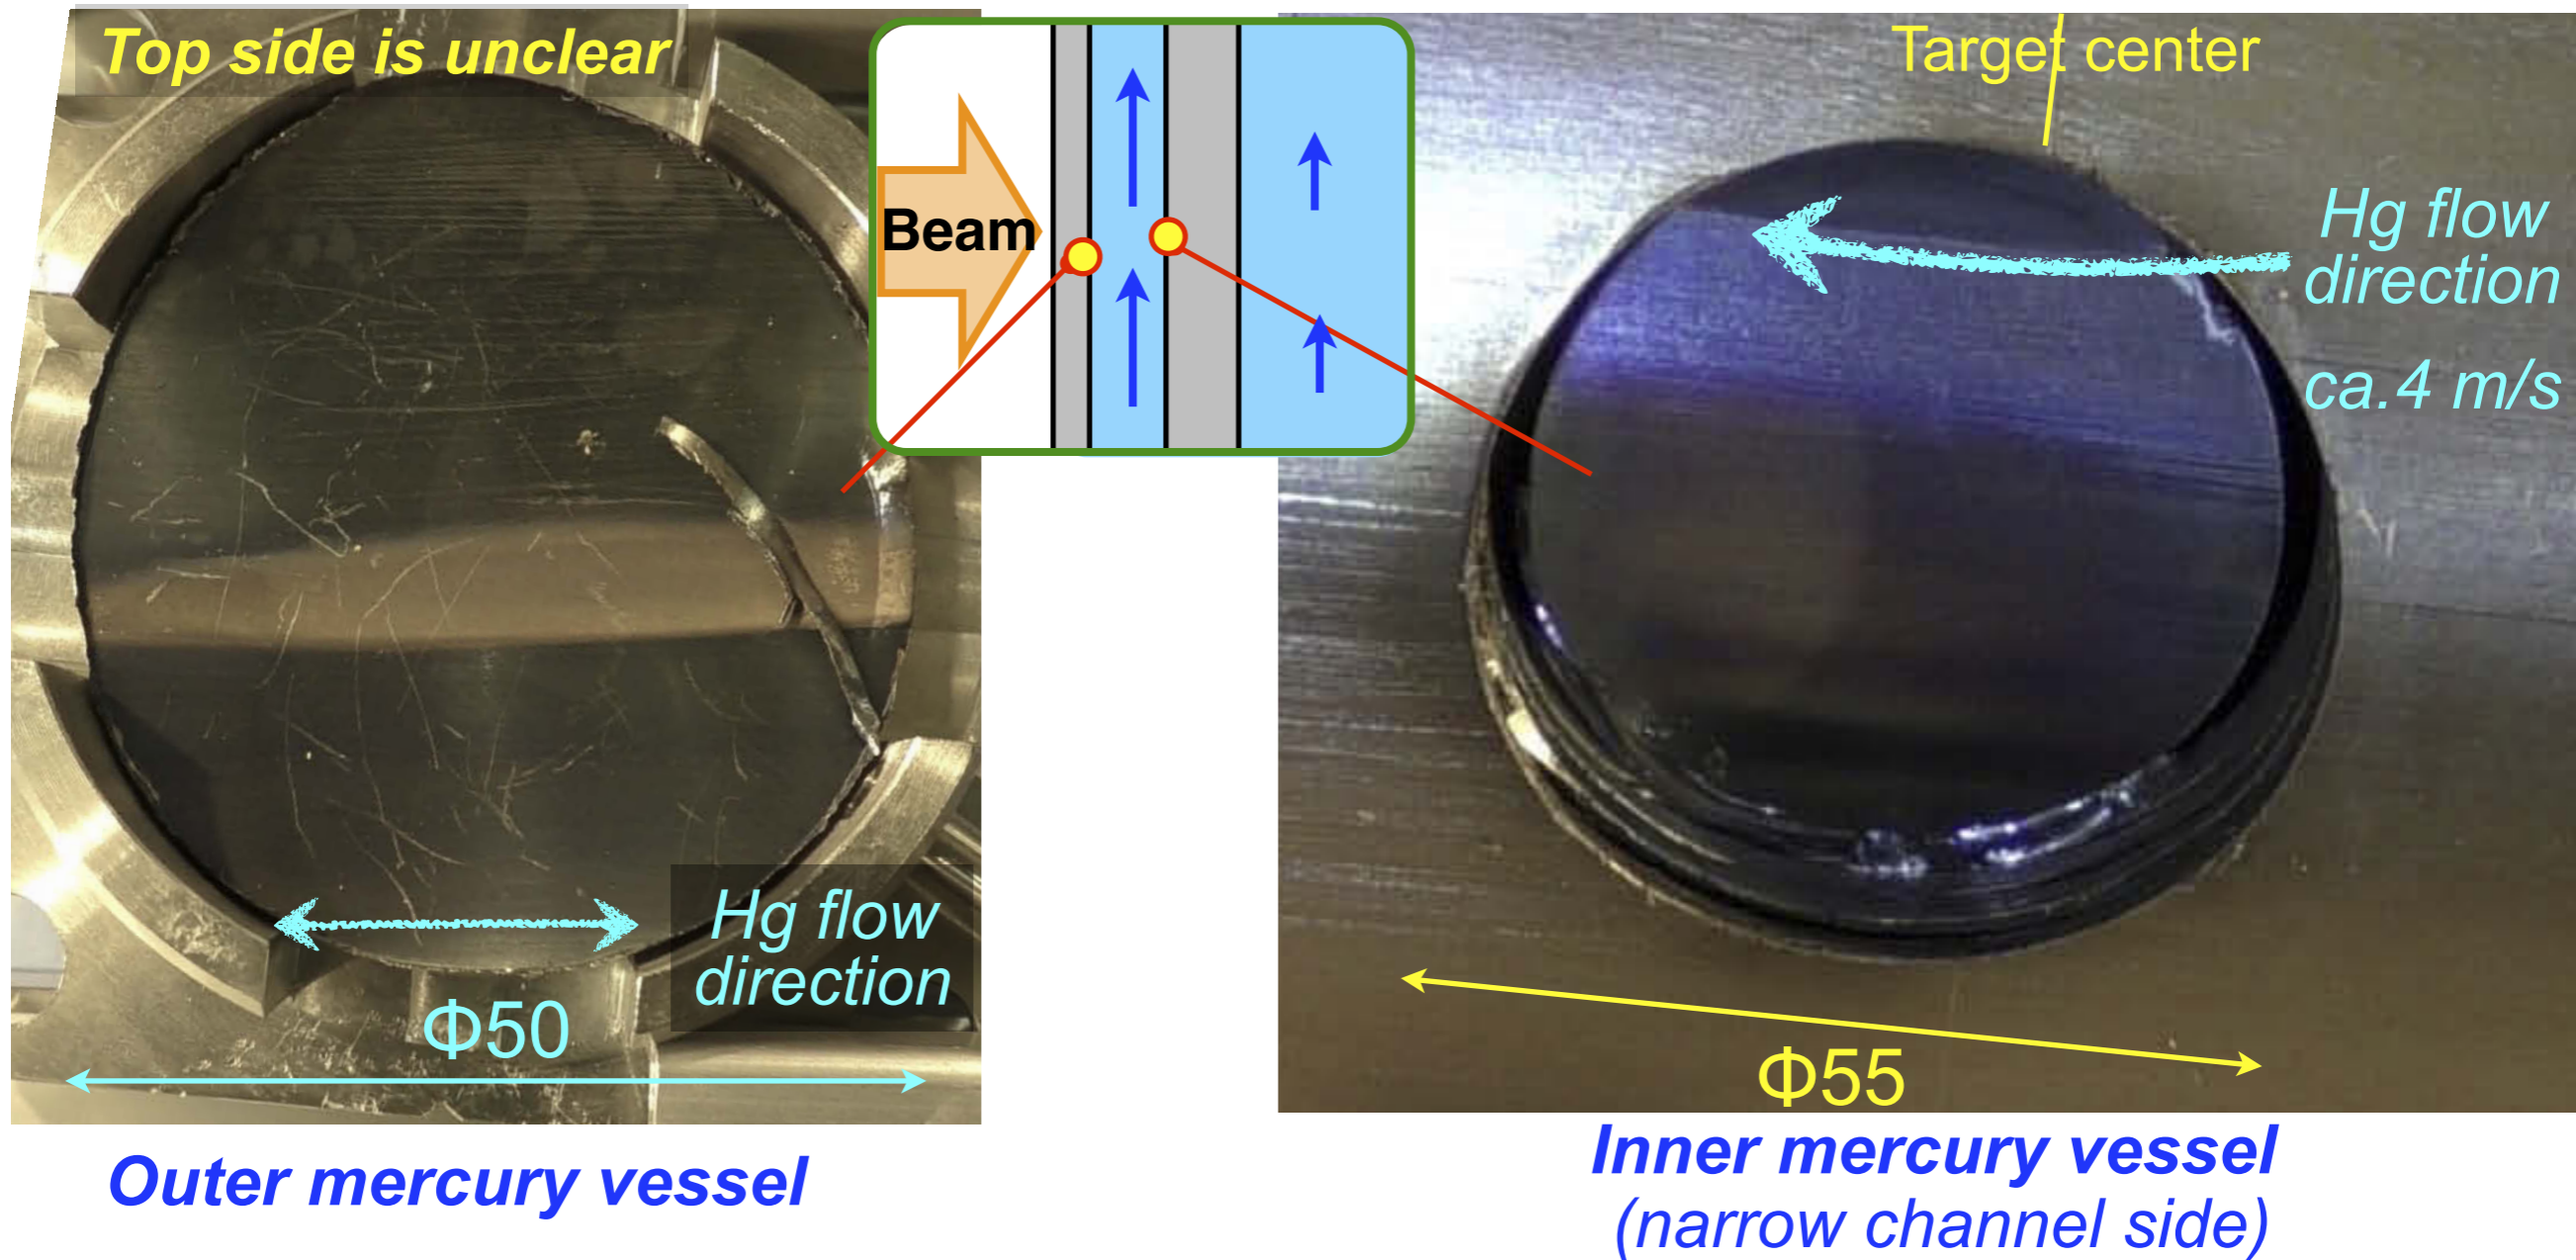
Outer mercury vessel

**Inner mercury vessel
(narrow channel side)**

- Annular cutter was ca. 7.5 mm offset from center
- Horizontal damage band due to change of roughness was observed
- Machined scratch is recognized at top and bottom side, eroded depth seems small
- Color of surface is changed by heat of cutting
- Severe damage due to the cavitation and erosion was not observed on inner side 8

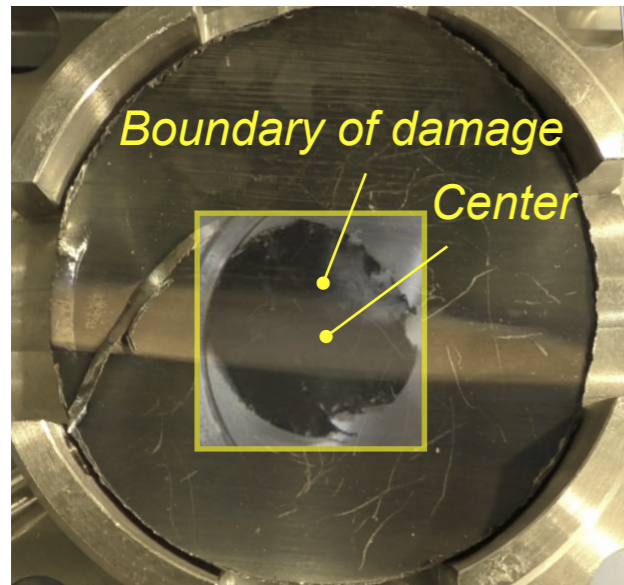
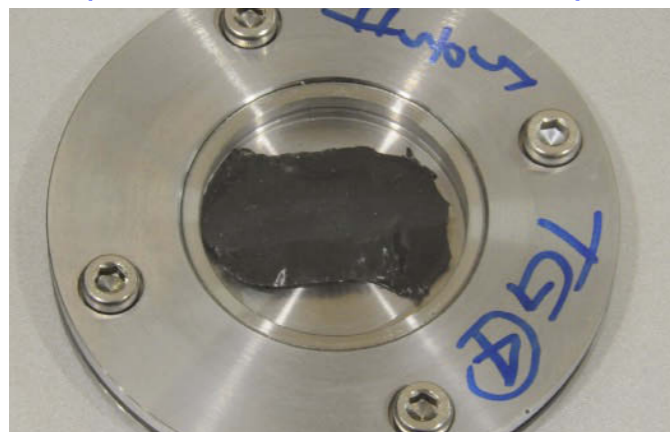
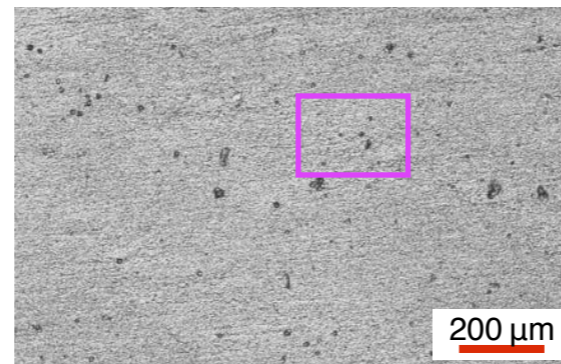
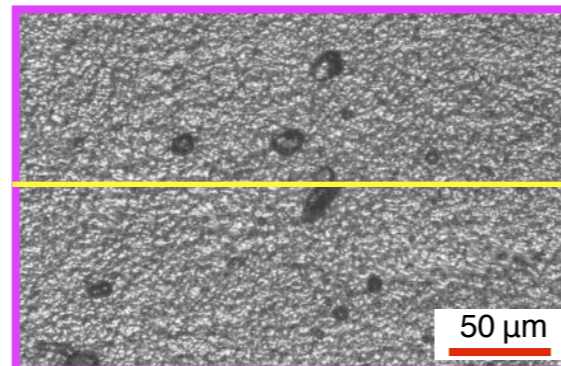
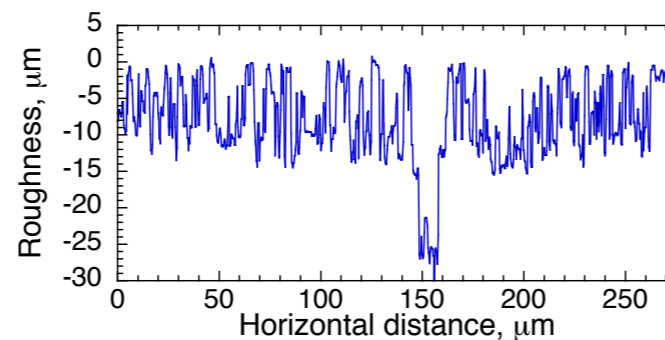
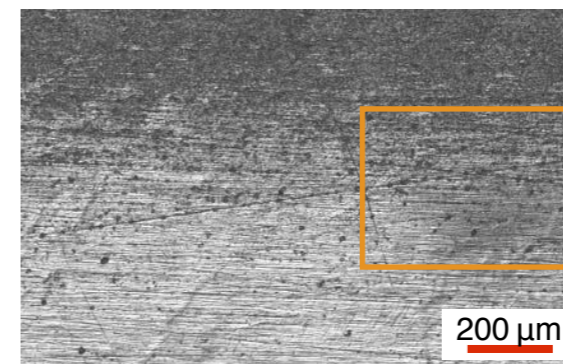
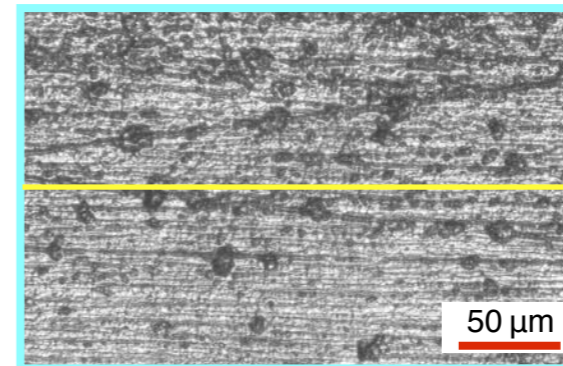
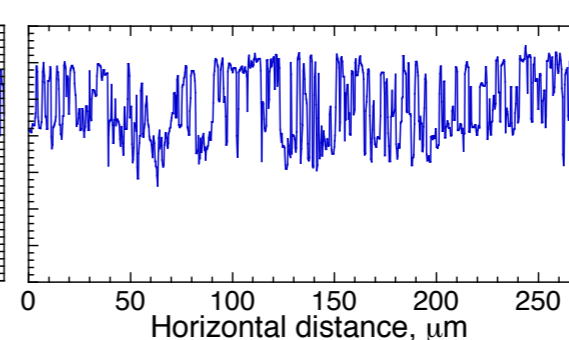
Center of band-like damage

Boundary of band-like damage

- Damage band seems to be formed by accumulated pits
- Maximum depth at around center is not changed much compared with off-center
- Relatively deep pits are scattered with rough surface
- Maximum damage depth at center is $25 \pm 5 \mu\text{m}$ (deeper than predicted value 10-15 μm)

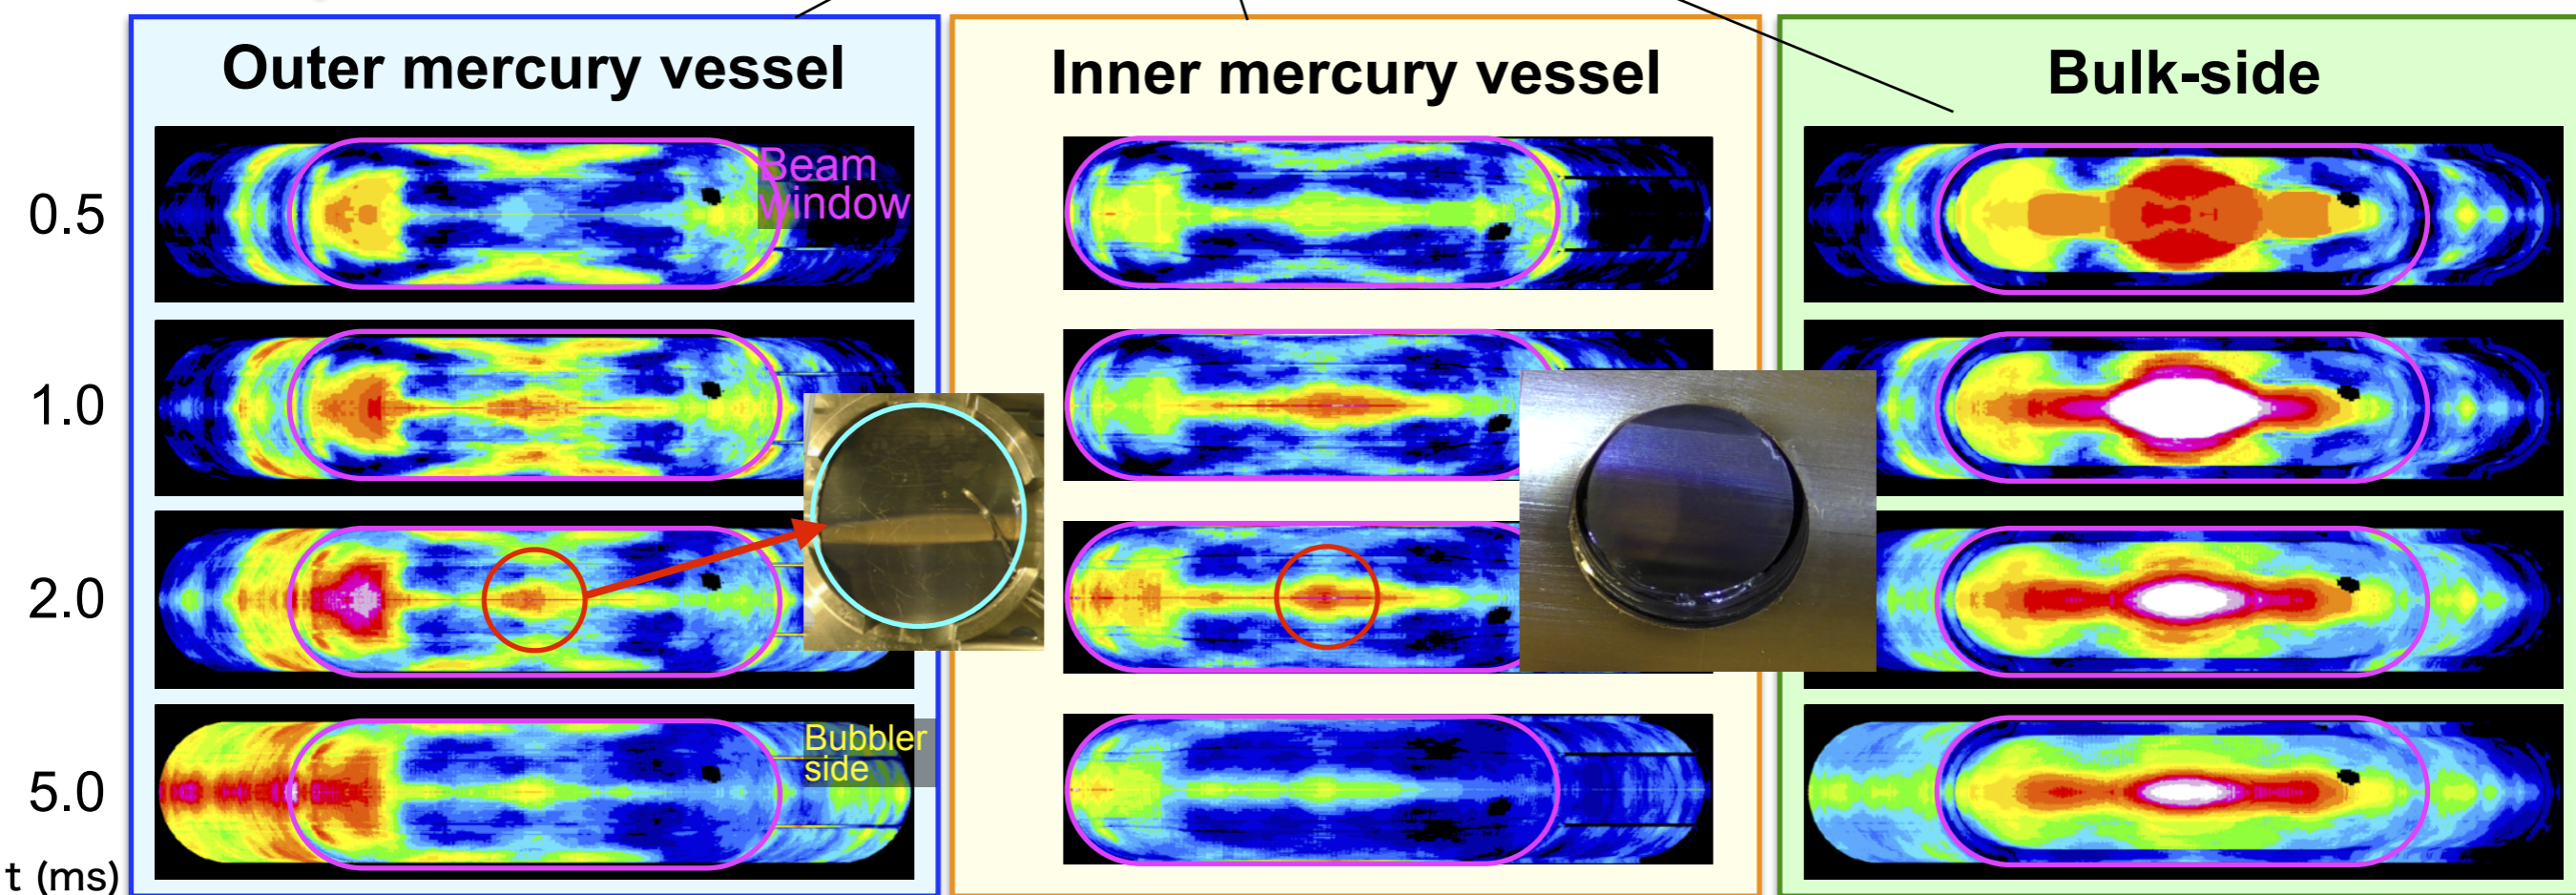
Distribution of accumulated value of negative pressure period: T_{Naccum}

- Accumulated negative pressure period up to 2 ms seems to be correlated with the damage distribution on cut out disk
- Short time of negative pressure period is effective to form damage in narrow channel

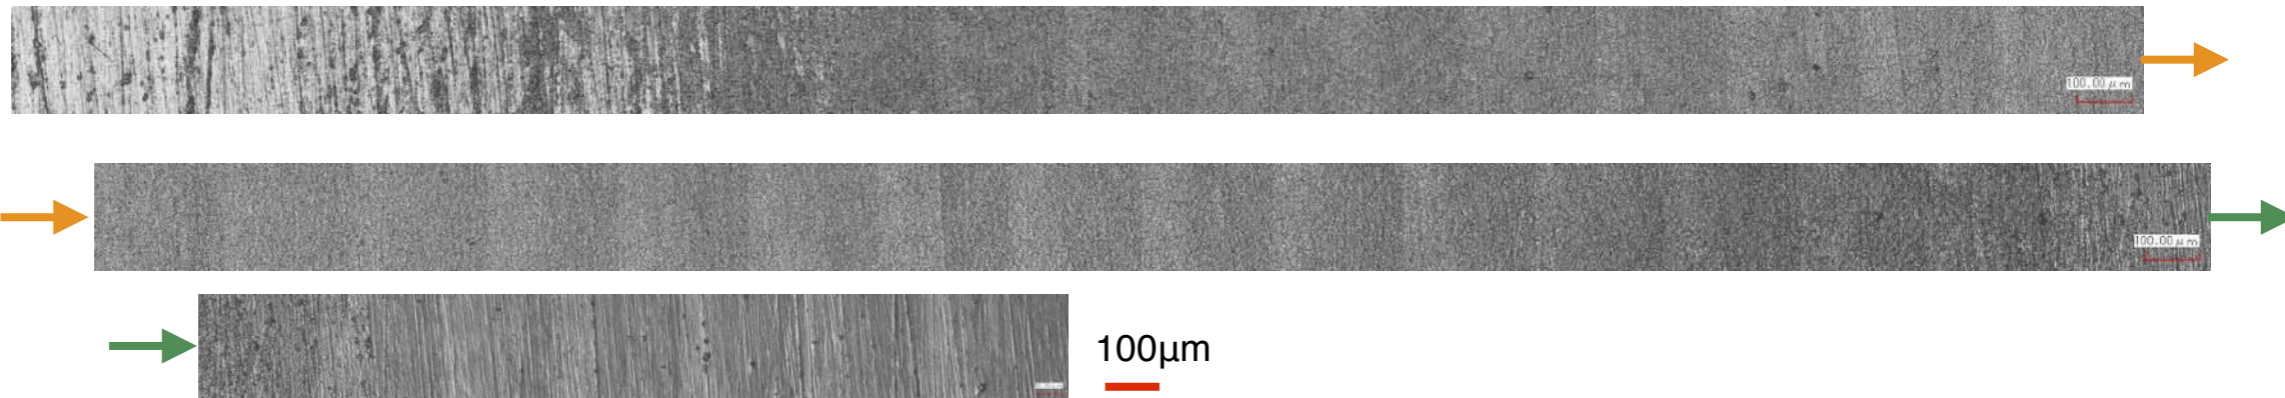
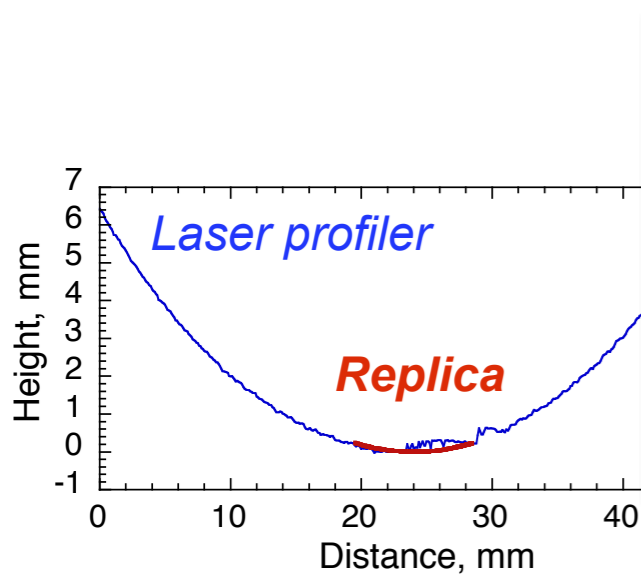
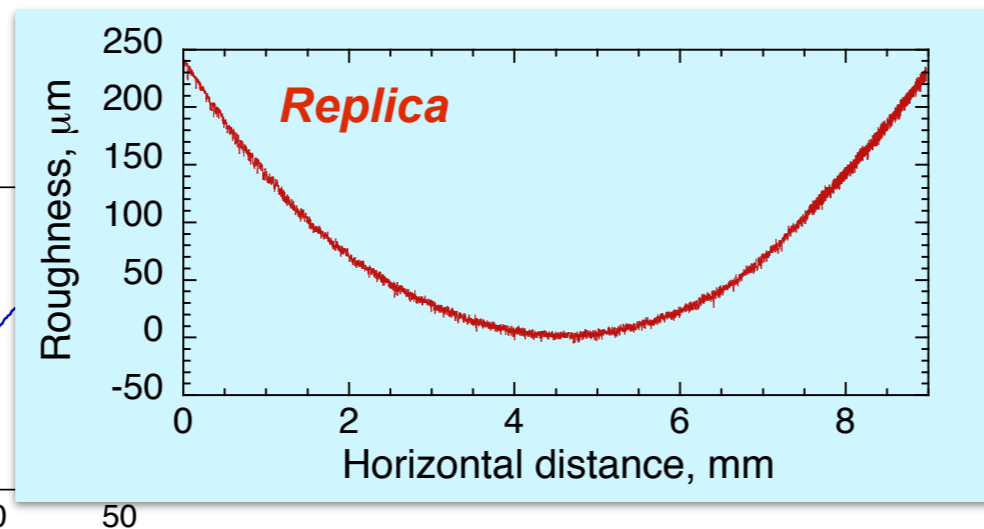
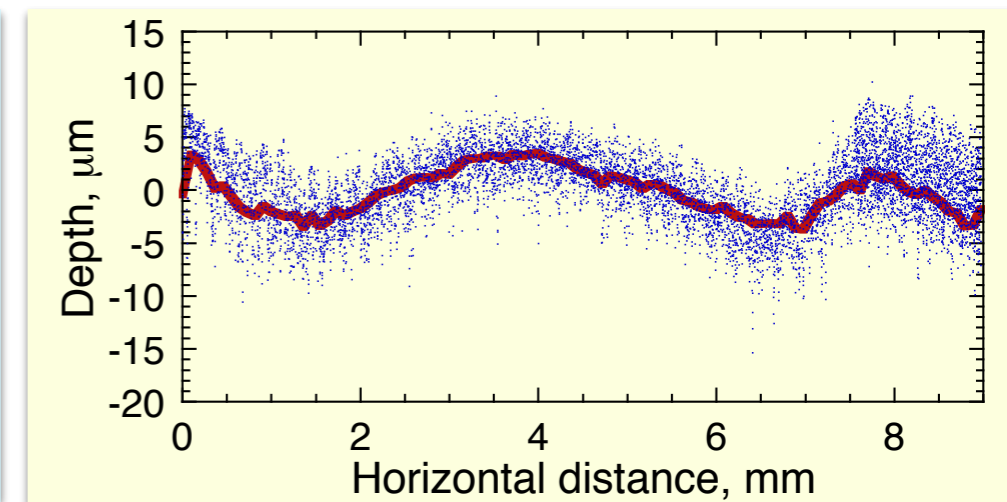
- Silicone rubber replica (Struers Repliset-F1, 0.1 μm in resolution) was used to quantitatively measure the damage depth using laser microscope
- Clear surface erosion was not detected
- Surface roughness (swell) is about $\pm 10 \mu\text{m}$
