Hardness of a carburized surface layer on AISI 316L stainless steel from high-use Spallation Neutron Source target vessels after irradiation

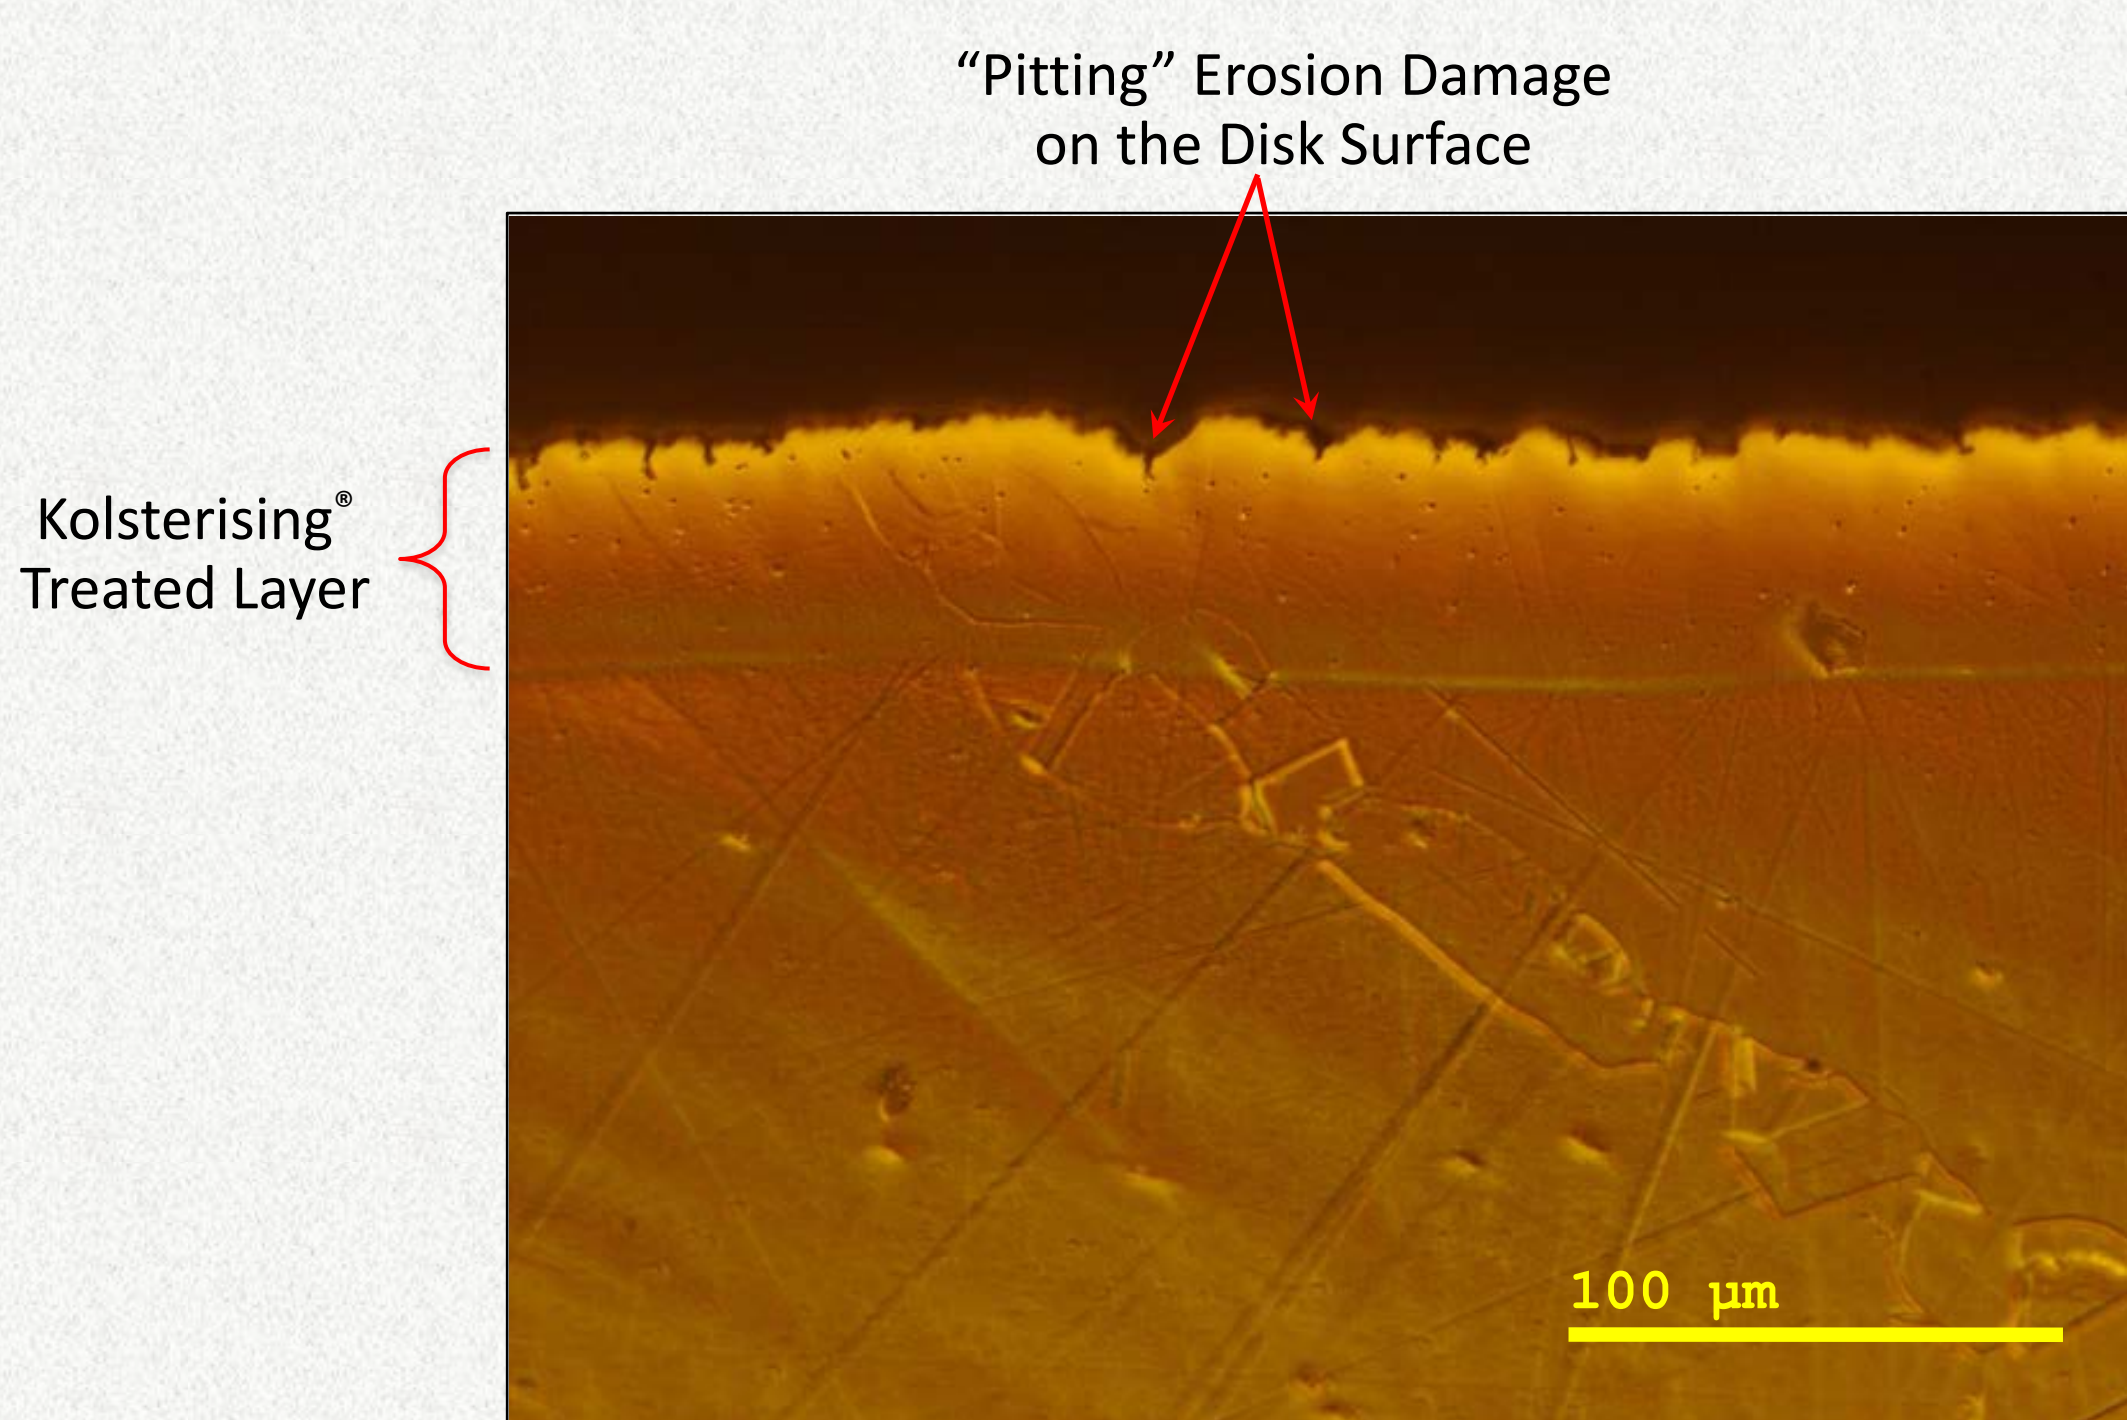
The treatment increases the carbon content at the surface to ~6 wt%, which gradually decreases to the base metal carbon concentration of ~0.2 wt% C at approximately 50 μm. While the treatment increases the resistance of the surface to erosion, damage to the surface eventually occurs in the form of pits, as shown in Figure 1, followed by steady-state mass loss.

Figure 1. Cross section micrograph of specimen from SNS mercury target vessel containing a Kolsterising treated layer pitted by erosion damage.

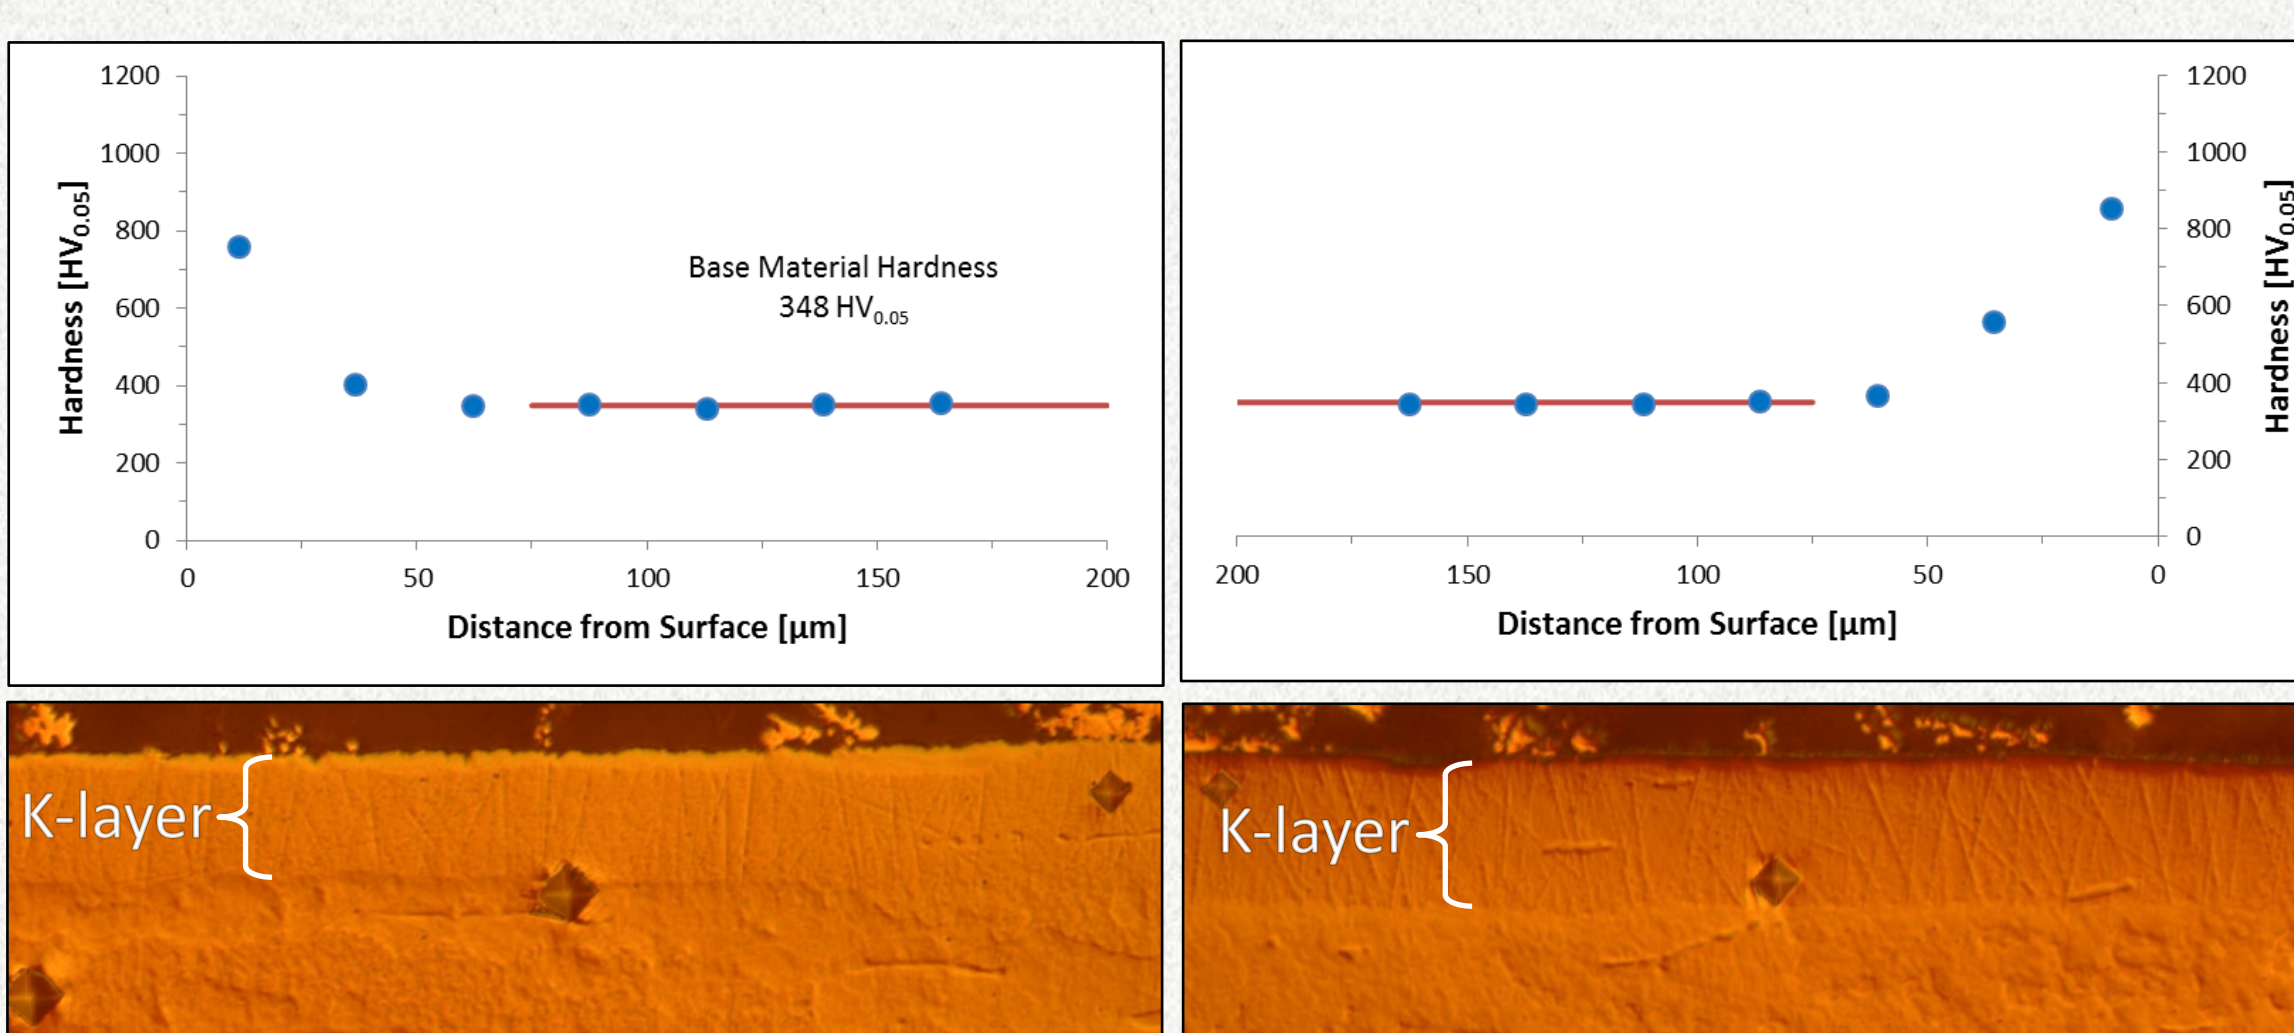
A typical hardness profile and micrographs of the microhardness testing indentations for specimen D6-17 (7.25 dpa) from Target 9 are shown in Figure 4. The average base metal hardness was approximately 345 HV_{0.05}, and the K-layer was present on both the bulk-mercury facing surface and the surface facing the window flow. The peak hardness values (759 and 852 HV_{0.05}) were measured at approximately 10 μm from the vessel surface. The gradual increase in hardness near the surface was an indication that the carbon atmosphere had maintained a hardened surface layer.

Figure 4. K-layer hardness profiles for Specimen D6-17 from Target 9: bulk mercury facing surface (Left) and window flow facing surface (Right).

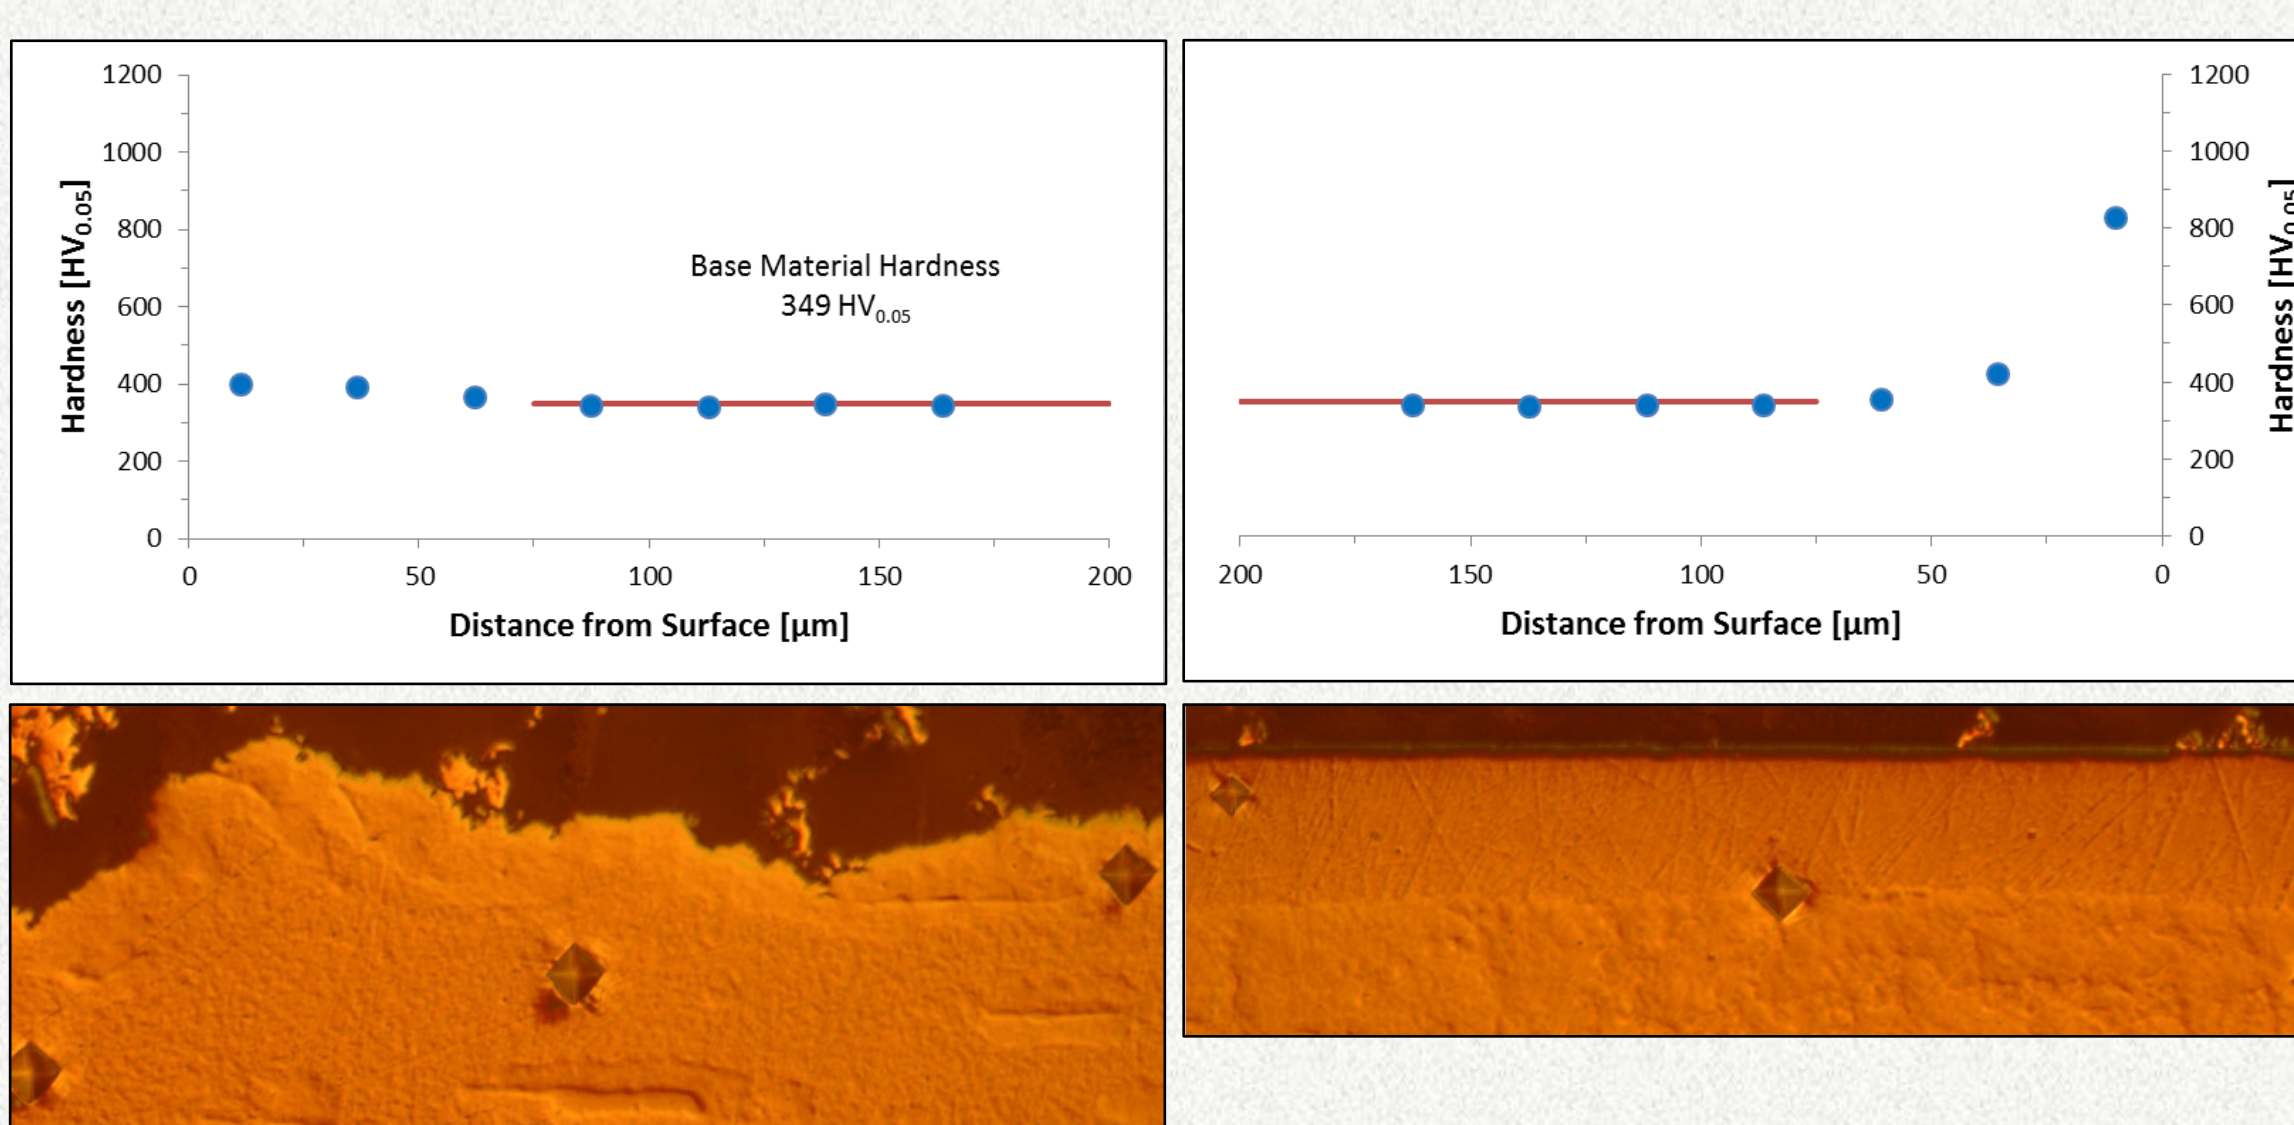
On some specimens, there were areas observed where cavitation-induced erosion had penetrated the K-layer and enhanced erosion of the substrate had begun, as shown for specimen D6-18 (7.4 dpa) from Target 9 in Figure 5. No hardened layer was measured in areas where the K-layer was absent or thinned appreciably, an example of pitting damage to D6-15 from Target 8 is shown in Figure 6.

Figure 5. K-layer hardness profiles for Specimen D6-18 from Target 9: bulk mercury facing surface (left) and window flow facing surface (right).

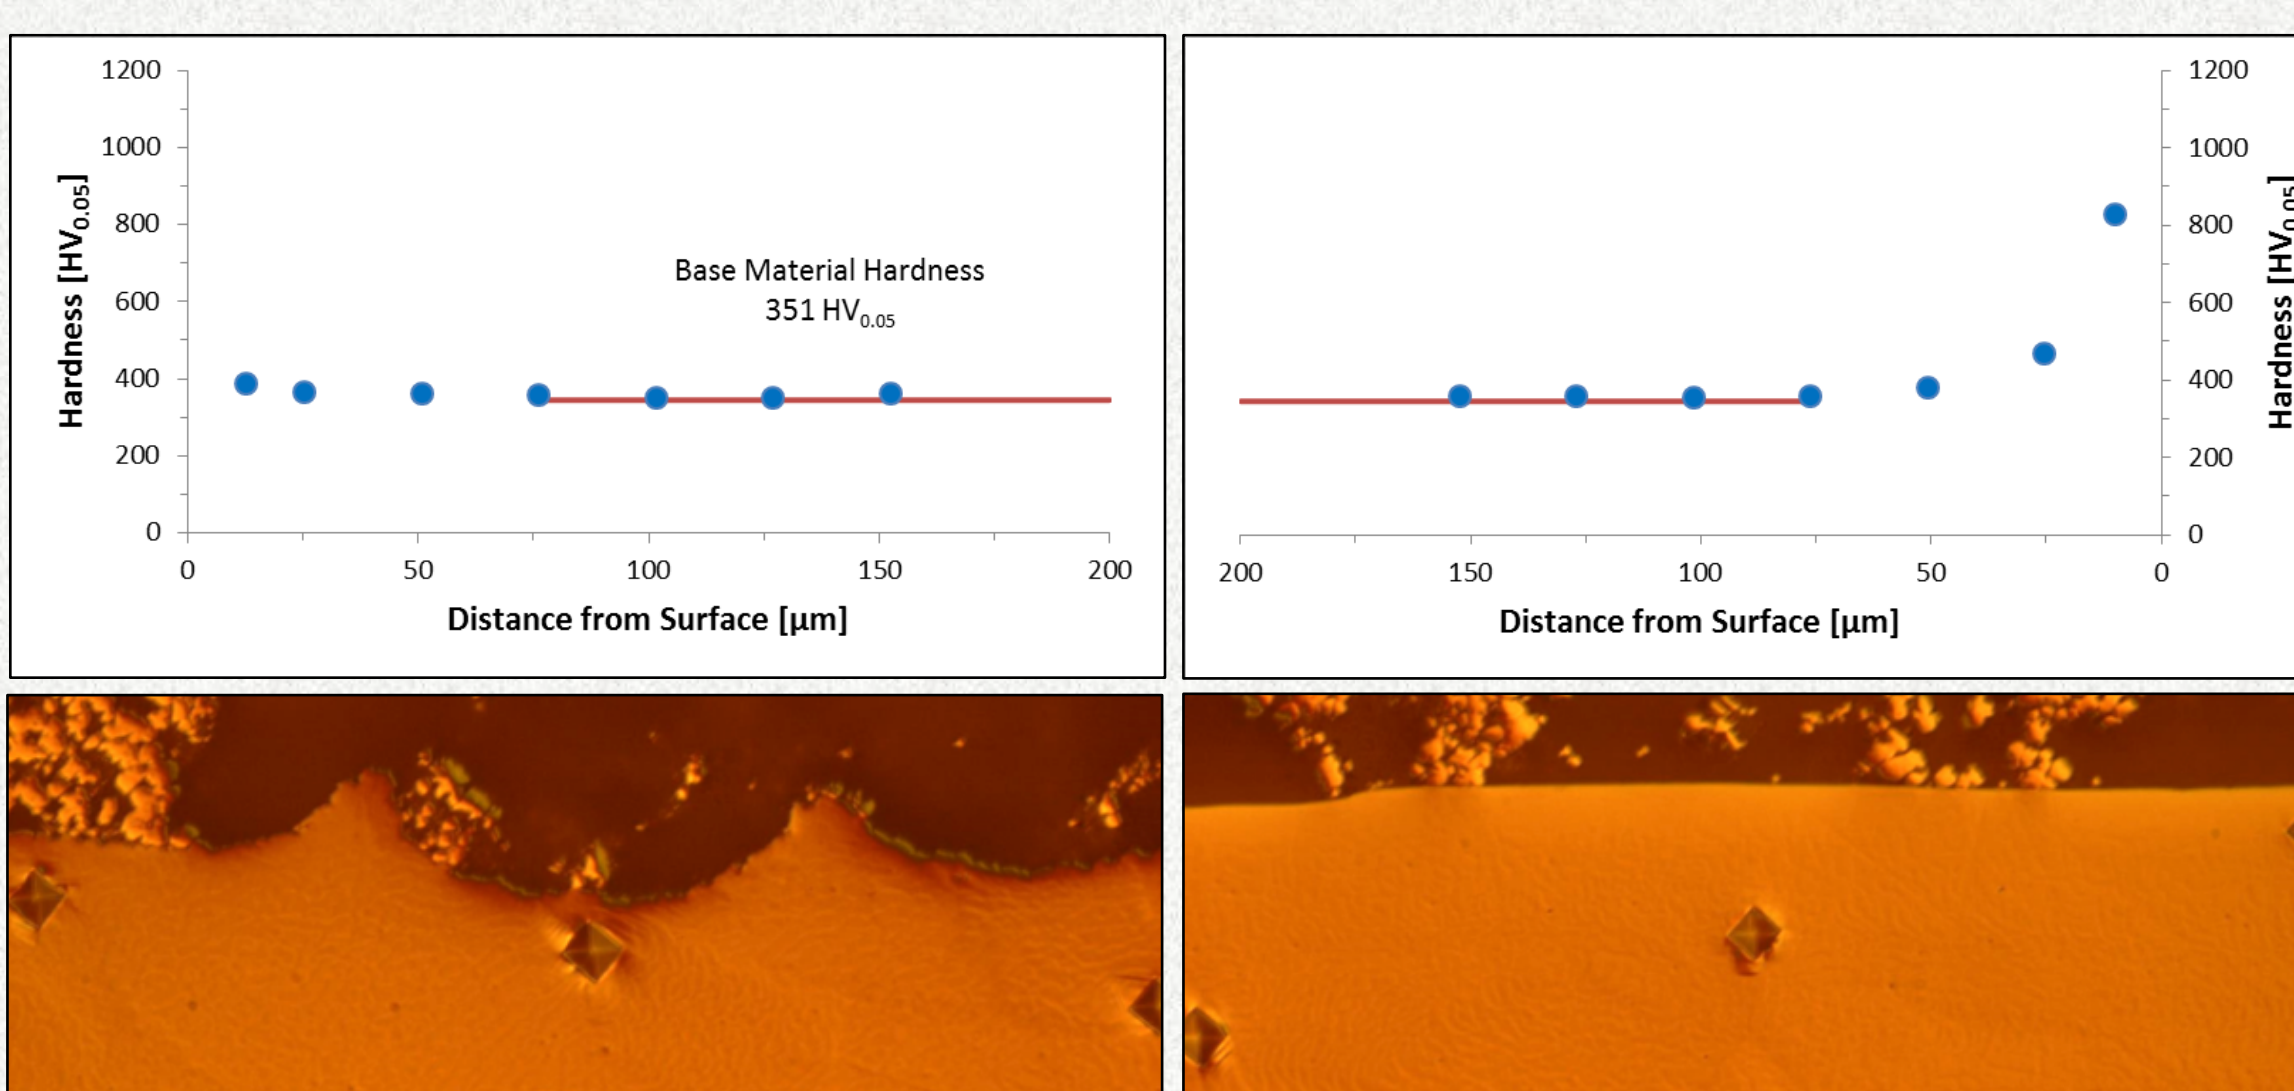
Figure 6. K-layer hardness profiles for Specimen D6-15 from Target 8: eroded surface facing the bulk mercury (left) and window flow facing surface (right).

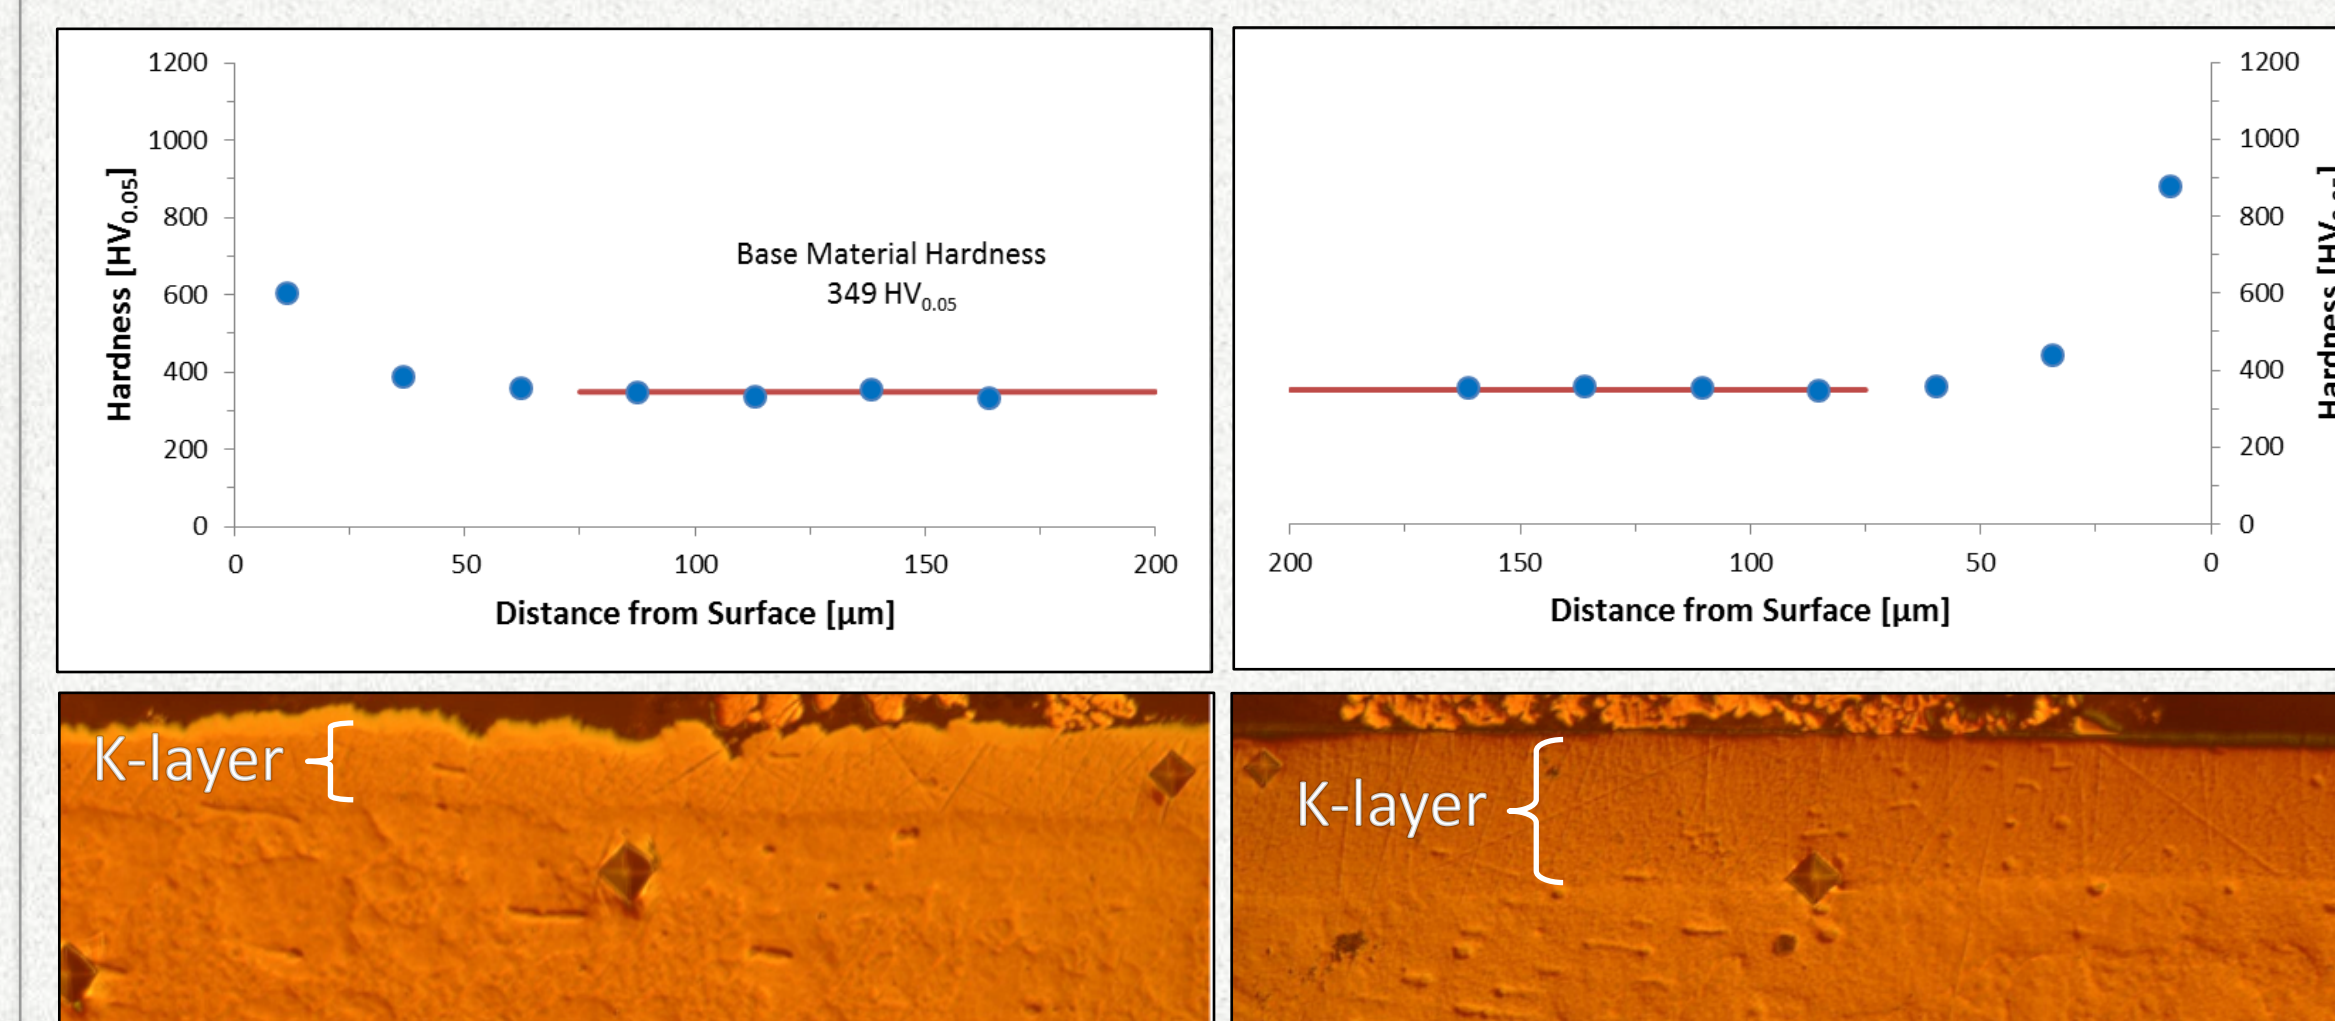
For most specimens the surface facing the bulk mercury flow appeared to be more eroded compared to the surface facing the window flow, as shown in Figure 7. This observation was also made previously on specimens examined from Targets 1 and 2. These observations show that surface facing the window flow was better protected from cavitation-induced erosion due to the mitigating effects of high velocity flow and narrow channel confinement between the inner and outer windows.

Figure 7. K-layer hardness profiles for Specimen D6-19 from Target 9: bulk mercury facing surface (left) and window flow facing surface (right).

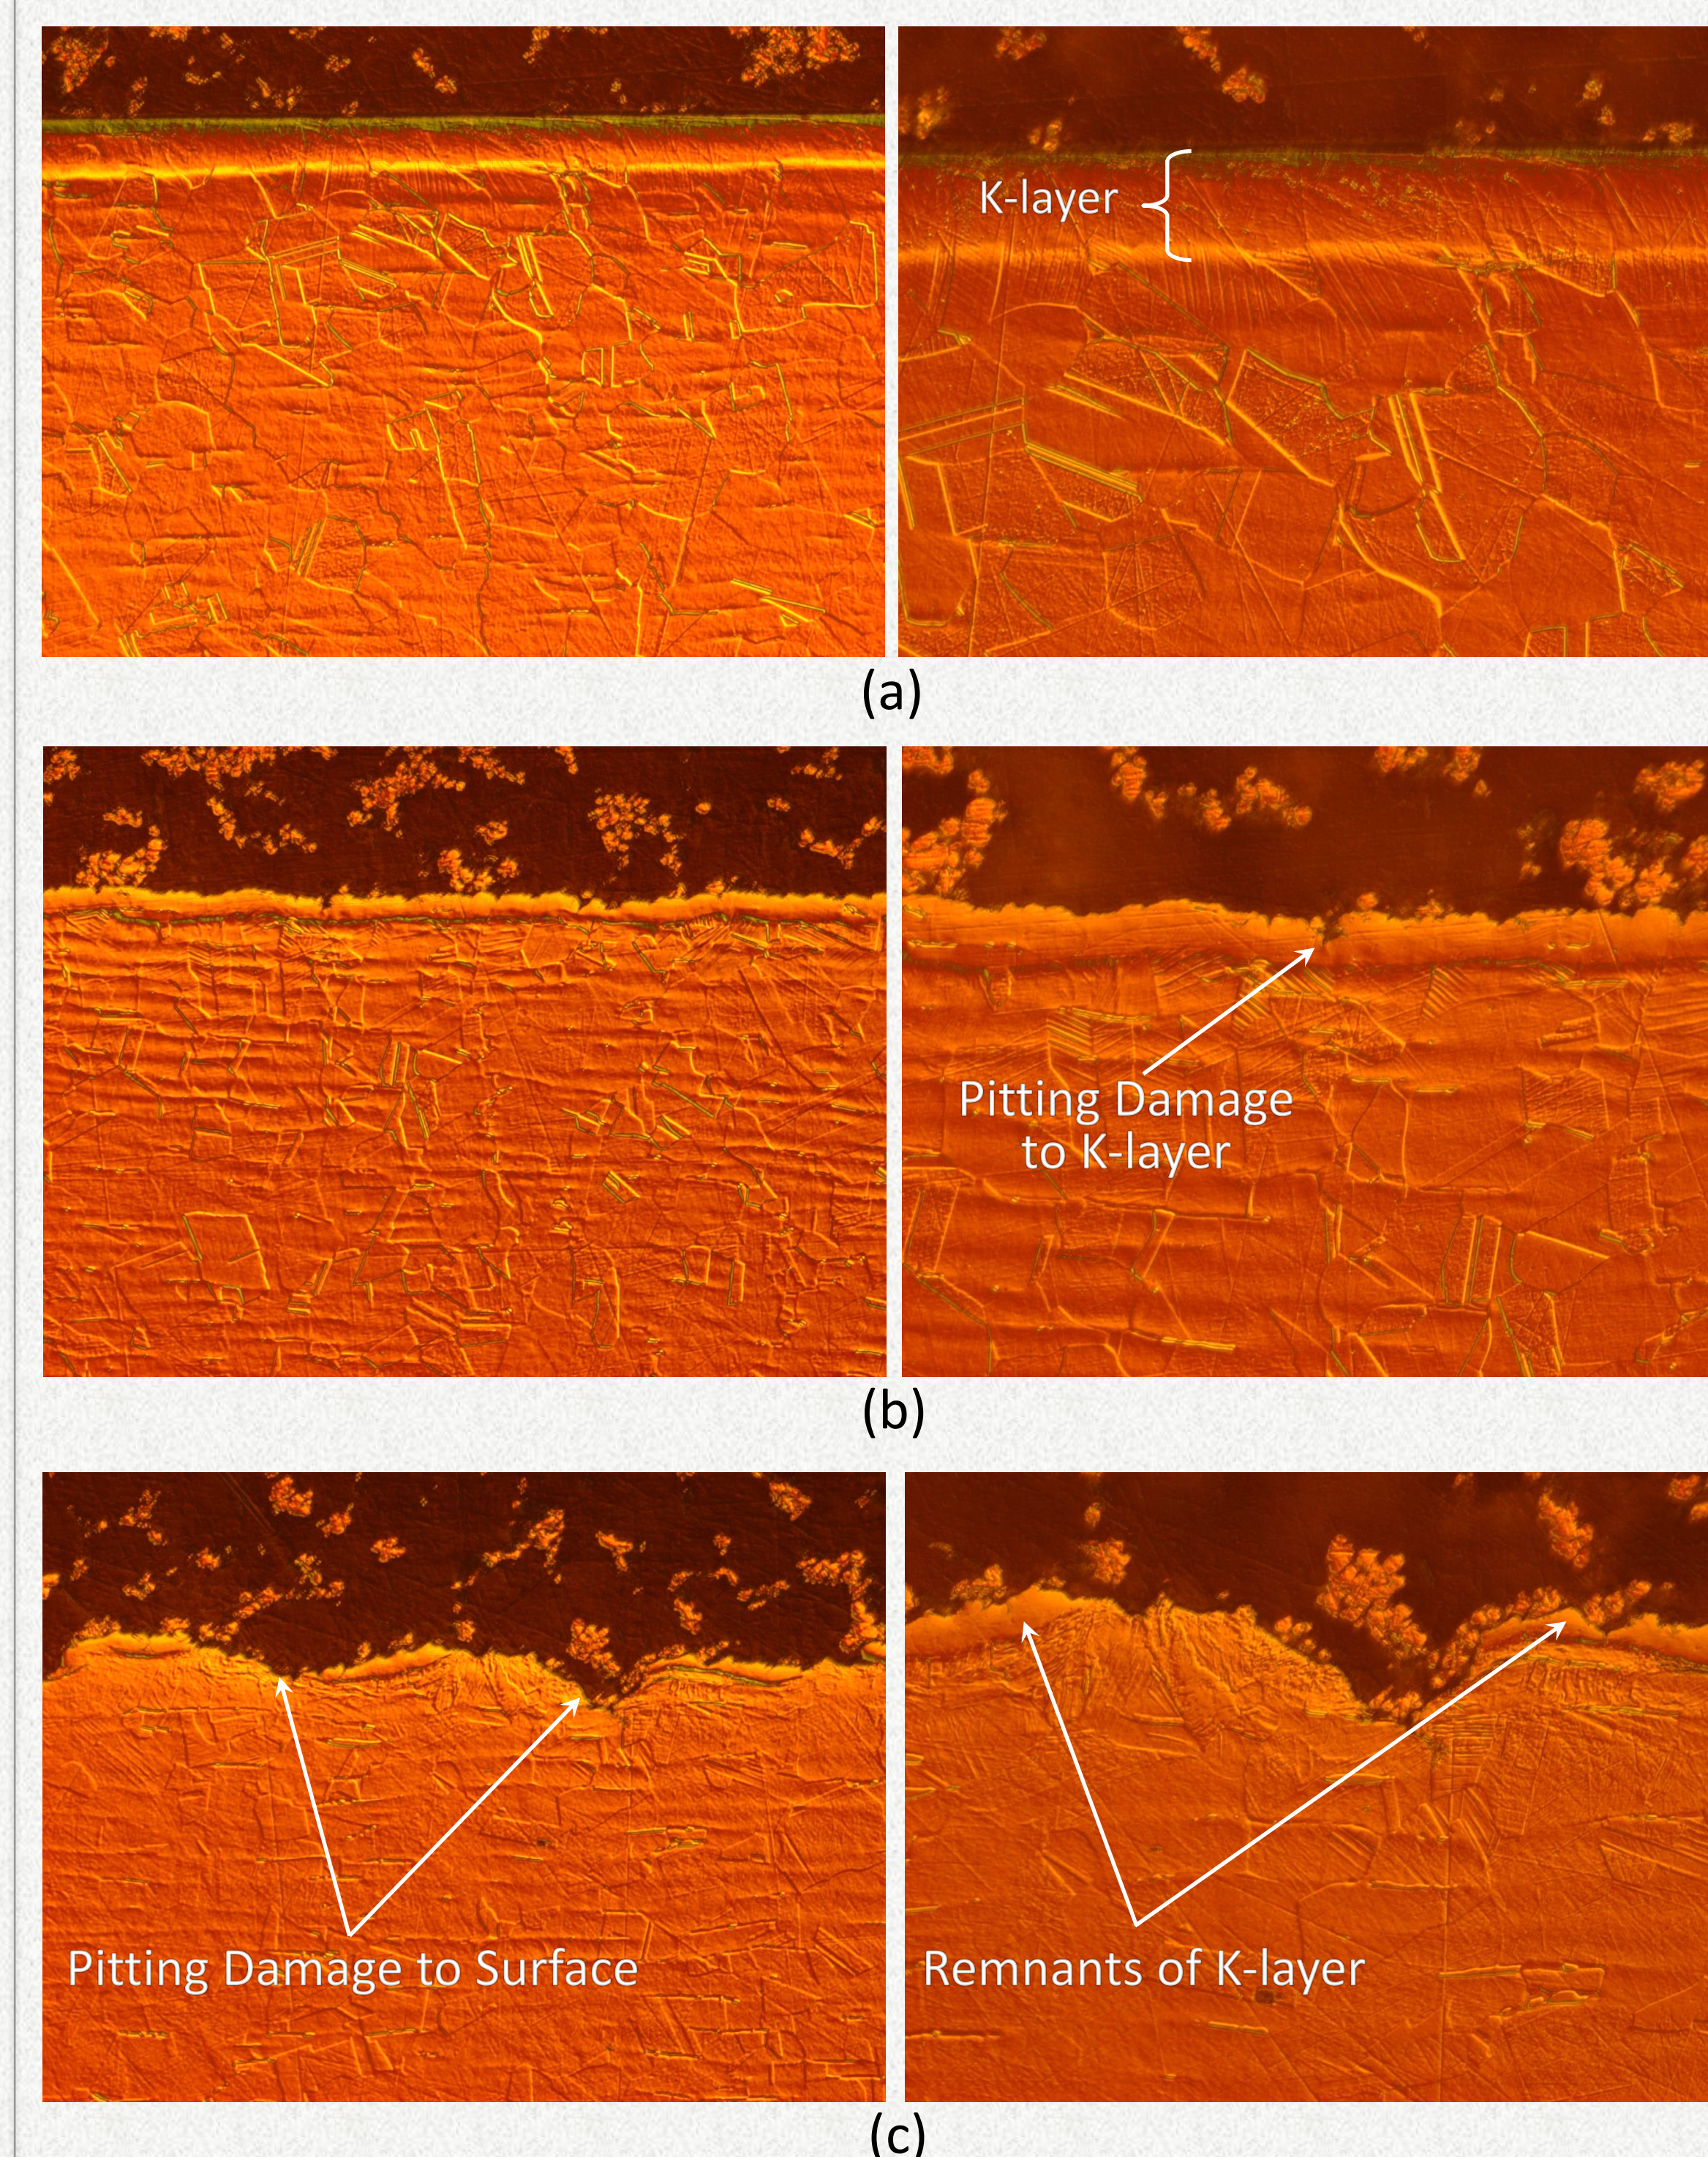
Metallography of the K-layer specimens captured the K-layer in different stages of erosion damage. Three set of images from Target 9 specimens are shown in Figure 8. The region in Figure 8 (a) was a relatively undamaged area on the specimen, whereas the images in Figure 8 (b) was from a region of the specimen where erosion damage to the K-layer had commenced. The K-layer of the specimen in Figure 8 (c) was completely compromised and accelerated erosion of the base metal was underway.

Figure 8. Examples of the various stages of cavitation-induced erosion damage: (a) little or no damage, (b) moderate erosion to K-layer, and (c) heavily damaged K-layer and vessel surface.
