<div>Neutron Technologies Division</div> <div>Nonconformance Request Form</div>	<div>NR Number:</div> <div>106010200-NCR10007</div> <div>Date:</div> <div>6/9/2024</div>
<div>Descriptive Title:</div> <div>P-5001 Sensor Mercury Leak</div>	<div>PO or Work Order:</div> <div>1661909</div>
<div>Description of Nonconformance:</div> <p>On Thursday, May 30, 2024, at approximately 3:30am, the mercury vapor levels in the service bay began to increase from 20 µg/m³. By 5:20 am, the mercury vapor level increased to 100 µg/m³. Remote handlers later located the site of the mercury leak. The leak location was the back P-5001 mercury pump differential pressure sensor. Leaks from the mercury system are not compatible with on-going operation. The pressure sensors were leak tested before installation and operated for a time (on the order of days) without a leak.</p> <div>

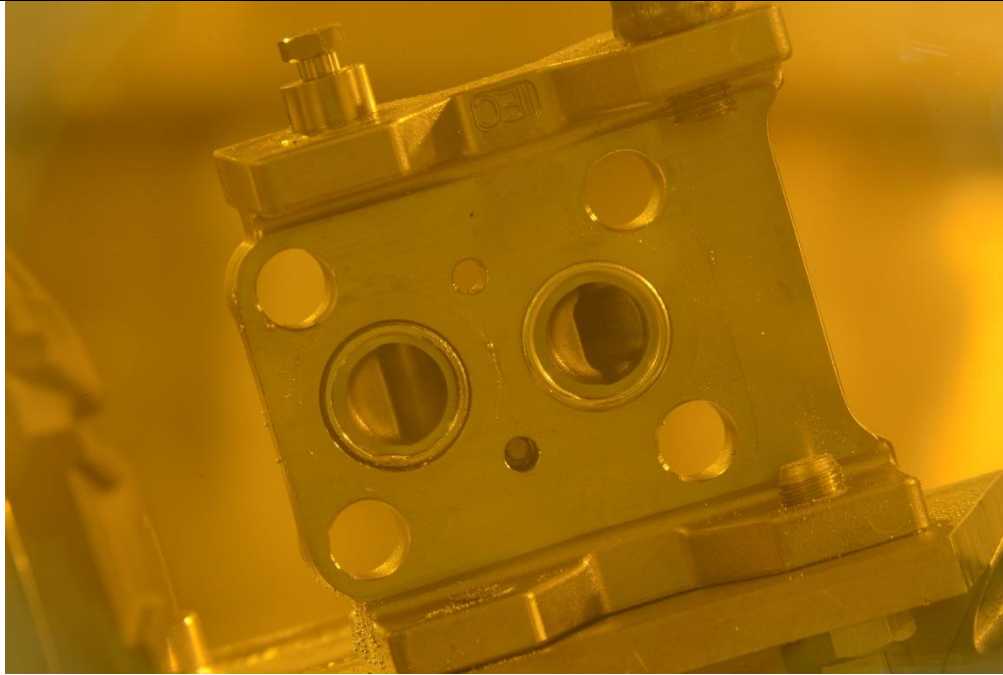
This supports the conclusion that the cause of the mercury leak is corrosion of the silver-plated Inconel X-750 process seals. These seals are present in the Rosemount 3145N sensors, including both P-5001 sensors that were installed during this run cycle. Due to this, it would be expected that the second of the P-5001 sensors would develop a leak soon if returned to service.

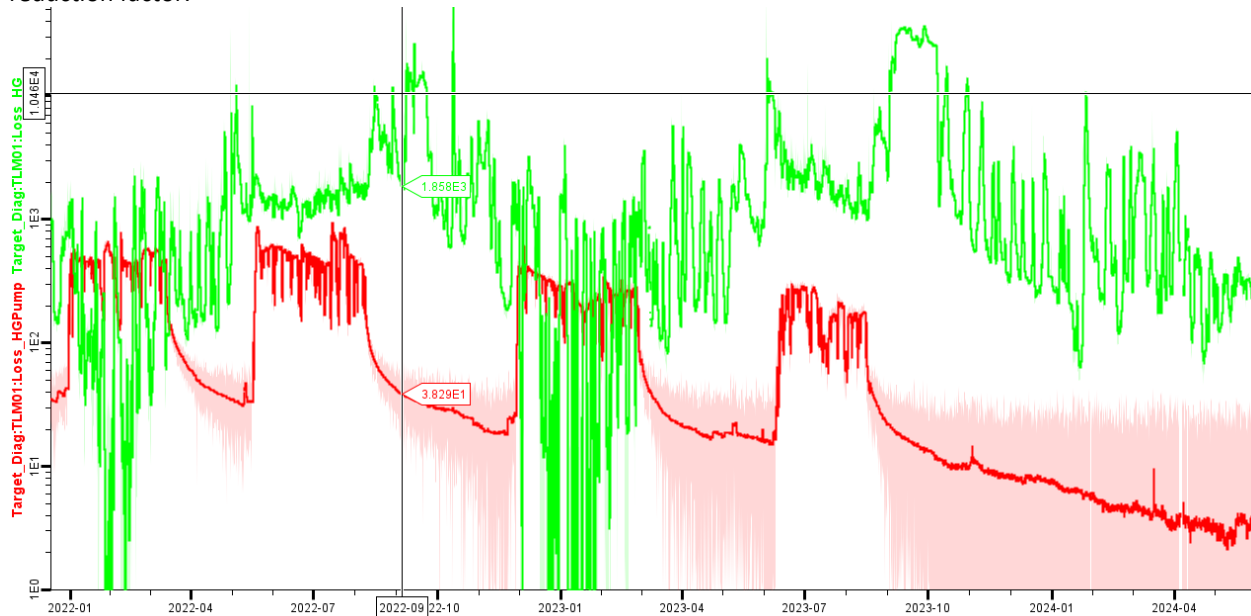
There are ion chambers located in the service bay that can be used to estimate the radiation dose to the sensors. The figure below shows the dose rates measured by two such ion chambers over approximately the past 2 years of operation. Note that the vertical axis is in log scale. The green trace is an ion chamber located by the mercury return pipe, under the shielding. The red trace is an ion chamber located on top of the mercury pump. The mercury pump has shielding that causes the reduction in the dose rates. The P-5001 sensors are located on the side of the mercury pump. Past approaches to estimating the doses on these sensors have reduced the dose rates measured at the top of the pump by a factor of 2 to reflect the differences in shielding thickness between the top and

side of the pump tank. [Reference email from Platfoot to Winder, 6/5/2024.] For this work, we will conservatively not include this reduction factor.

The peak dose rates over the period shown above were $1\text{e}3$ Rad/hr. The next run cycle is approximately $5\frac{1}{2}$ months long, providing a maximum total dose rate of $4\text{e}6$ Rad over this period. This value is likely conservative. Available references [K. U. Vandergriff, "Designing Equipment for Use in Gamma Radiation Environments," Oak Ridge National Laboratory, ORNL/TM-11175, 1990] provide information on radiation resistance of different materials. For example, for SBR, radiation damage information spans from $2\text{e}6$ to $6\text{e}7$ Rad, which is around the calculated dose for the run cycle. Ethylene-propylene rubbers have similar experience with some formulations showing no degradation when tested at $5\text{e}6$ Rad. Therefore, elastomer seals, while representing a reduction in effectiveness in withstanding radiation compared to a functioning metal seal, would have a reasonable expectation of lasting through the next planned run cycle. Given the reduced lifetime of the elastomer seals, these sensors should be replaced no later than the FY25A outage.

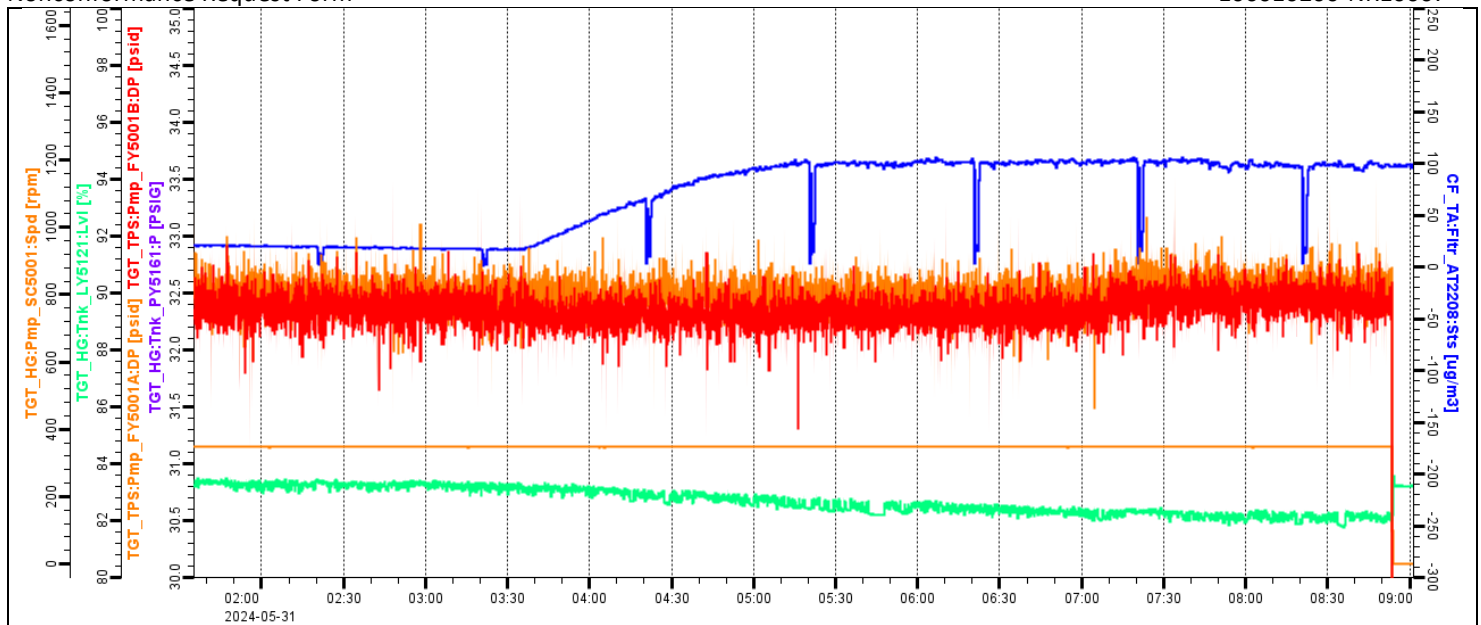
In the case of failure of these seals, the failure mechanism would be expected to be similar to that seen with the leaking silver-plated seals. In that case, as shown below, the indications of a failure were mercury vapor (CF_TA:Fltr_AT2208) and level (TGT_HG:Tnk_LY5121). The differential pressure sensors both continued to report the same pressures, despite the leak in one sensor. If the leak was allowed to continue to grow, it could eventually affect the pressure reading, but the previous behavior provides assurance that any failures are likely to be detected before the TPS system no longer can perform its function.

Therefore, an elastomer seal may be used in place of the metal seals in the P-5001 sensors to allow operation of the existing TPS sensors. These seals should be replaced at the earliest opportunity but provide reasonable assurance to reach to the end of the next operating cycle.

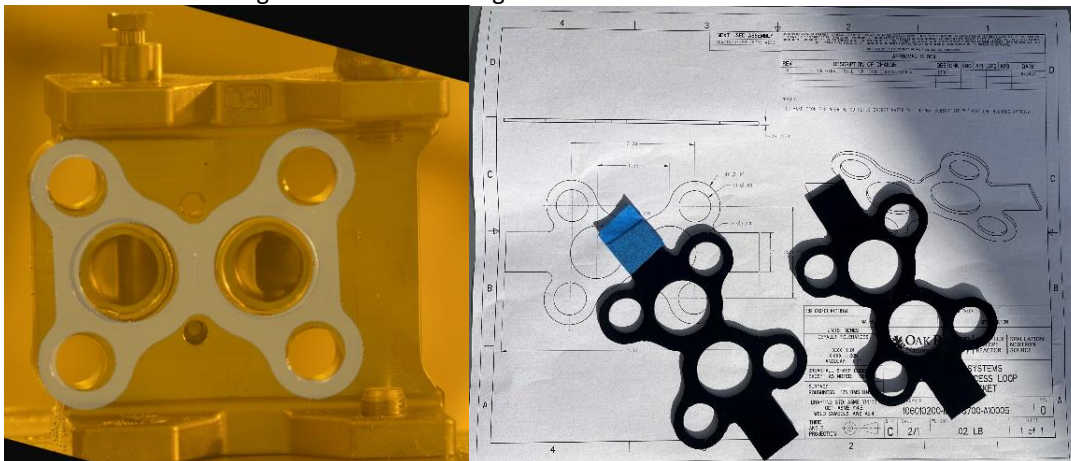
Drawing 106010200-M8U-8700-A10005 has been developed as a prototype gasket design. It uses 1/16" EPDM gasket material. The dimensions are based on measuring photographs and comparing to expected values, and so may have significant error when compared to actual sensor dimensions. The figure below shows a rough approximation of the gasket size and shape on the process flange on the left, and a picture of some of the actual gaskets used on the right.

Repair both P-5001 sensors by removing the existing silver-plated Inconel X-750 seals and replace with an elastomer gasket.

The sensors were repaired by removing the silver-plated seals, and re-assembling generally per Rosemount Reference Manual 00809-0100-4835 Rev BG, Page 63, except using the gasket in place of the process C-rings, and not using torque tools to measure the applied torque. The seals were then pressure tested to verify assembly. See 106070100-WK110010 for more details of the assembly and testing process.

The pressure testing showed no detectable leakage at 50 psig for the high-pressure volume, and at 30 psig for the combined high-pressure and low-pressure volumes. The sensitivity of this test is estimated to be on the order of $2e-3$ torr*L/s of air. This test provides
