EVENT					
Event Title         LWS#1 HOG Leak Event         Date/Time of Event         3/6/2025 @ 0648 hrs					
Event Number*	RER SNS-4362	ACTS Issue Number	<u>.48805</u>		
CRITIQUE					
Date/Time of Critique         3/7/2025 1pm         Critique Owner         Mike Dayton					
Critique Facilitator	Jeff Killian	Critique Recorder	Samantha Milligan		
Critique DRAFT Date**	3/12/2025	Critique ISSUE Date	3/20/2025

#### **Brief Event Description**

Four personnel were contaminated uniformly on their skin and clothing as activated gases were vented into Light Water System (LWS1) Room TA-B103 of building 8700. The vented gases were from the Hot Off Gas (HOG) system that contains activated gases of Carbon-11 (C-11), H-3, and noble gases. The personnel were inside TA-B103 to perform maintenance, to respond to a G64 alarm, and to secure the leak.

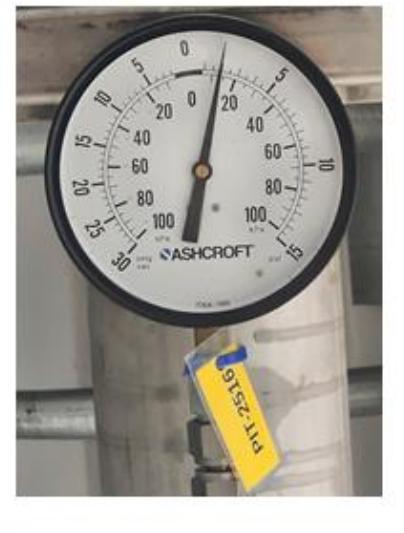
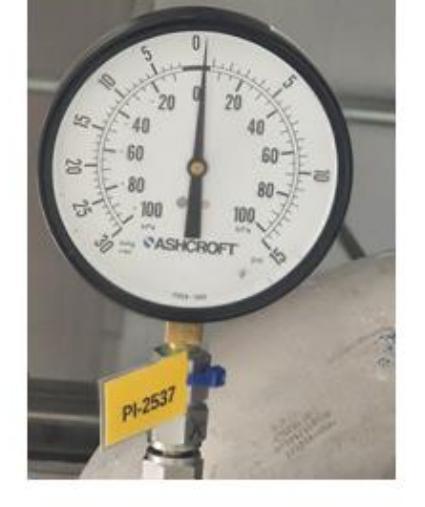
### HOG Design modification to increase back pressure

- The design change installed a back-pressure control valve (needle valve) to control the flow. At that point, the butterfly valve was fully closed. Pressures for the nitrogen in the tanks was monitored with no issues.

- This new design reduced the dose rate detected on the PCE Room HOG Line radiation monitor (PPS\_TA:RadMon\_PCE\_HogLine:Rad) from 85mrem/h to <5mrem/h, and stack monitor readings from 30,000 cps to 23,000 cps.

- The needle valve provided finer resolution of flow control in lieu of using the coarser butterfly valve.
- Additional decrease in radiation levels and stack monitor readings occurred after the ion change column in loop 4 was replaced.
