Dr. Bertrand Blau :: Head of SINQ & UCN Operations :: Paul Scherrer Institut

Investigations on the Premature Failure of SINQ Target #11 and its Countermeasures

ICANS XXIII, Chattanooga (TN), USA, 14th October 2019

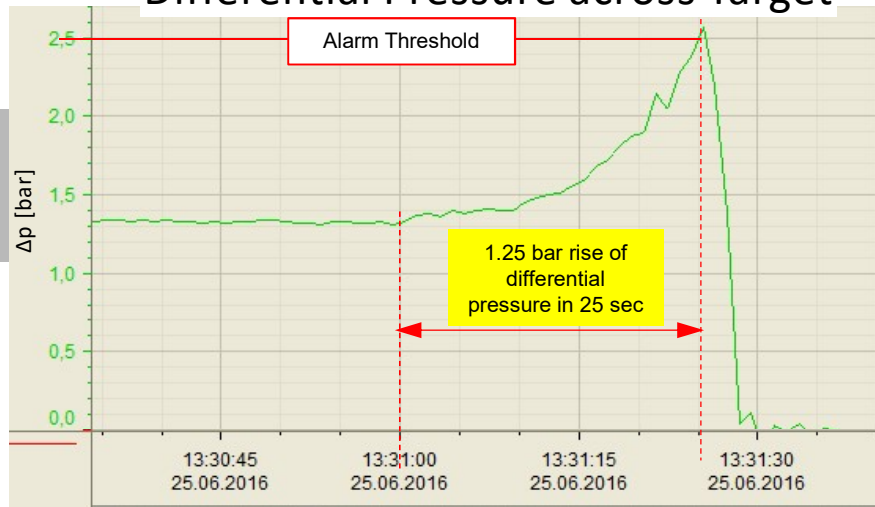
Differential Pressure across Target

- Sharp rise in differential pressure of cooling water across target => severe blockage of cooling passage
- p-beam switched off

7. As the affected blocked region was growing quickly, the pressure drop across the target rose finally till alarm threshold was reached. By switching off the proton beam the heat deposition finally stopped

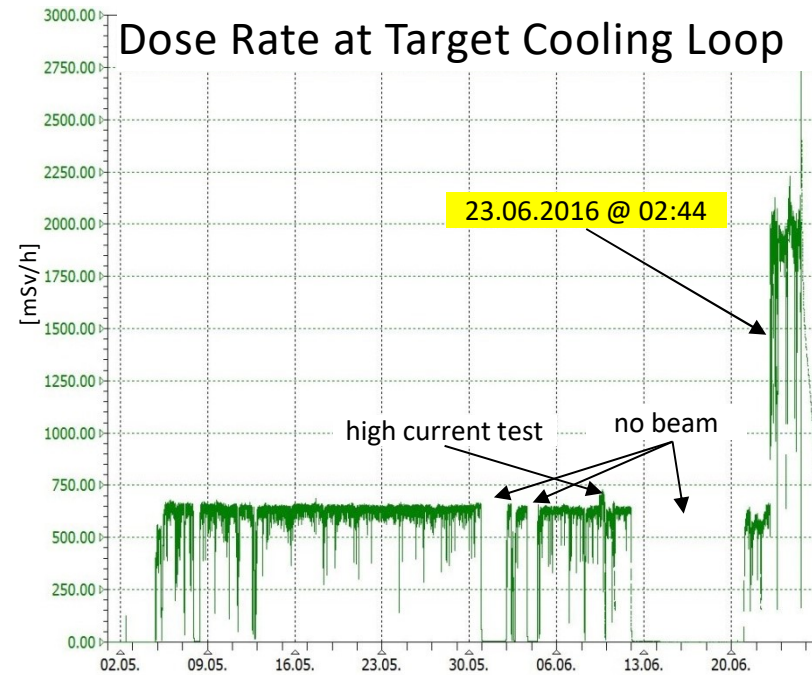
Dose Rate at Target Cooling Loop

- Sharp increase in dose rate measured close to target cooling pipe
- Overfocussed p-beam

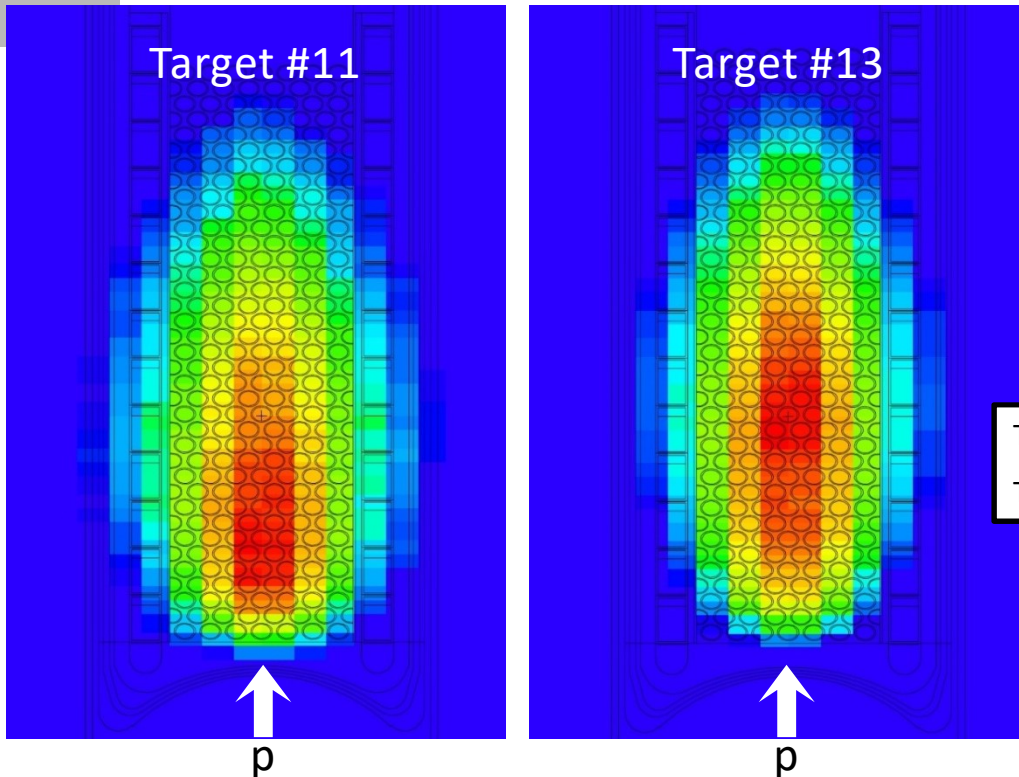
calculated neutron flux (with MCNP6.1)

In T-13 the peak of the neutron production rate moves up due to the lower density Zircaloy rods

≤ 10% calculated reduction in neutron yield as compared to T-11

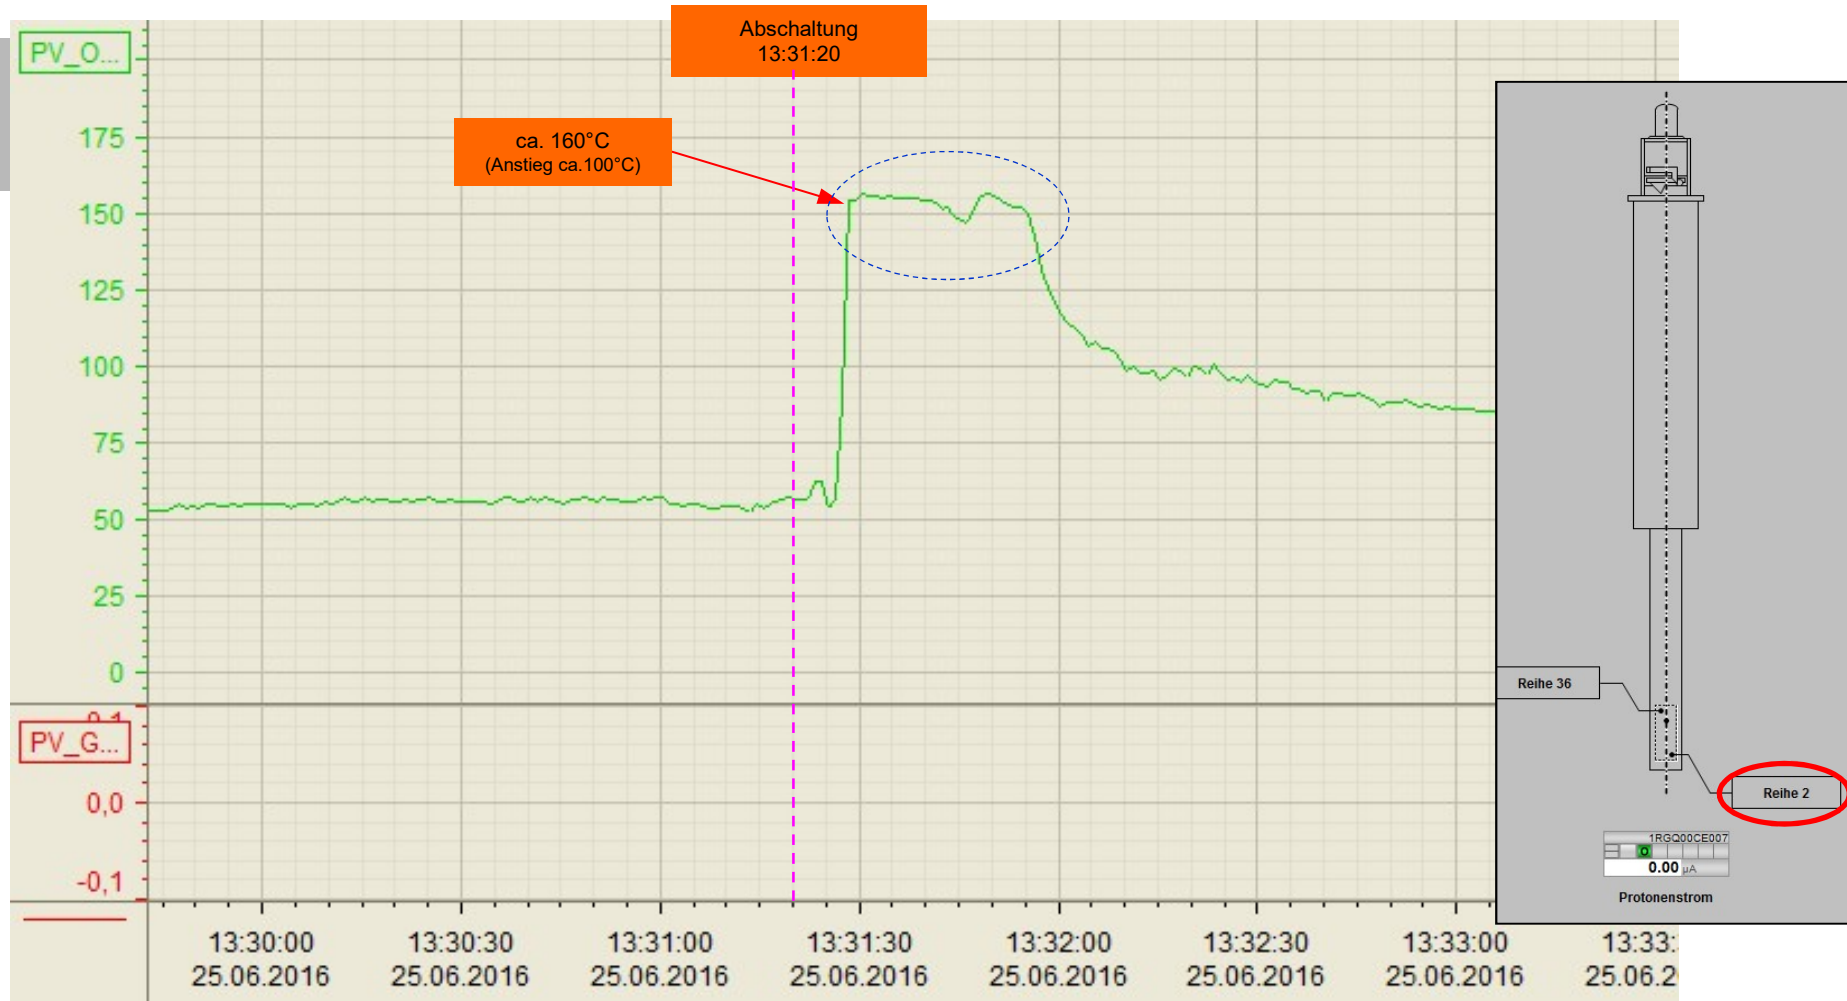
Temperatur im Target (Cannelloni-Reihe 2) RNQ01_CT011
