The Path to Reliable 1.4 MW Operation of SNS Targets

Presented to
Neutron Advisory Board

Presented by
Don Abercrombie
Instrument and Source Division Director

June 30, 2016
Clinch River Cabin
Oak Ridge, Tennessee

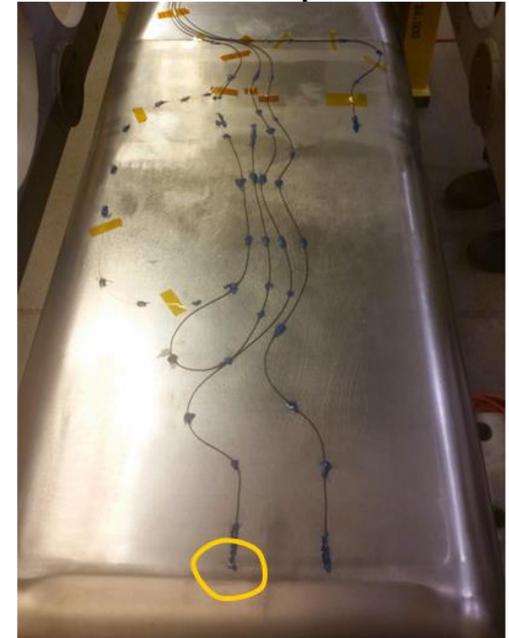
Strain sensors on target

- Plan addresses a broad set of issues relating to target robustness/reliability and included improvements in target analysis and design, PIE capabilities, and issues affecting welding.
- Significant activities included the mitigation of partial penetration weld vulnerabilities, implementation of gas injection, and addition of strain sensor monitoring.

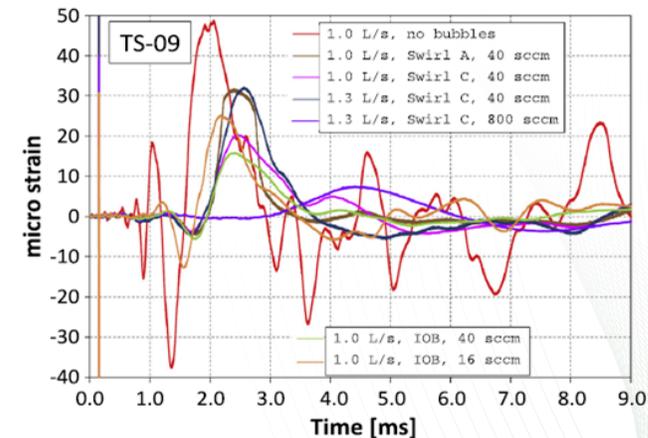
Gas injection mitigates pressure pulse and erosion

Tests in LANSCE beam at WNR show strain mitigation reduction factor of 5 and CDE damage by a factor of 16

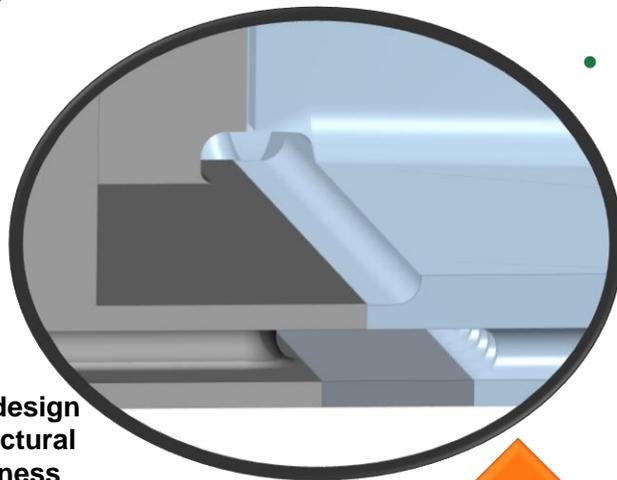
Weld redesign for structural robustness

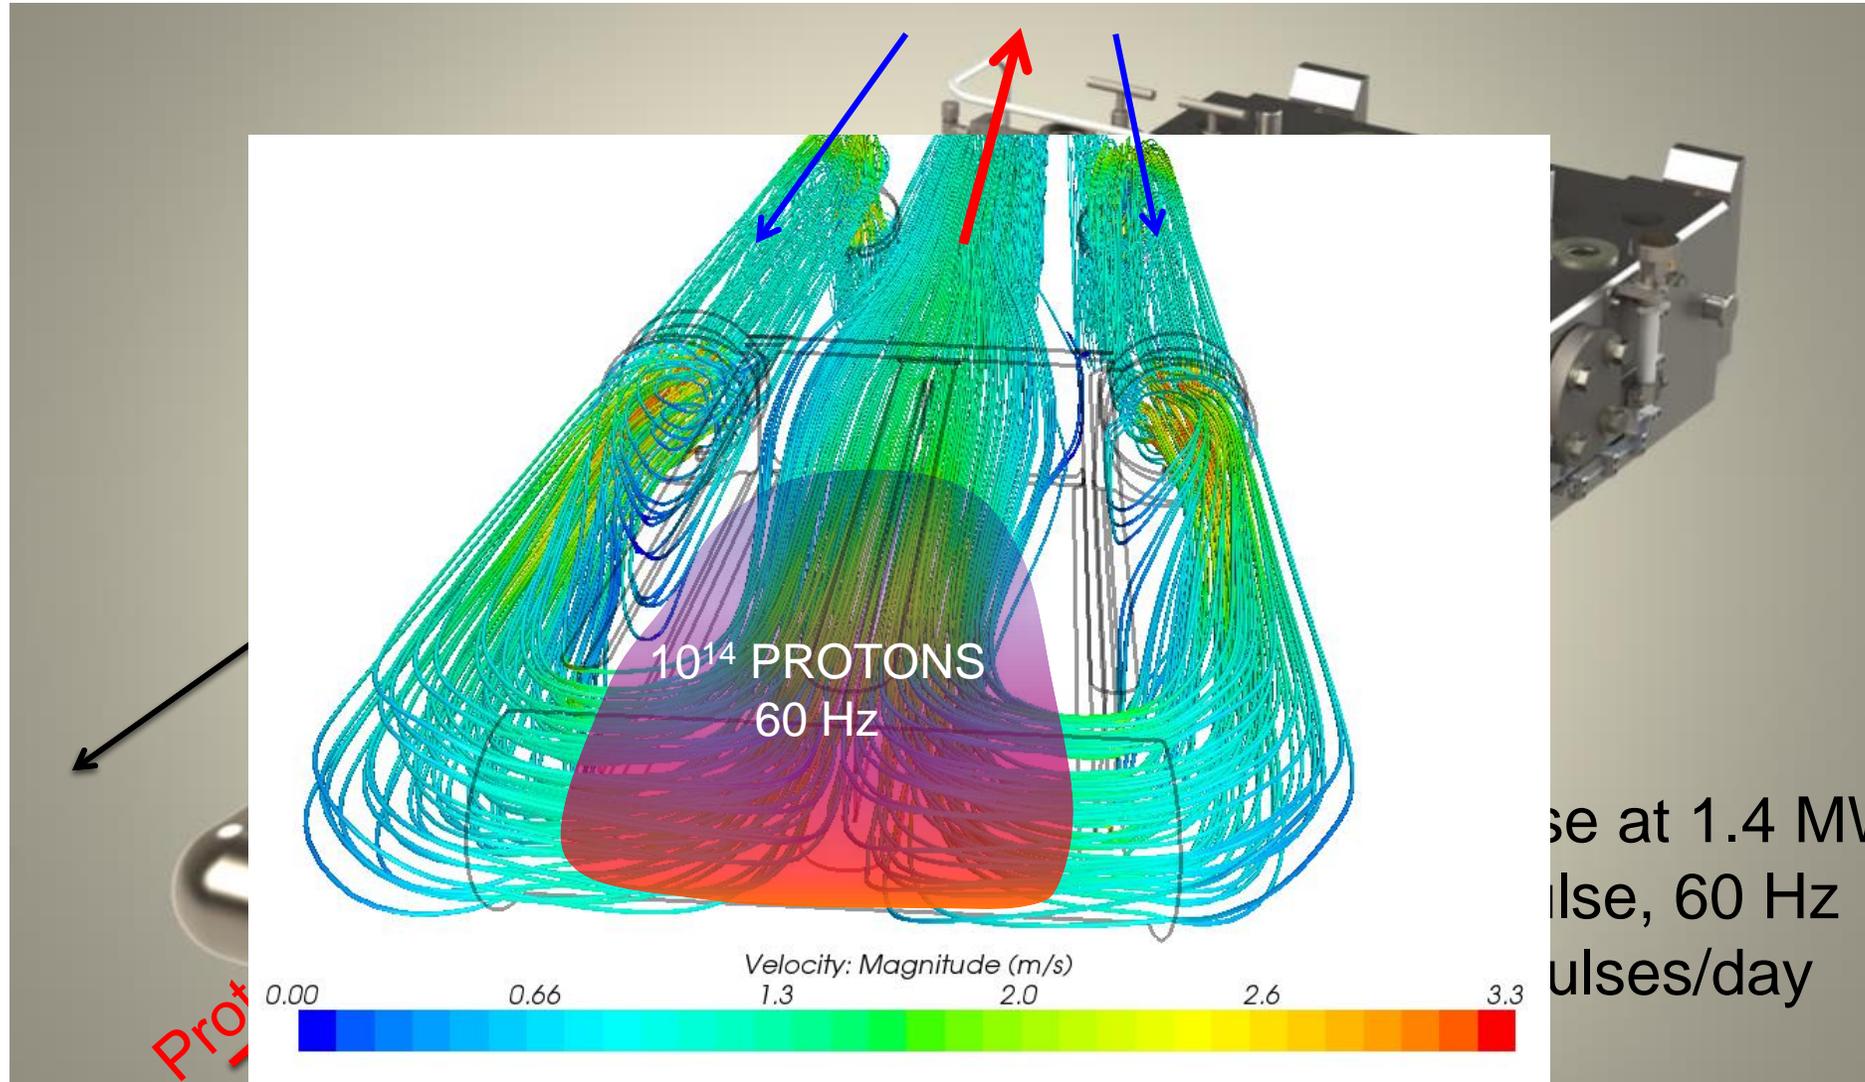
The target module is a stainless steel vessel that holds the mercury flow

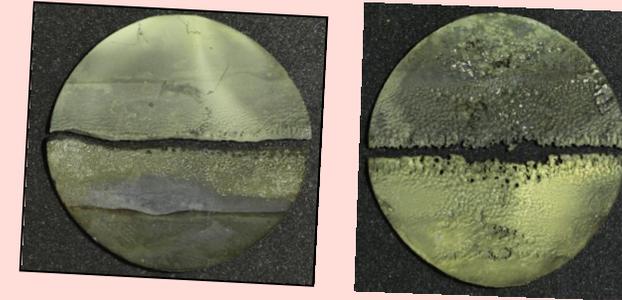
T2 PIE – Inner window which is typical for original target design

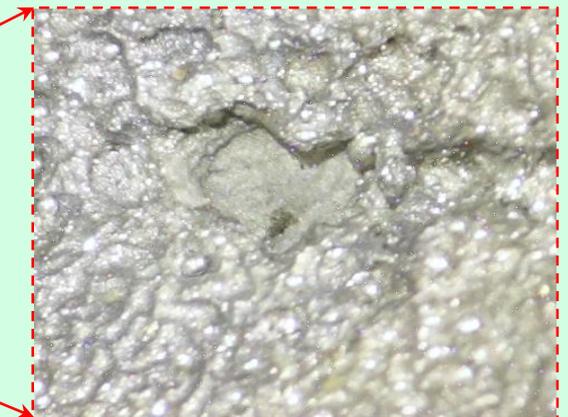
T12 PIE – Front corner leak which occurred in the same location for T13

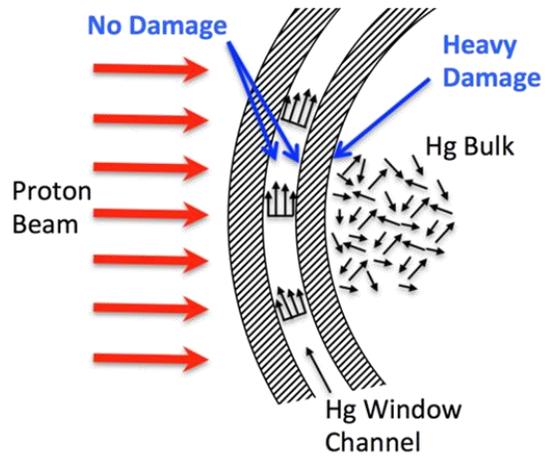
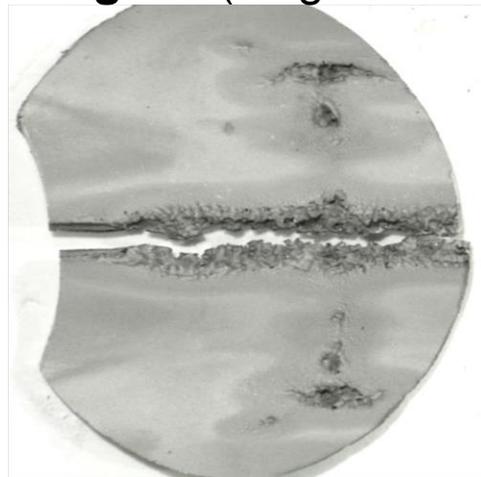
Target 6 (Original flow)

Original SNS Target

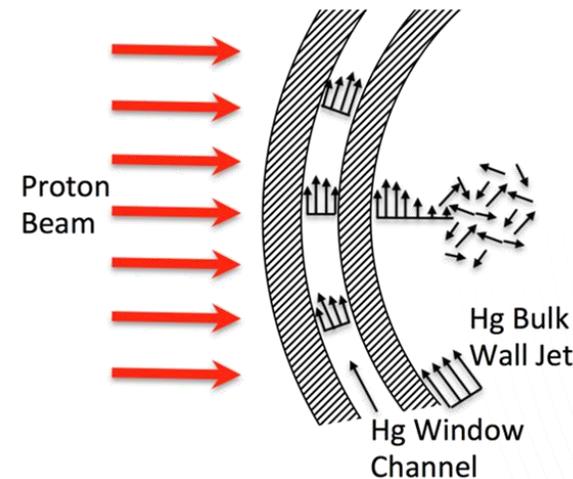
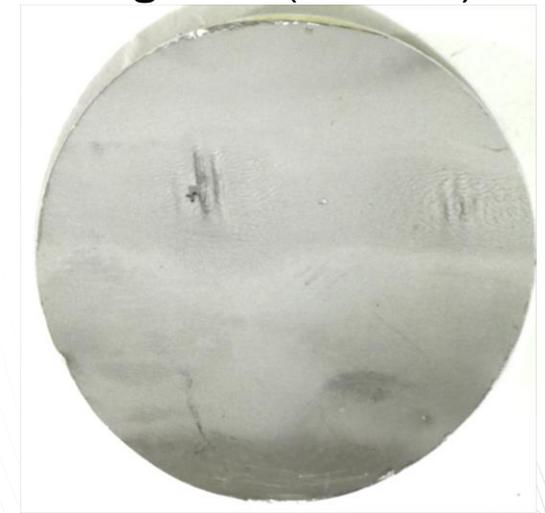
Target 10 (Jet-flow)

- Results at SNS proved even better than expected, with almost no damage

Jet-flow Target

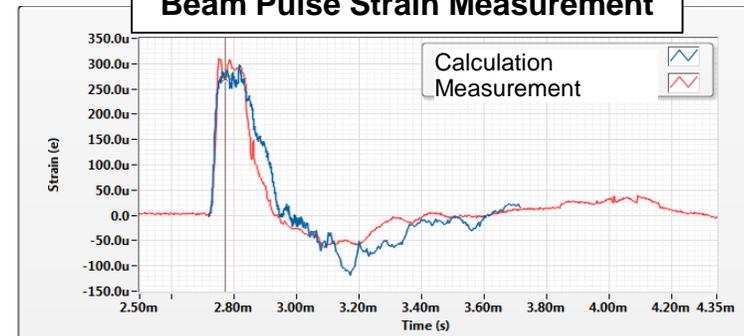
Beam Pulse Strain Measurement

Beam pulse strain measurement showing excellent correlation with model

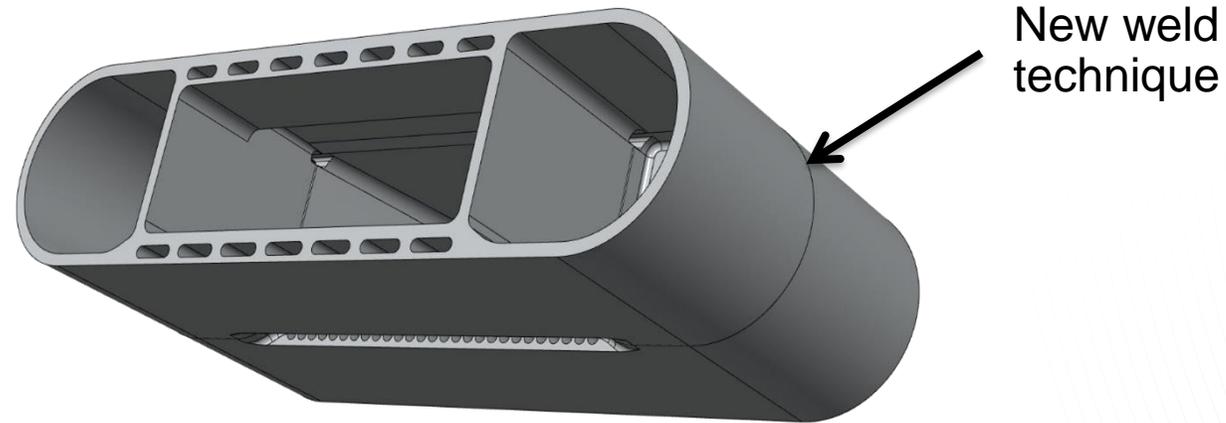
- *Benefit:* Reduce fabrication vulnerabilities
- *Highlight:* TIG vs. E-beam welding mock-up
- *Developing:* Weld distortion test, fabrication specification update

Weld mockup for weld distortion test

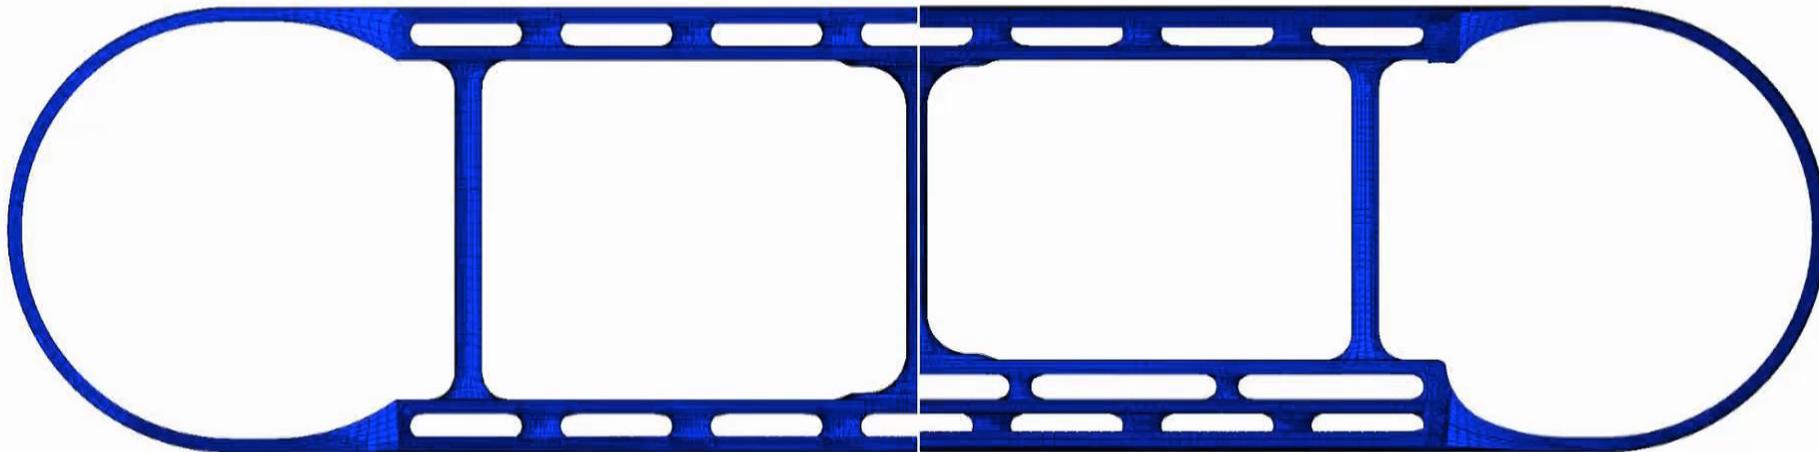
Example of computer simulation

- Simulations used to determine if new design is suitable for use

Original Target

Jet-Flow Target

Deformation is scaled up 300X

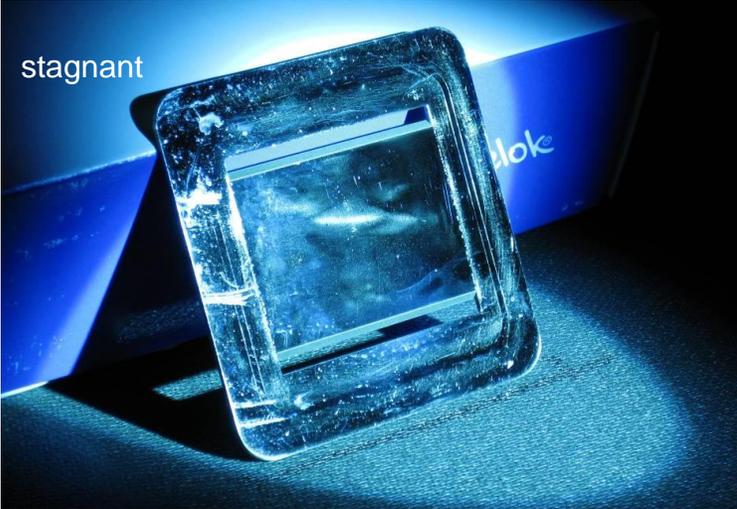
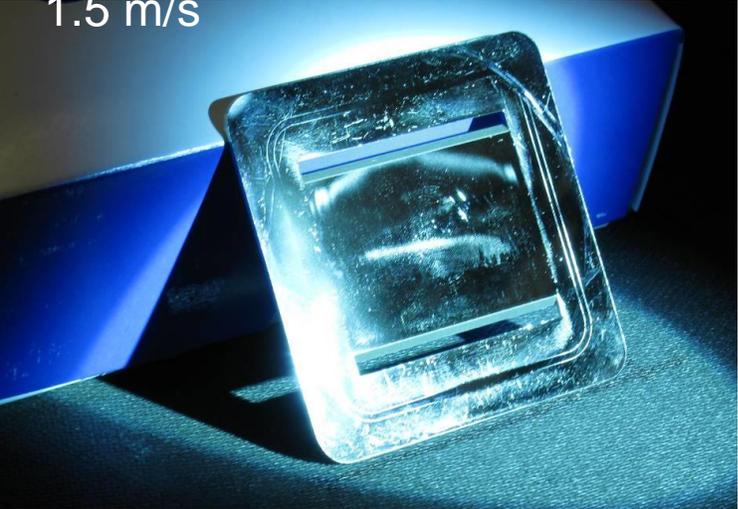
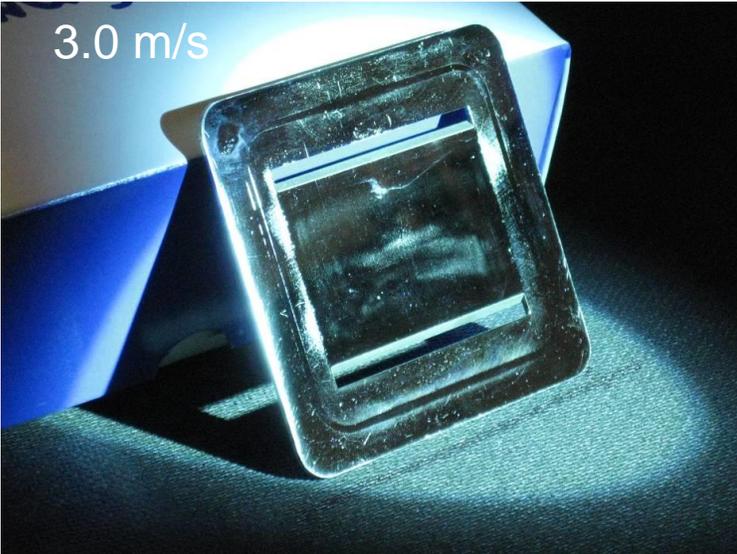
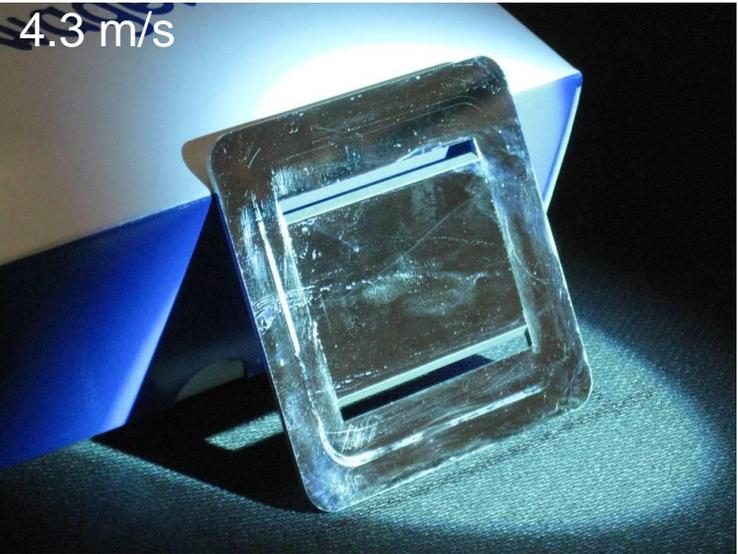
LANSCCE/WNR tests at 2.7 MW level showed a factor of 2 reduction of CDE by directed flow

100 pulses per test condition

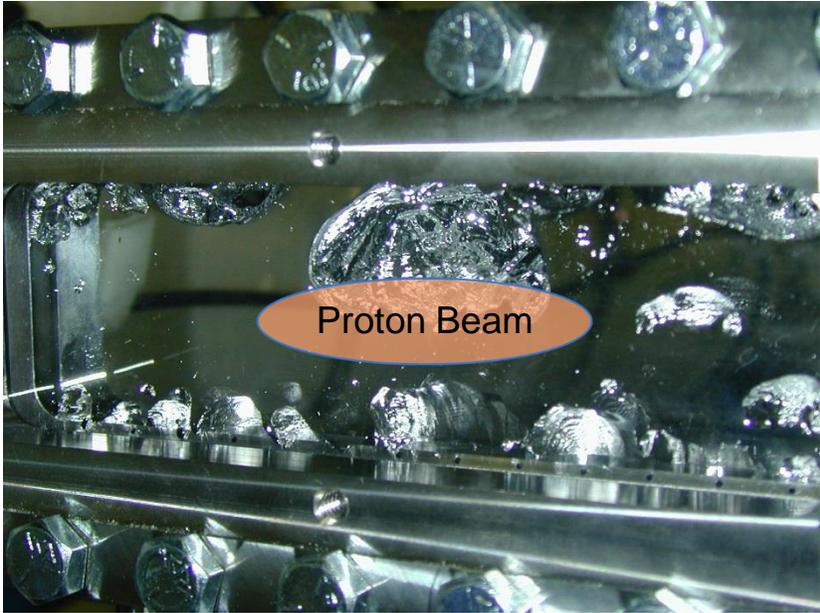
Jet-flow Configuration

Gas injection at the wall has reduced CDE damage by a factor of 16 in LANSCE WNR tests

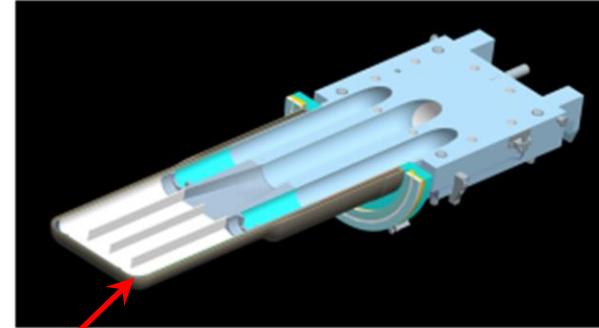
Target 12 & 13 Leak location

- The leak locations in Targets 12 and 13 were identified using an articulating videoprobe
- The leaks in Target 12 and 13 were in the same location – at the end of the “driver side” supply passage
- The Target 12 and 13 leaks are thought to be caused by cavitation-induced erosion – the first time targets have failed from cavitation

Bubble emanating from T13 leak (submerged under mercury)

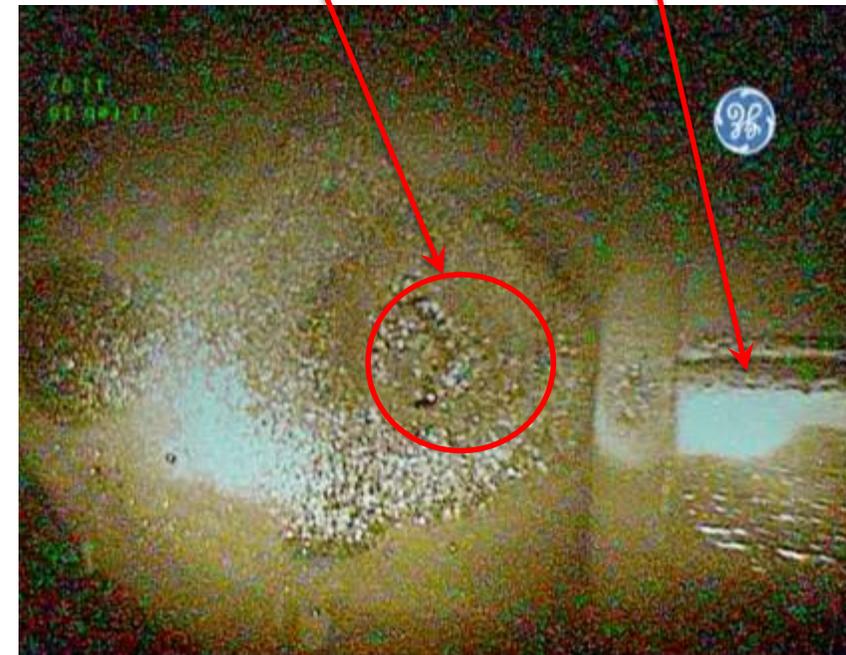
Cracked T12 inner wall
