SINQ – A status report

13th International Workshop on Spallation Material Technology, 31.10.- 04.11.2016,
Chattanooga, TN, USA

SINQ Target-11 – Search for failure mode(s)

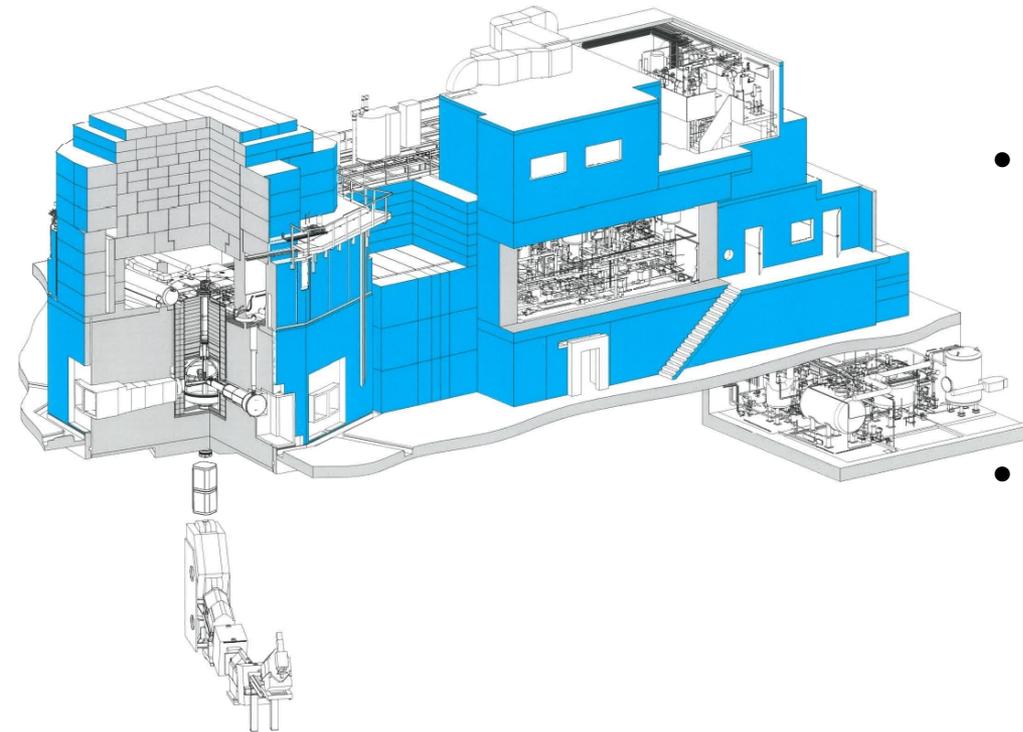
- Vertical setup
- MegaWatt CW Spallation Source
- 575 MeV protons, up to 1.6 mA beam current
- Targets
 - Solid & LM Targets operated (see next slides)
- Moderators & Reflector
 - D₂O tank (reflector) with light water shield
 - Liquid D₂ moderator insert
 - H₂O scatterer
- 17 Neutron Instruments
 - 13 instruments @ cold source
 - 3 instruments @ H₂O scatterer
 - 2 instruments @ thermal ports
 - NAA irradiation station
- STIP program (talks of Yong Dai)

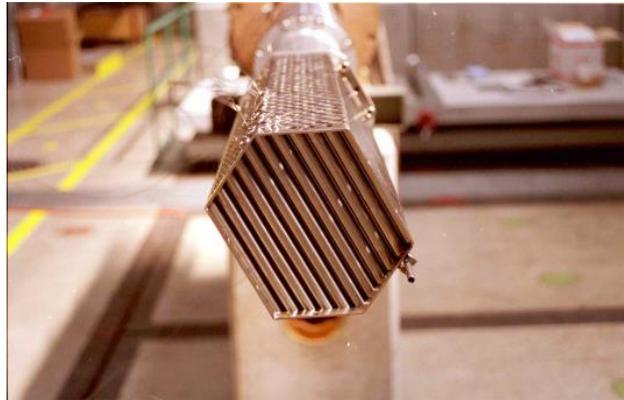
MARK I

SINQ Target-1 and 3*
Operation 1996-1999
Full Zircaloy-II rods
Hemispherical BEW

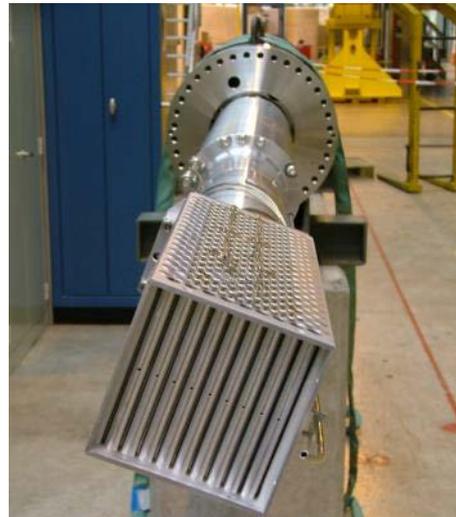
MARK II & III

SINQ Target-4, 5,6 and 7
Operation 2000-2008
Pb Filled Stainless Steel /
Zircaloy-II Tubes

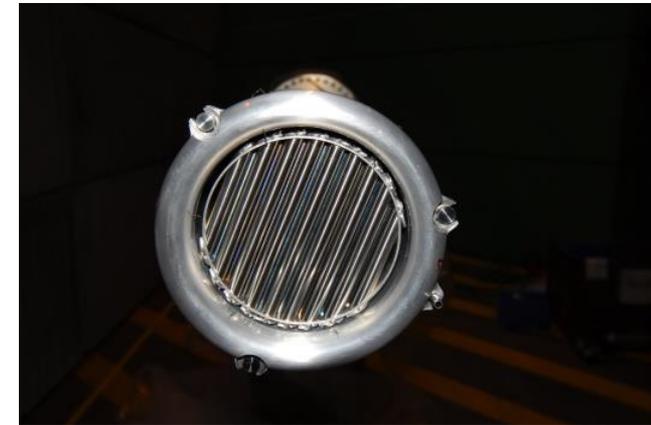
MARK IV

SINQ Target-8, 9, 10 and 11
Operation 2009 - now
Pb Filled Zircaloy-II Tubes
(dense packing)
Pb Blanket & inv. BEW

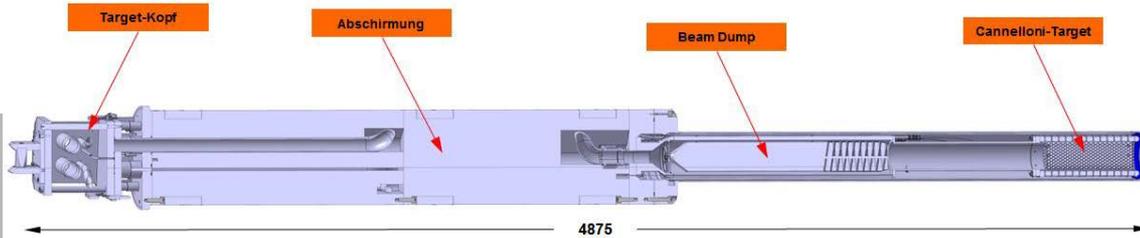
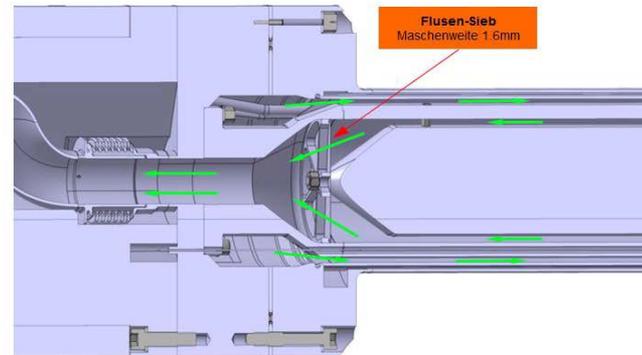
SINQ Cannelloni Target

Betriebstemperaturen Targetkühlung:	
- Vorlauf	46°C
- Rücklauf	58°C
- Durchfluss	11.5kg/sec

Coolant: D₂O
Mass flow rate: 10 – 12 kg/s
Max. velocity: 5-7 m/s
Pressure drop: ~ 1.5 bar

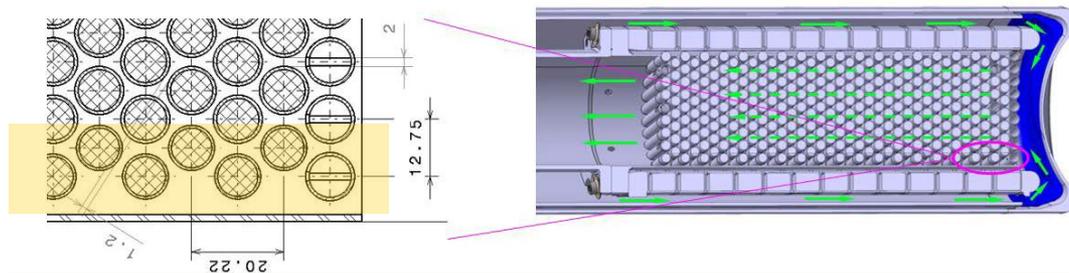
SINQ Target-11

Outermost columns of Target-11 equipped with thinner walled Zircaloy-II Tubes (0.606 mm instead of 0.75 mm wall thickness)

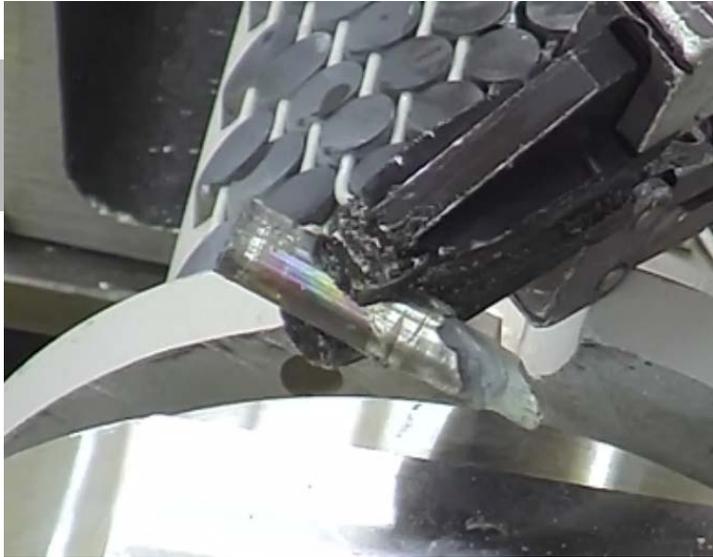
W STIP Sample Tube #6

- Operation 2013 & 2014
- High dose rates measured at the piping in the coolant plant room
- Indication for broken Cannelloni tubes
- Visual inspection in ATEC (Hot cell PSI West)

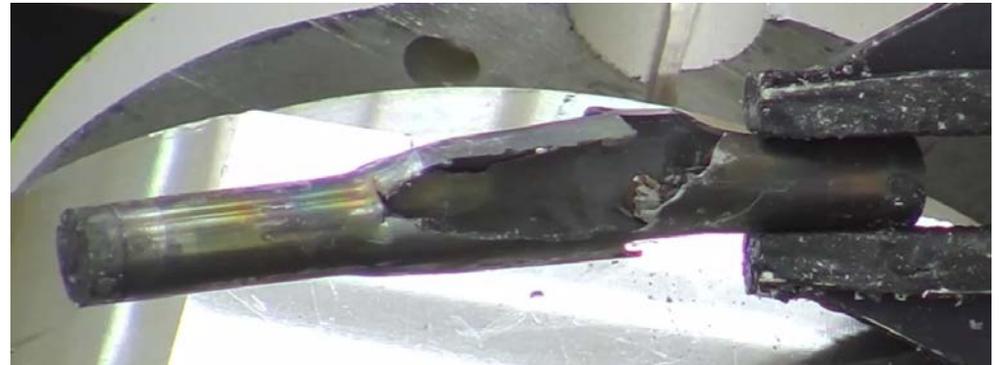
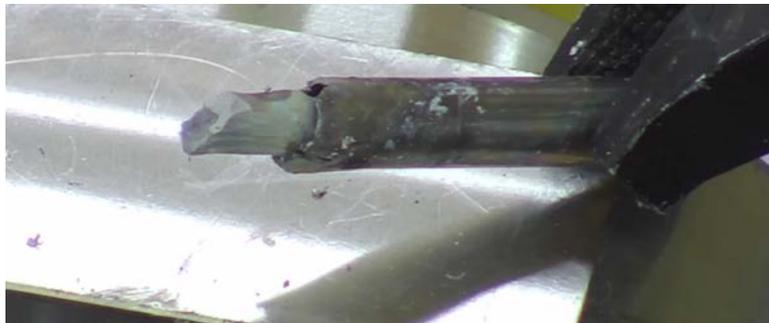
W STIP Sample Tube #8

Erosion of Tungsten ?
High dose rates in D₂O

9 STIP sample tubes showed
damage/ were damaged during
extraction

Decision: No STIP Sample Tubes in Target-11

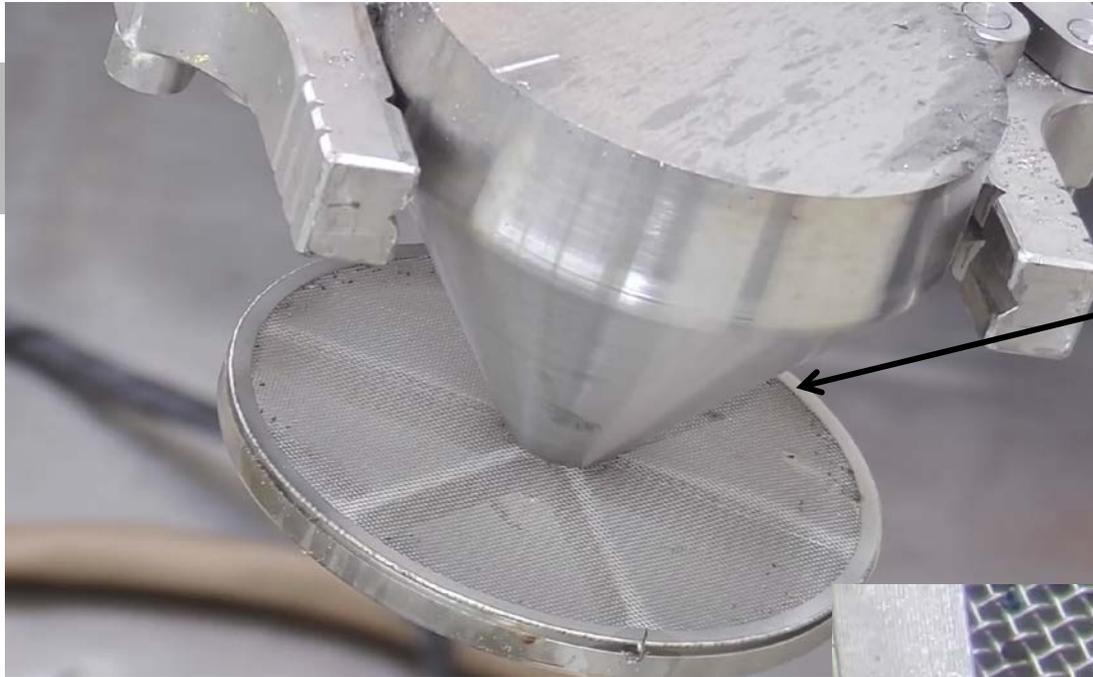
Sieve made from SS 1.4401
Mesh-Size $0.88 \times 0.88 \text{ mm}^2$

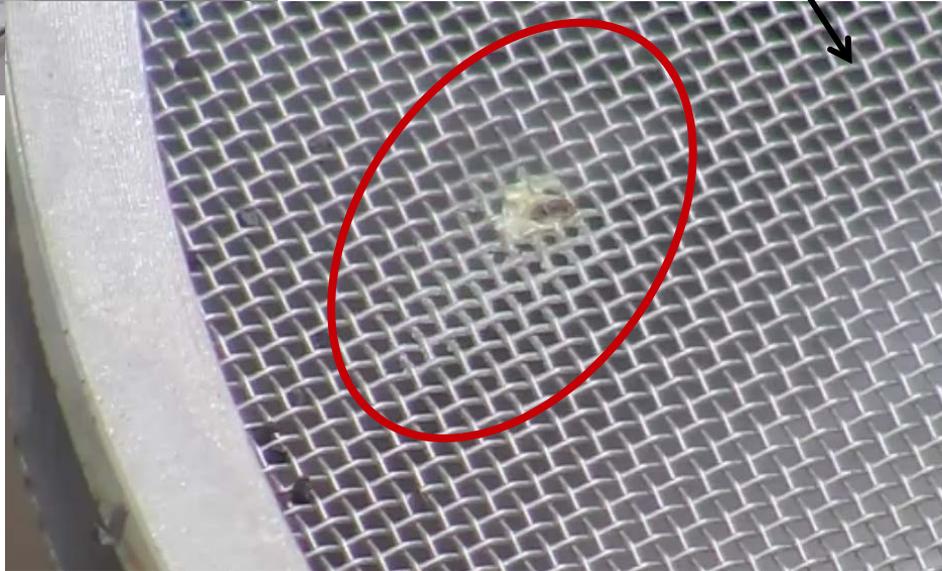
«Flusensieb» (fluff sieve) contained particles

Main D₂O cooling loop had to be continuously filtered during shutdown(s)

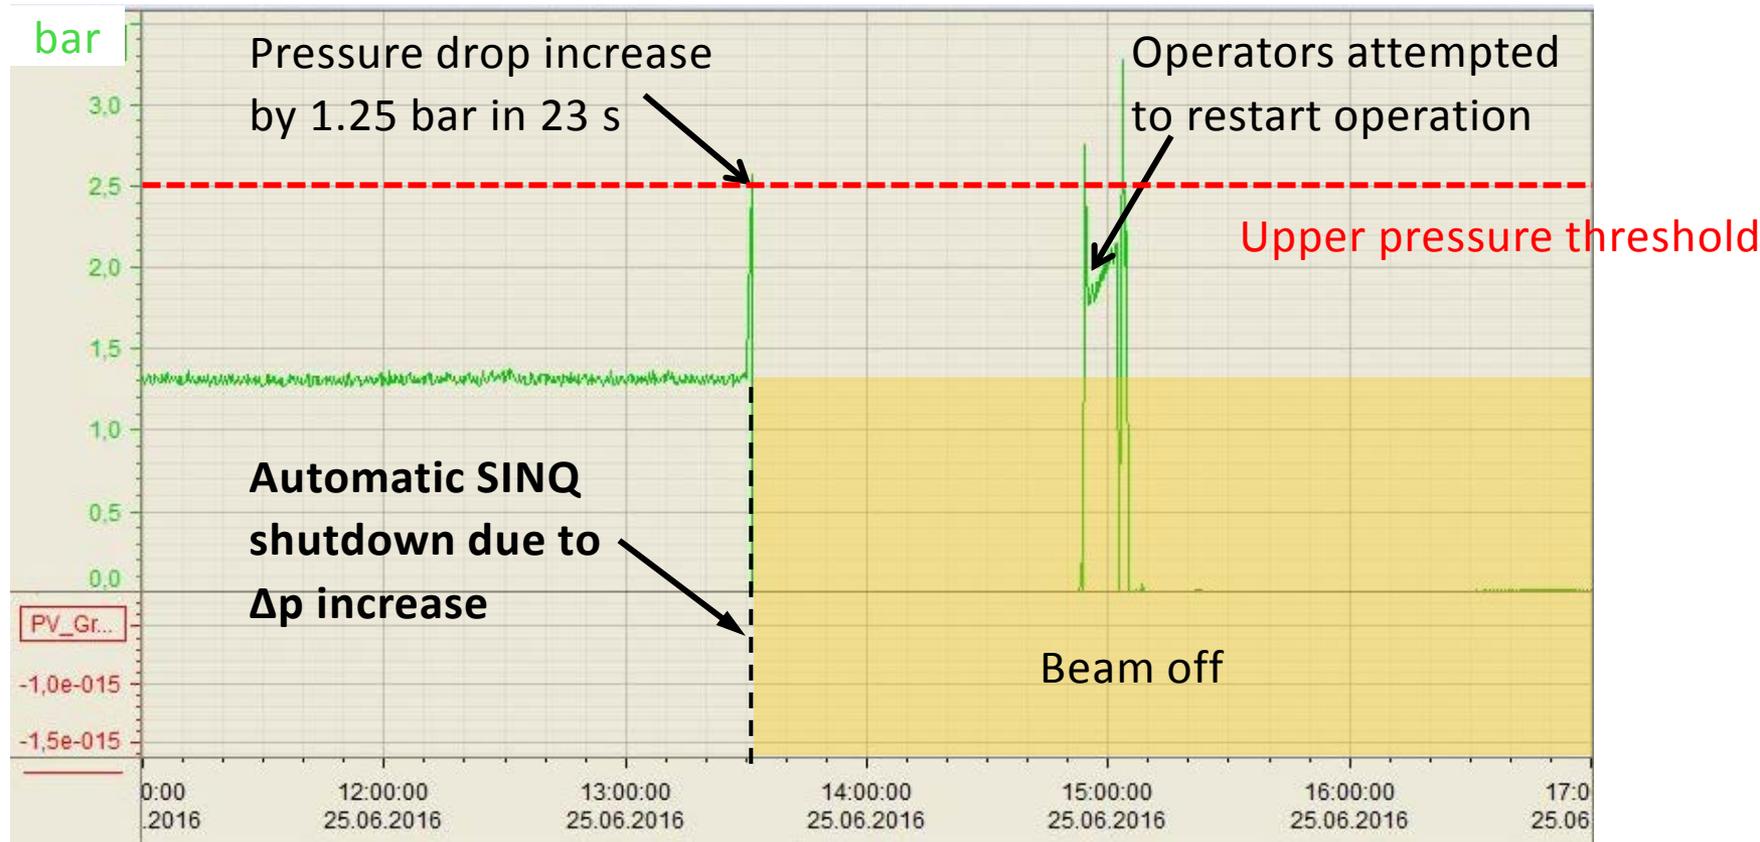
Operation SINQ Target-11 – Pressure drop

25. June 2016 SINQ operation was automatically stopped by SINQ safety system due to an abnormal high pressure drop in the main cooling loop
 Pressure drop in target cooling loop increased from 1.3 to >2.55 bar within 23 s.
 This corresponds to a reduction of the effective hydraulic cross section of 40 – 50%.

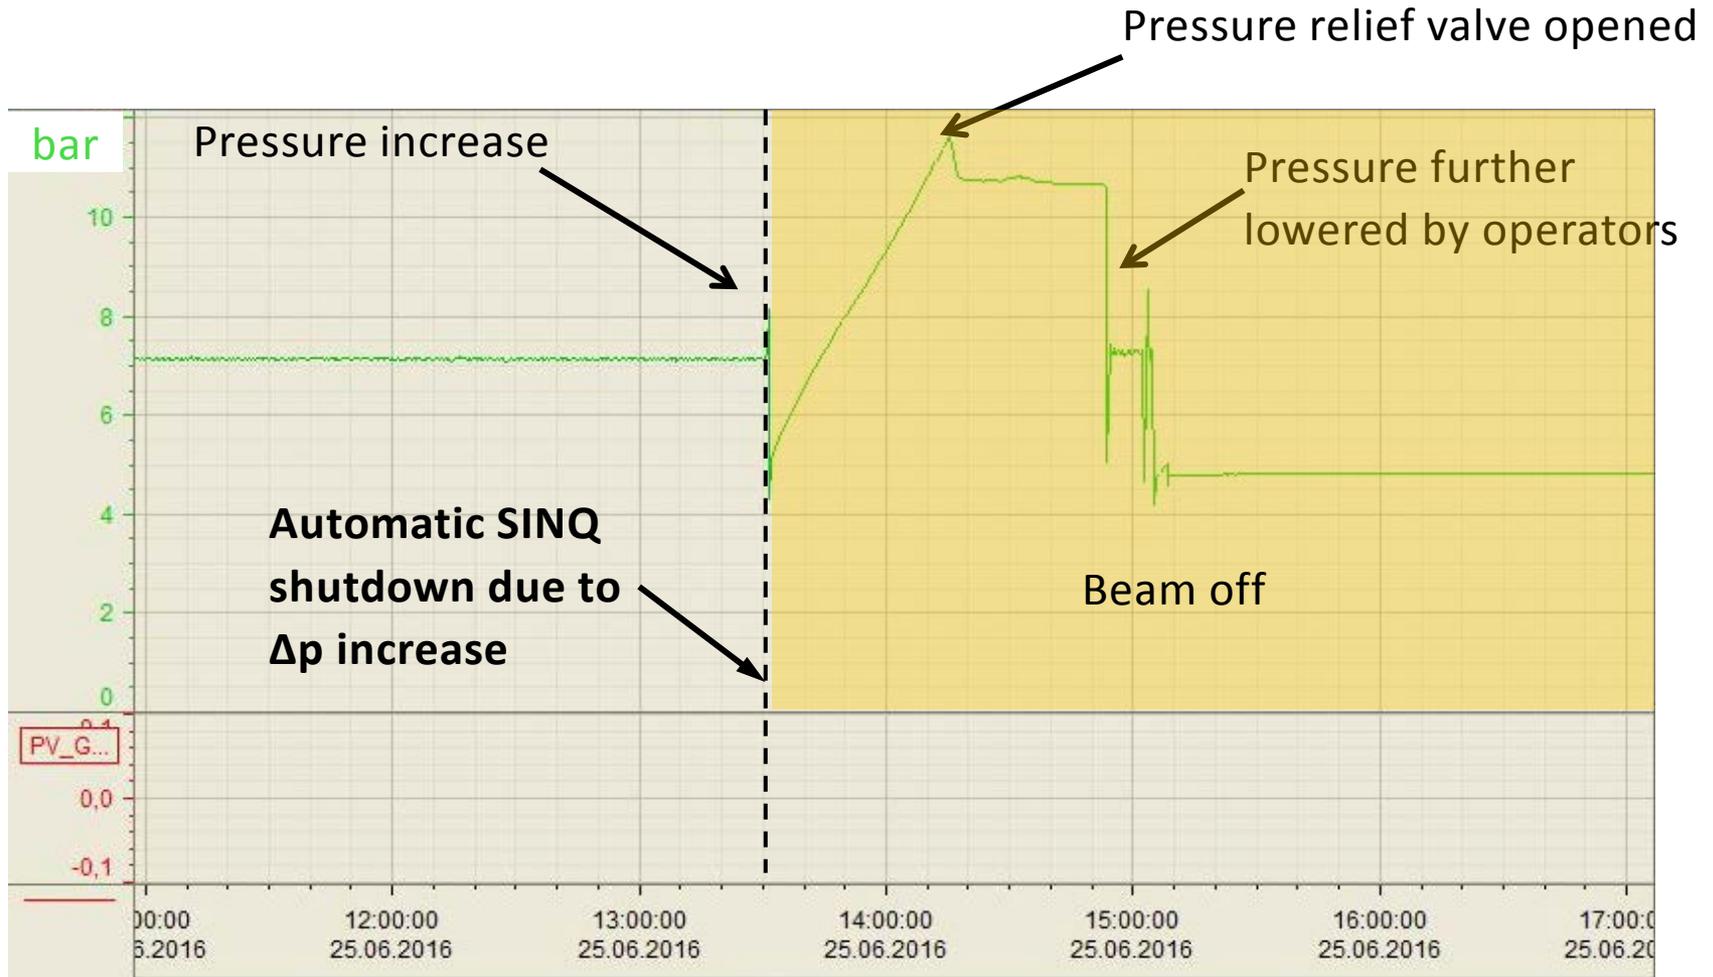
Operation SINQ Target-11 - Pressure

Static D₂O pressure in SINQ Target-11 increased, even in beam-off state
 Pressure relief valve opened & further pressure release by operators

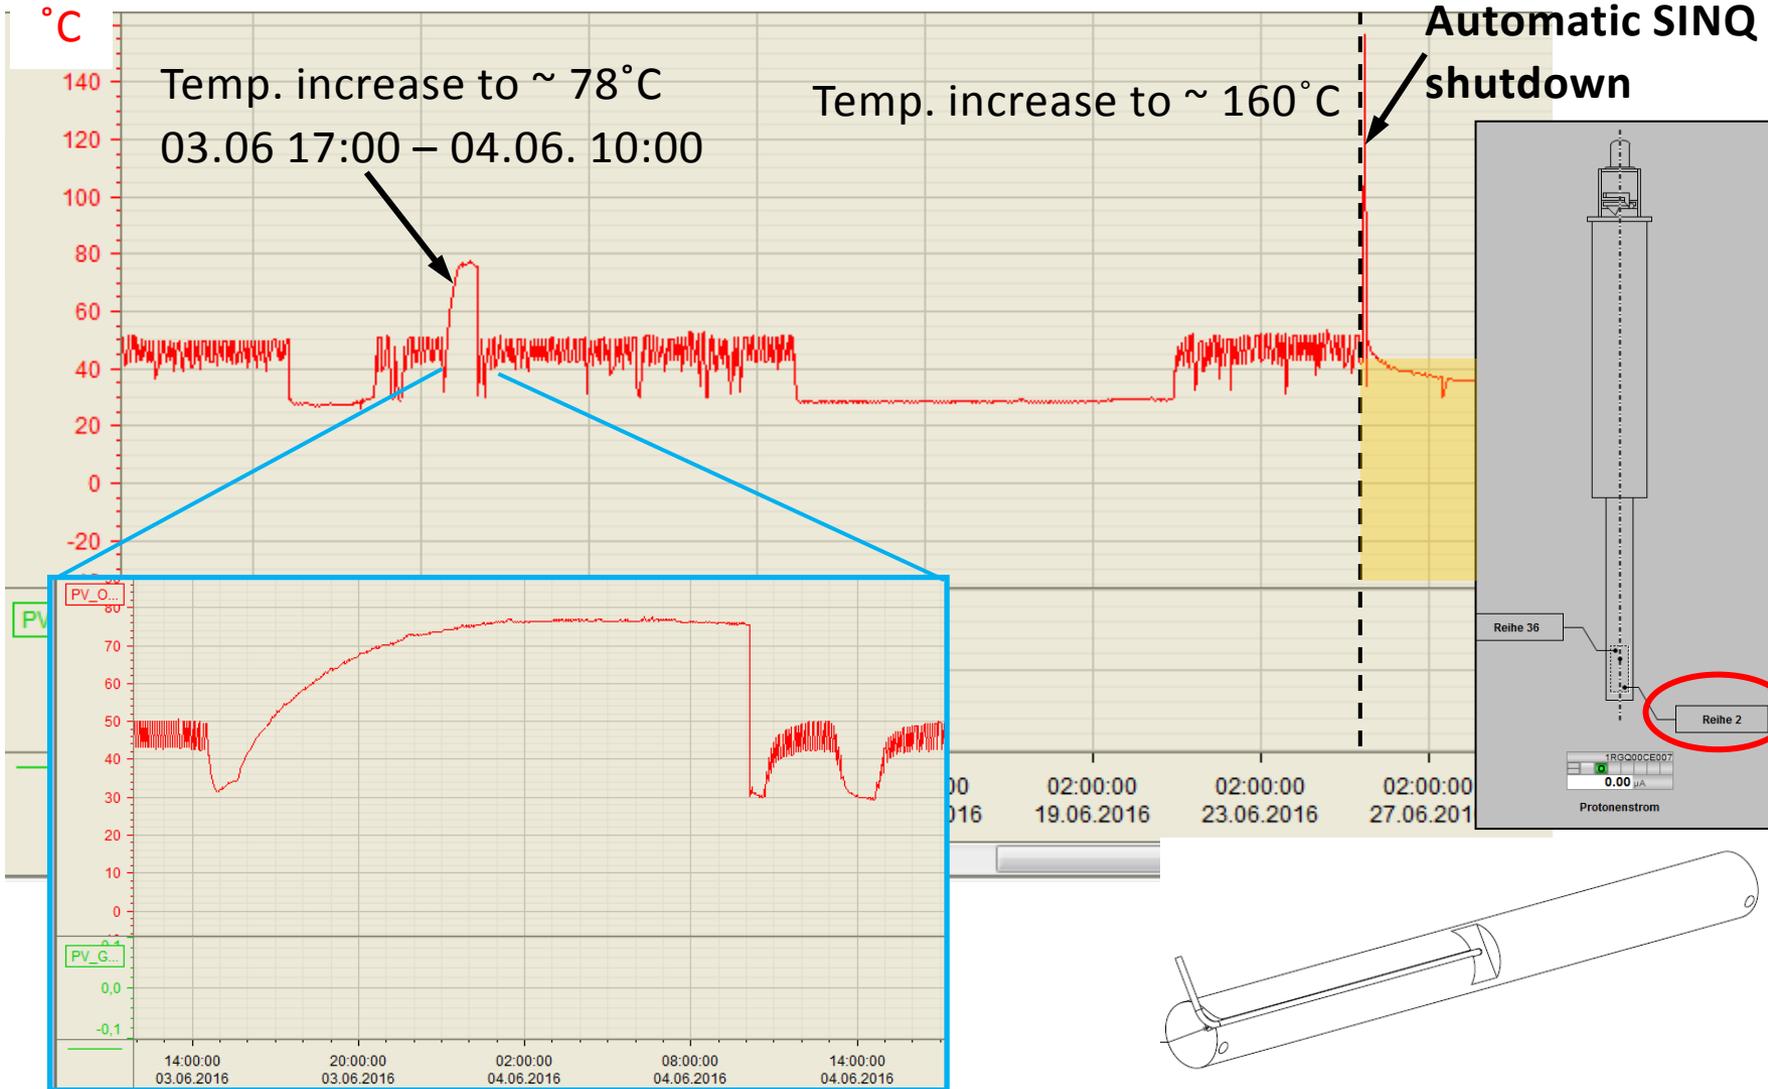
Operation SINQ Target-11 - Temperature

D₂O Temperature data in Row 2 of SINQ Target-11 from 03 - 27. June 2016

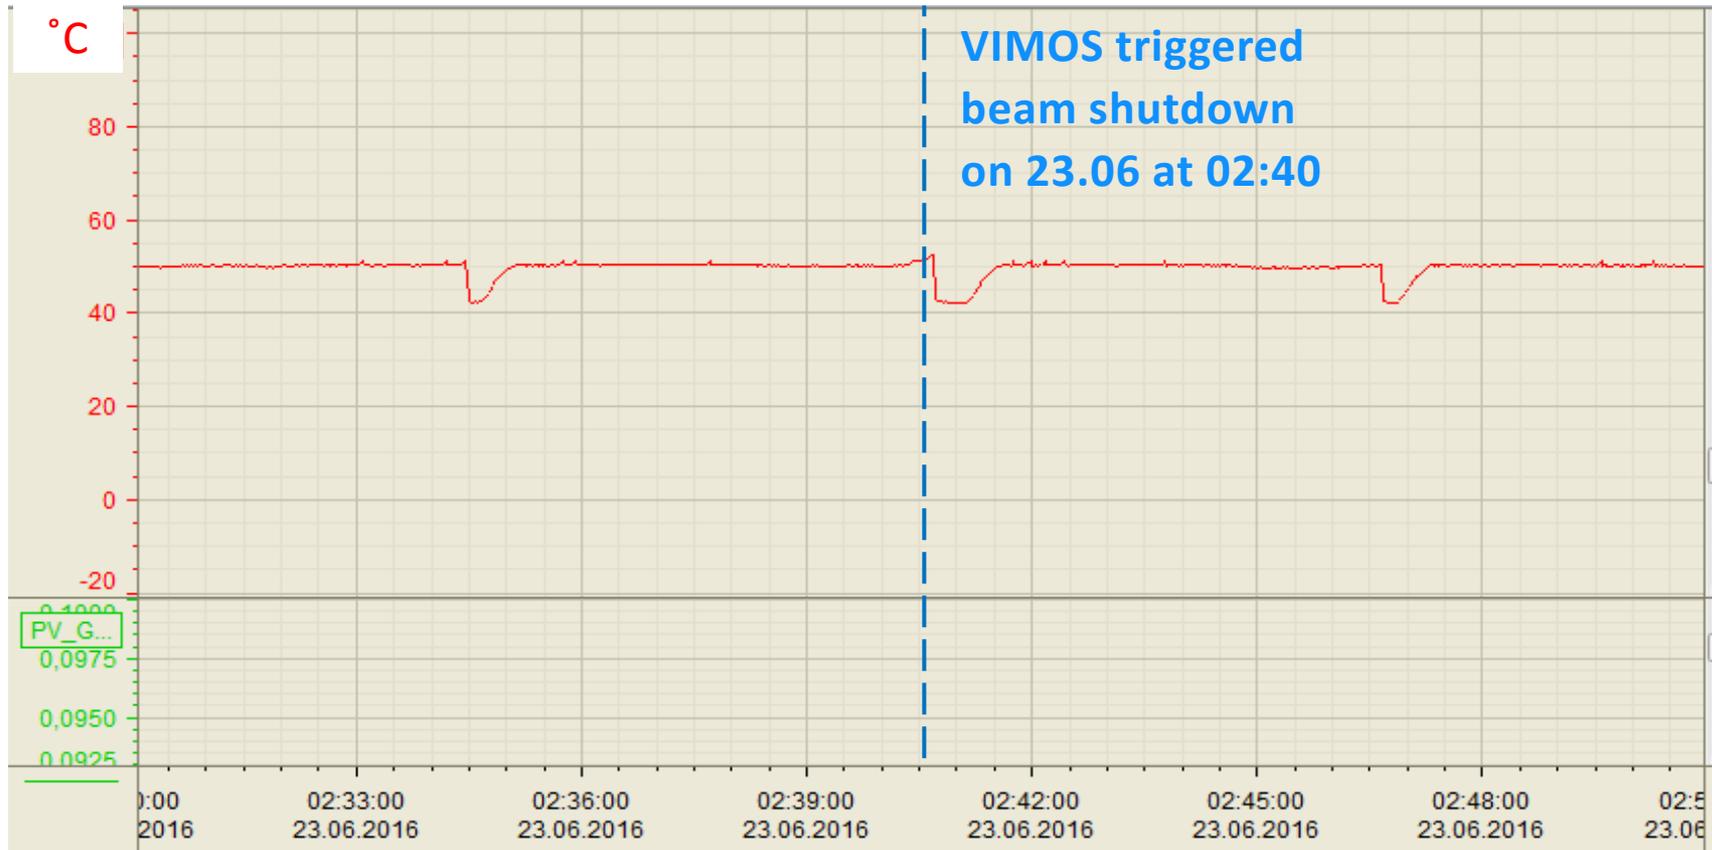
Operation SINQ Target-11 - Temperatures

In Row 36 an increase in temperature of 3°C was observed at the time of the VIMOS triggered beam shutdown.

Dose rate in SINQ cooling plant room increased ~ 5 minutes later.

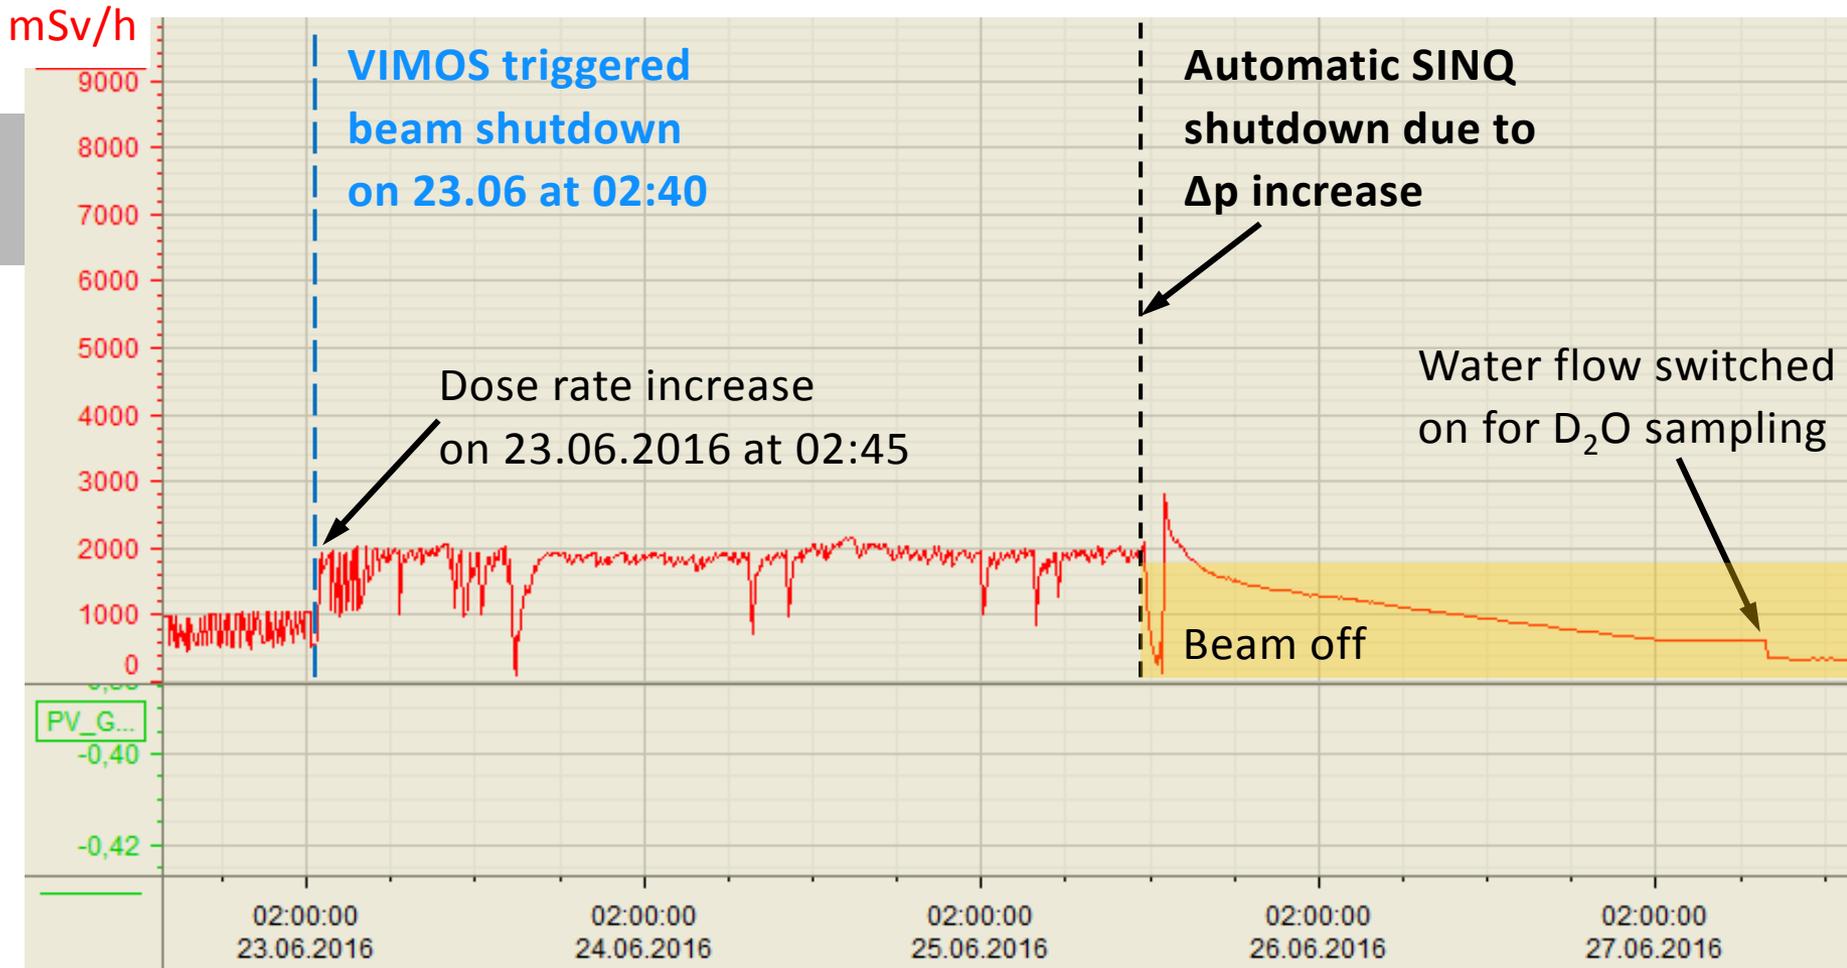
Operation SINQ Target-11 – Dose rate data

Dose rates (mSv/h) at the D₂O piping in the cooling plant room increase at 02:45
 Dose rate increase indicates failure of (a) Cannelloni(s); at ~02:40 D₂O temperature increase in Row 36 of Target by 3°C, in coincidence with VIMOS triggered shutdown
