# Pulsed Heavy Ion Irradiation of Tungsten

Jemila Habainy<sup>1,2</sup>

# Two types of rolled tungsten specimens

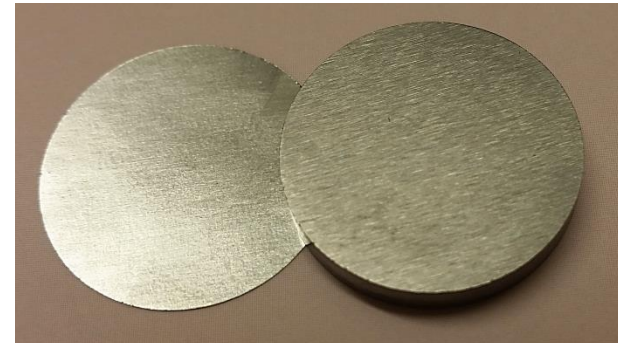
- Coin:
  - 20 mm dia., 3 mm thick
  - Beijing Tianlong Tungsten & Molybdenum Co., Ltd
  - Beam induced cyclic shear stress
- Foil:
  - 20 mm dia., 0.026 mm thick
  - Plansee Metall GmbH, Austria
  - Tensile and compressive stress waves

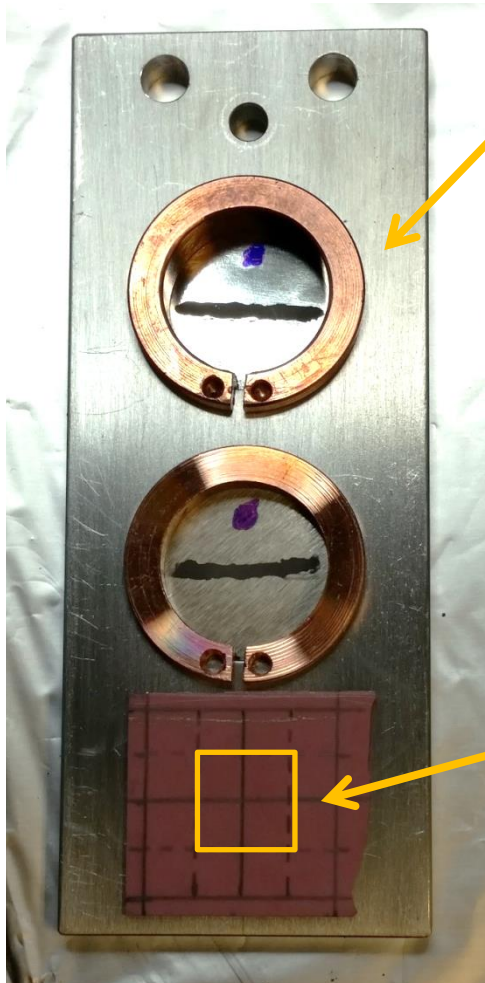
# Experimental set up – Sample holder

Copper rings fix the samples

Reflective tape for vibration measurements

Graphite used for temperature measurements

Luminescence target  
Beam spot  $\sim 1\text{cm}^2$

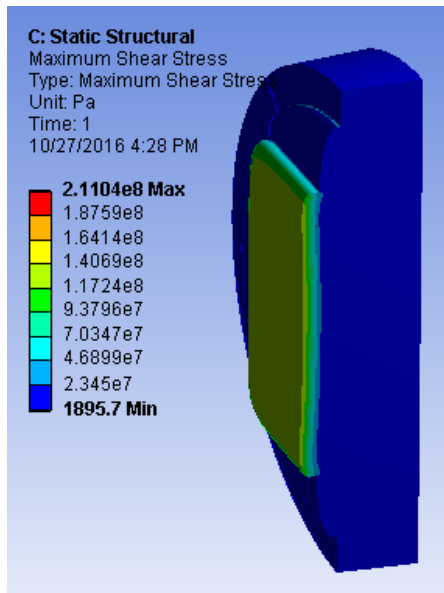
# Calculations on uranium beam irradiation

- Steady temperature: 87°C
- Temperature range during pulse: 113°C
- Max. post-pulse temperature: 200°C
  - ESS block: Max. 447°C
- Max. post-pulse shear stress on sample surface: 130 Mpa
  - ESS block: Max. 110 MPa von Mises stress

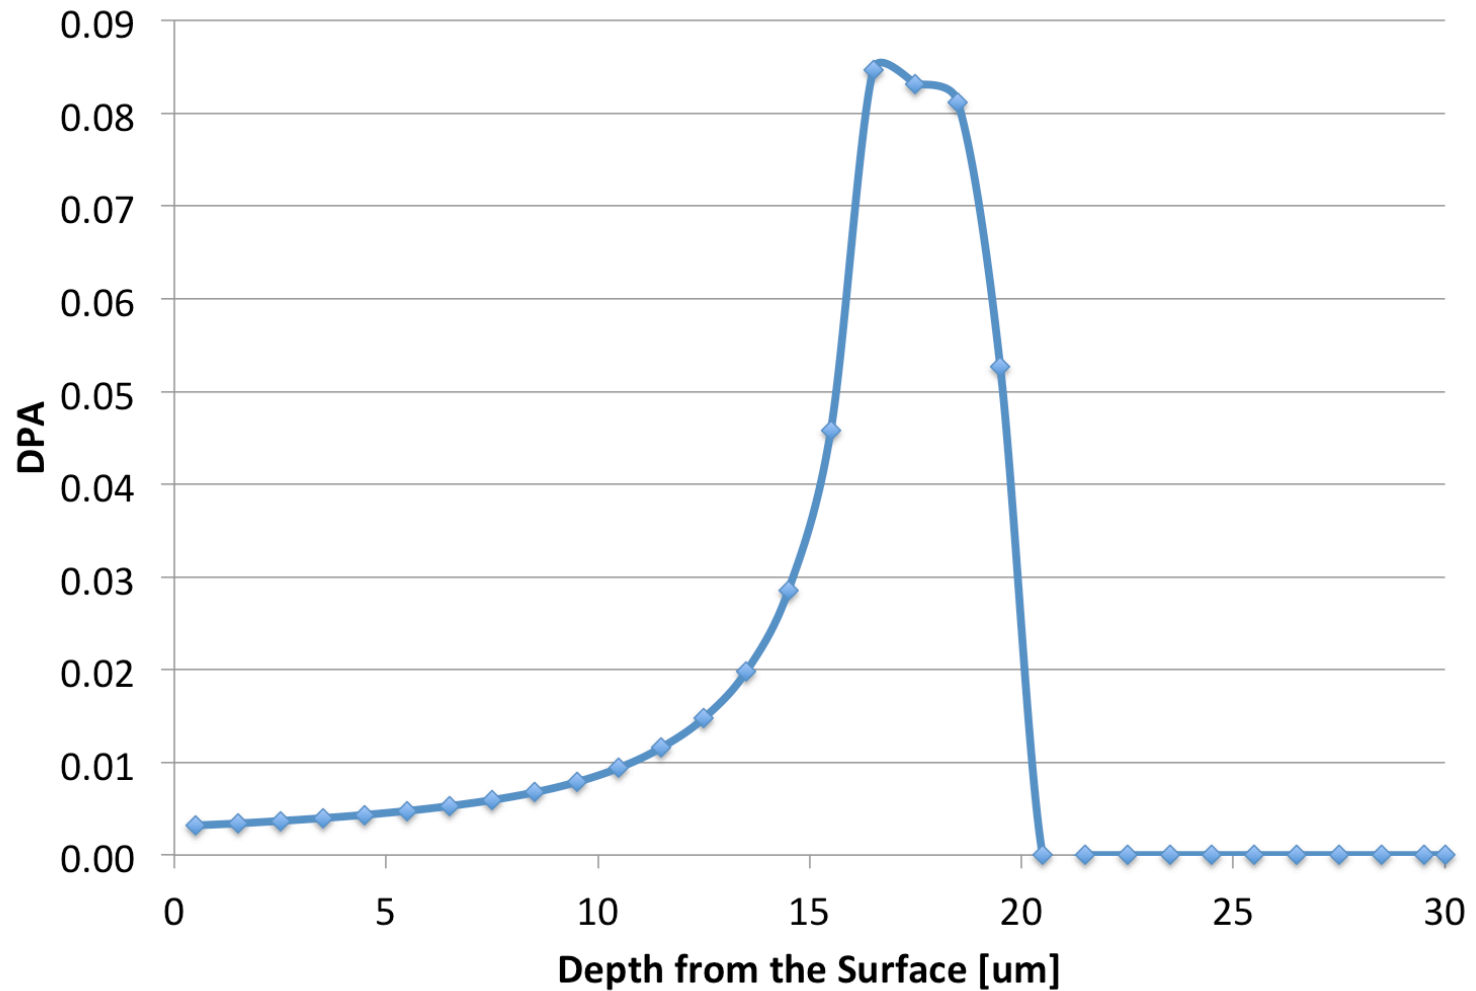
# Damage map

DPA for the particle fluence of  $1.0 \times 10^{14}$  U/cm<sup>2</sup>

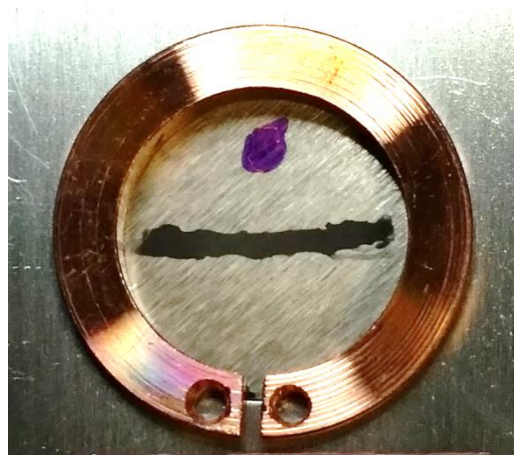
Coin 3 mm thick  
Flux  $\sim 1\text{e}10$  ions/s/cm<sup>2</sup>  
Fluence  $1\text{e}14$  i/cm<sup>2</sup>

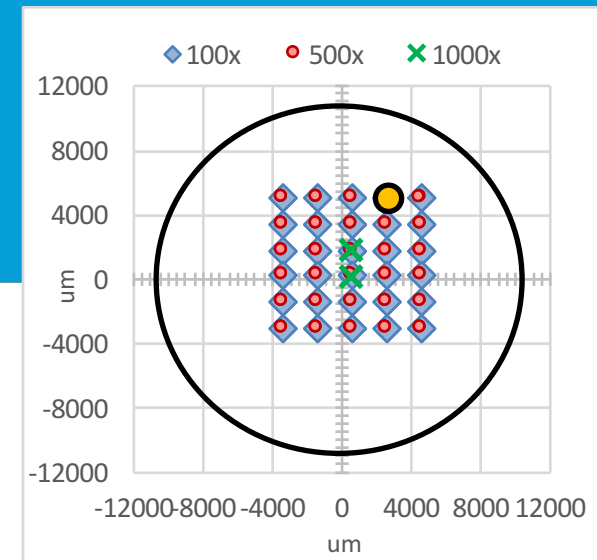
# SEM images reveal damaged oxide layer

Oxidized 2h in air at 500°C

Before and after image (100x) of the same position, top right corner of irradiated zone

Map of SEM image positions

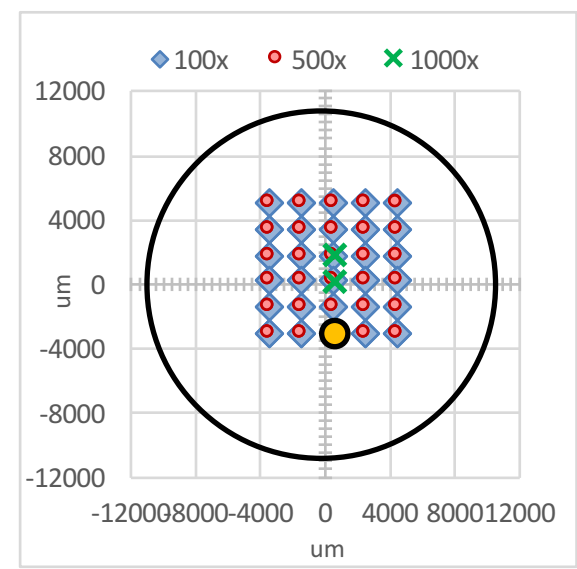
Map of SEM image positions

Higher mag. image of bottom/center position of same sample

Porous outer oxide scale clearly damaged

- Hardness tends to increase with depth, from 540 to 590 on average. 590HV0.5 corresponds to peak damage.
- Frequency of vibration increased with irradiation
- Beam induced dynamic stress caused damage to oxide,  $\sim 1.3\mu\text{m}$  lost
- Obtained stress with GSI beam comparable to ESS W stress
- Temperature during irradiation: base  $40^\circ\text{C}$  ( $87^\circ\text{C}$  calc.), range  $130^\circ\text{C}$  ( $113^\circ\text{C}$  calc.) Difference explained by graphite blackening and higher flux at times.
- Advantage of ion irradiation – sample can be collected immediately

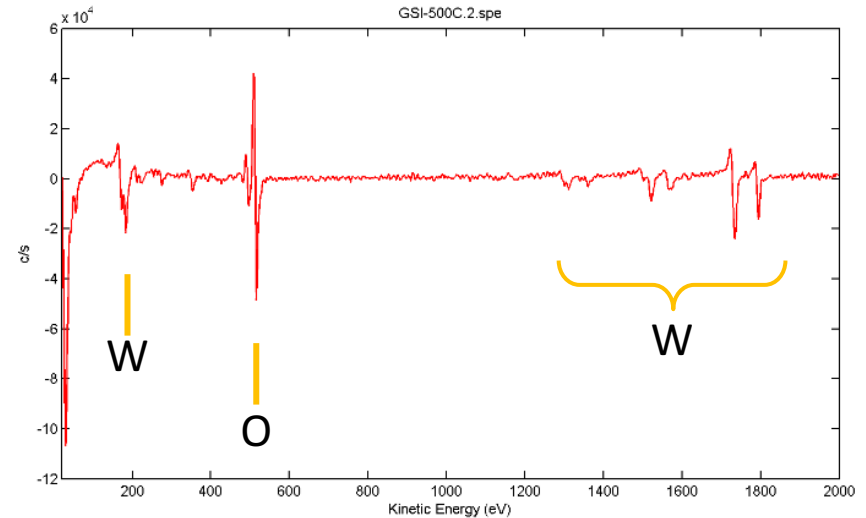
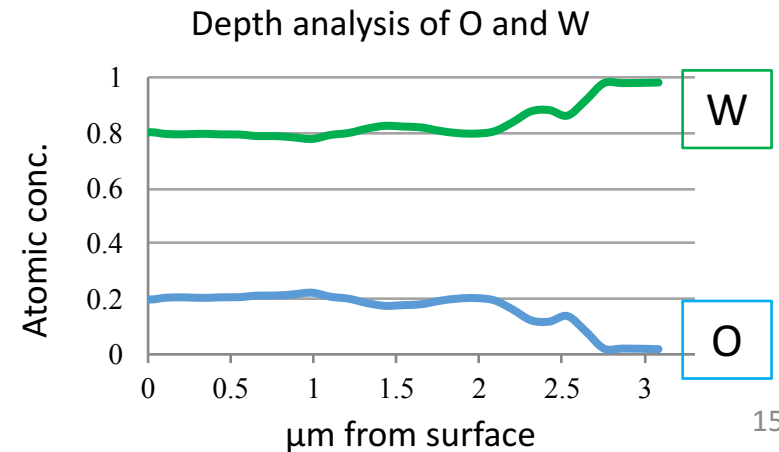
After pre-sputtering

- Oxide layer thickness:  $\sim 2.75 \mu\text{m}$
- Pre-sputtering to remove thin carbon layer on surface

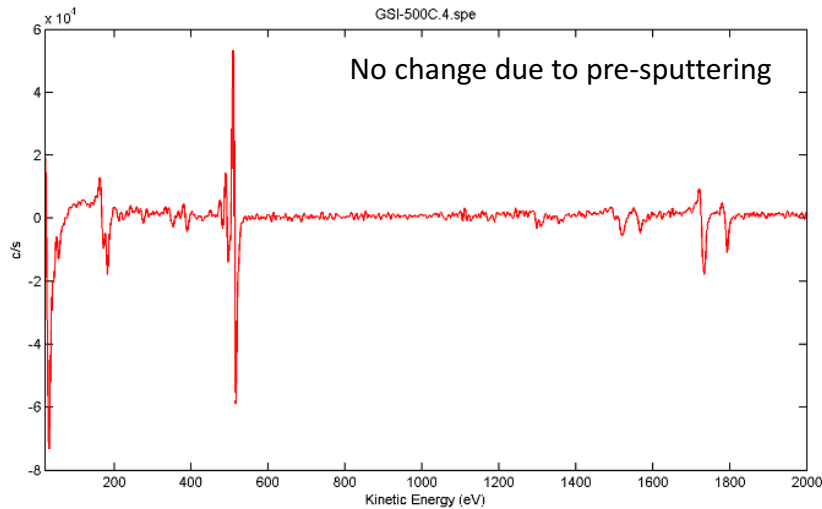
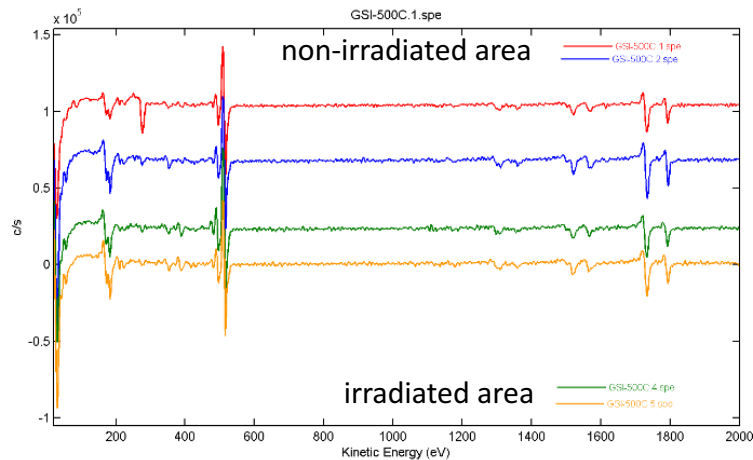
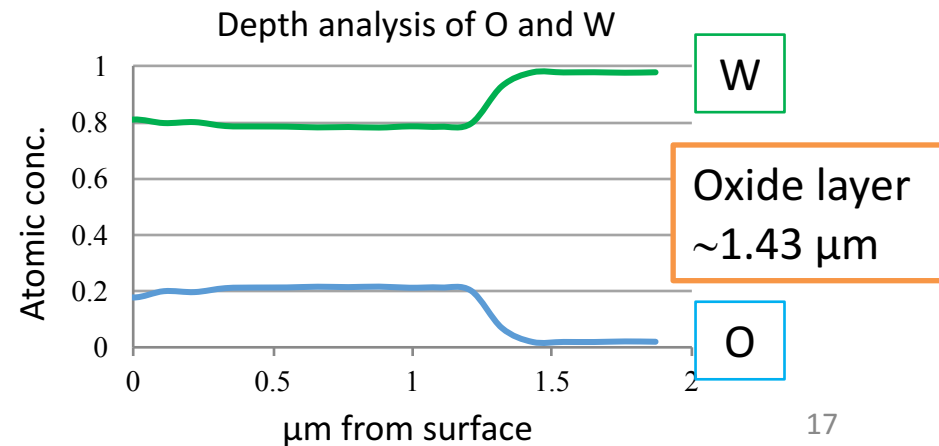
# Surface and depth analysis of irradiated oxidized area

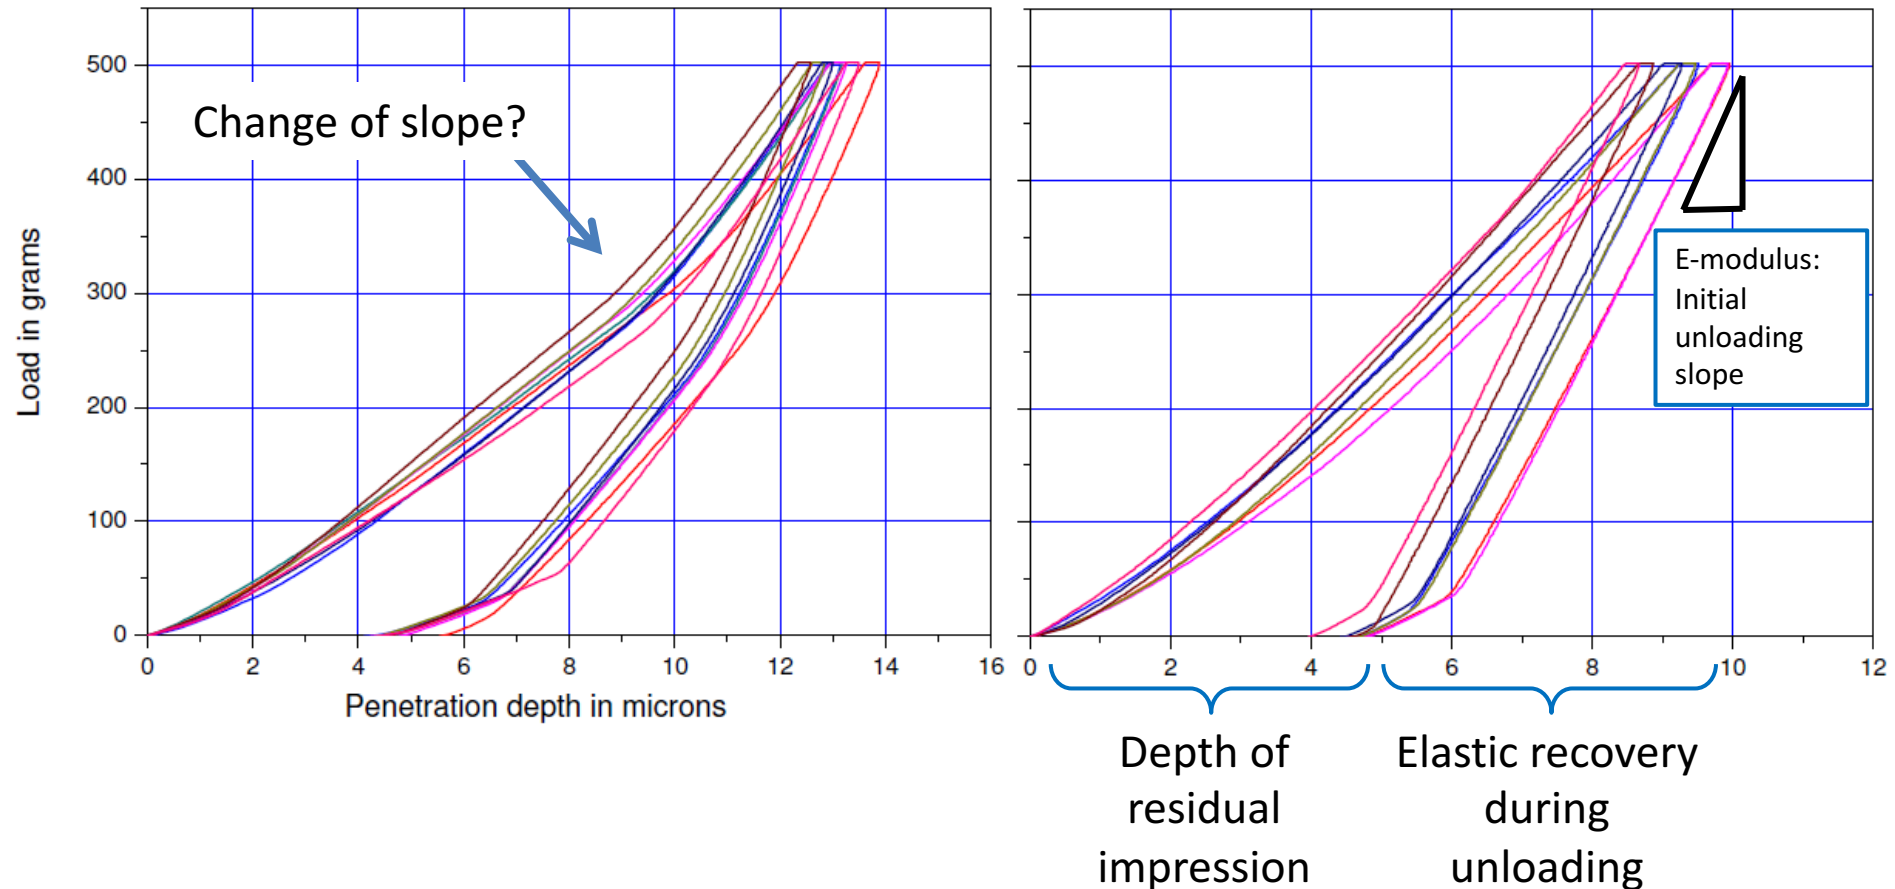
# Penetration depth at surface

Unirradiated-unspattered area

Irradiated zone-unspattered area

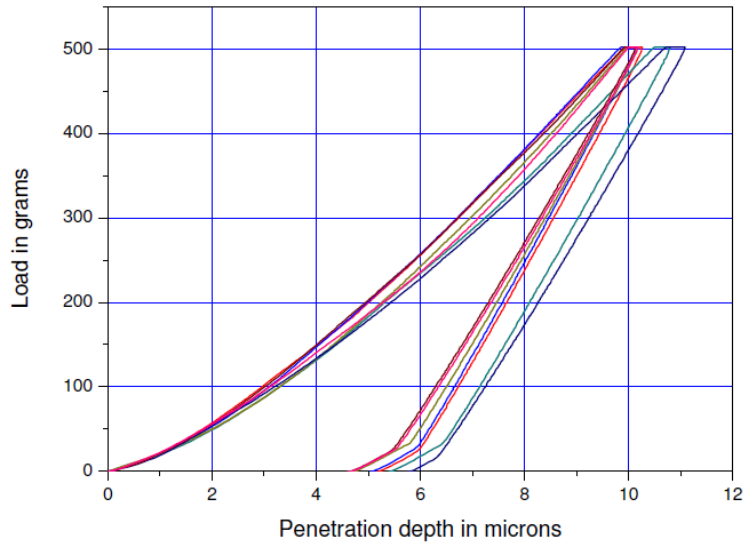
Irradiated zone - sputtered 6  $\mu\text{m}$

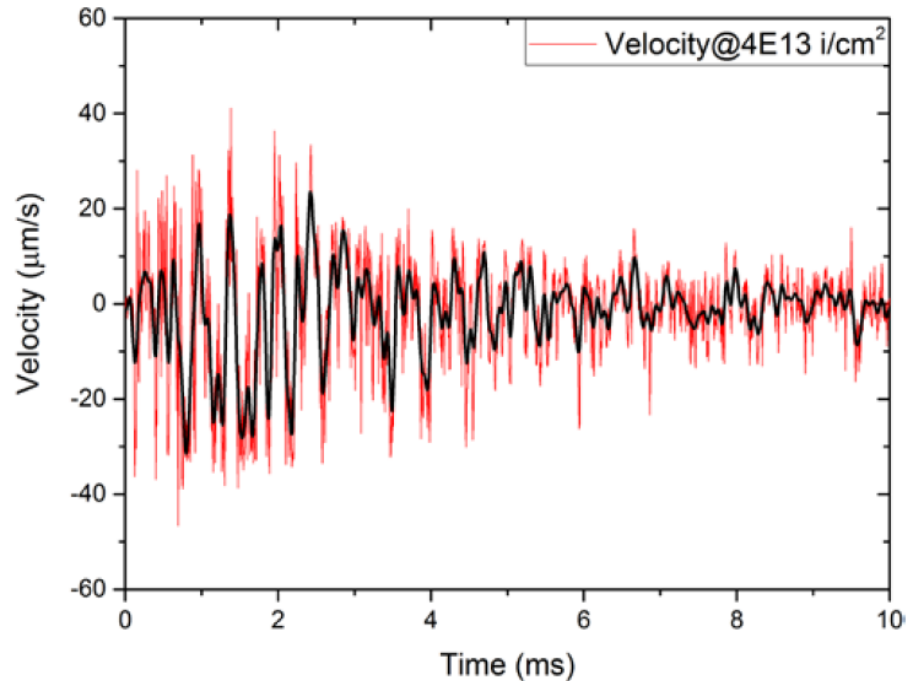
# Vibrational analysis of foil at $1e10$ U/(s·cm<sup>2</sup>) - Preliminary results

Surface velocity of W foil as a function of time at an accumulated fluence of  $5e10^{11}$  U/cm<sup>2</sup> (left) and  $4e10^{13}$  U/cm<sup>2</sup> (right)

Frequency of vibrations increased with irradiation – stiffening of irradiated area due to change of vibration mode?
