# Tensile properties characterization of irradiated AISI 316L from high-use target modules at the Spallation Neutron Source using digital image correlation

November 1, 2016

13<sup>th</sup> International Workshop on  
Spallation Materials Technology

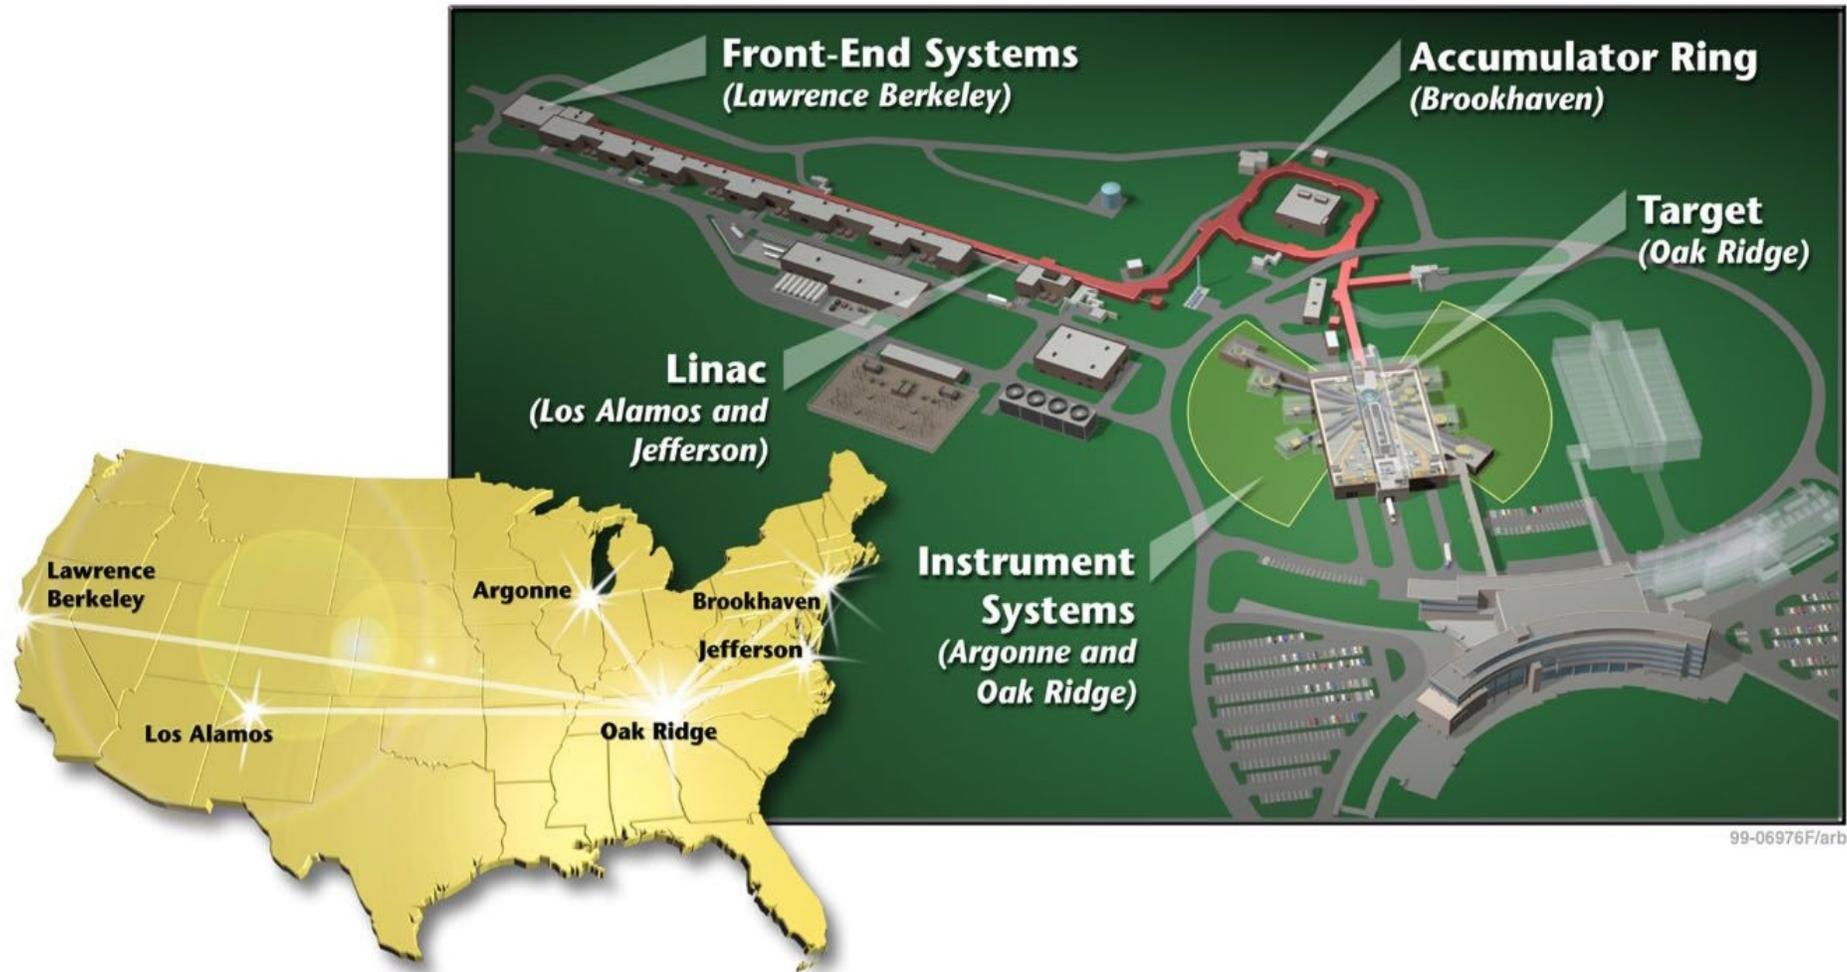
# The Spallation Neutron Source is a megawatt class accelerator-based pulsed neutron source

- Neutrons are produced via high-energy spallation reactions induced by injecting 1 GeV protons into liquid mercury at a frequency of 60 Hz

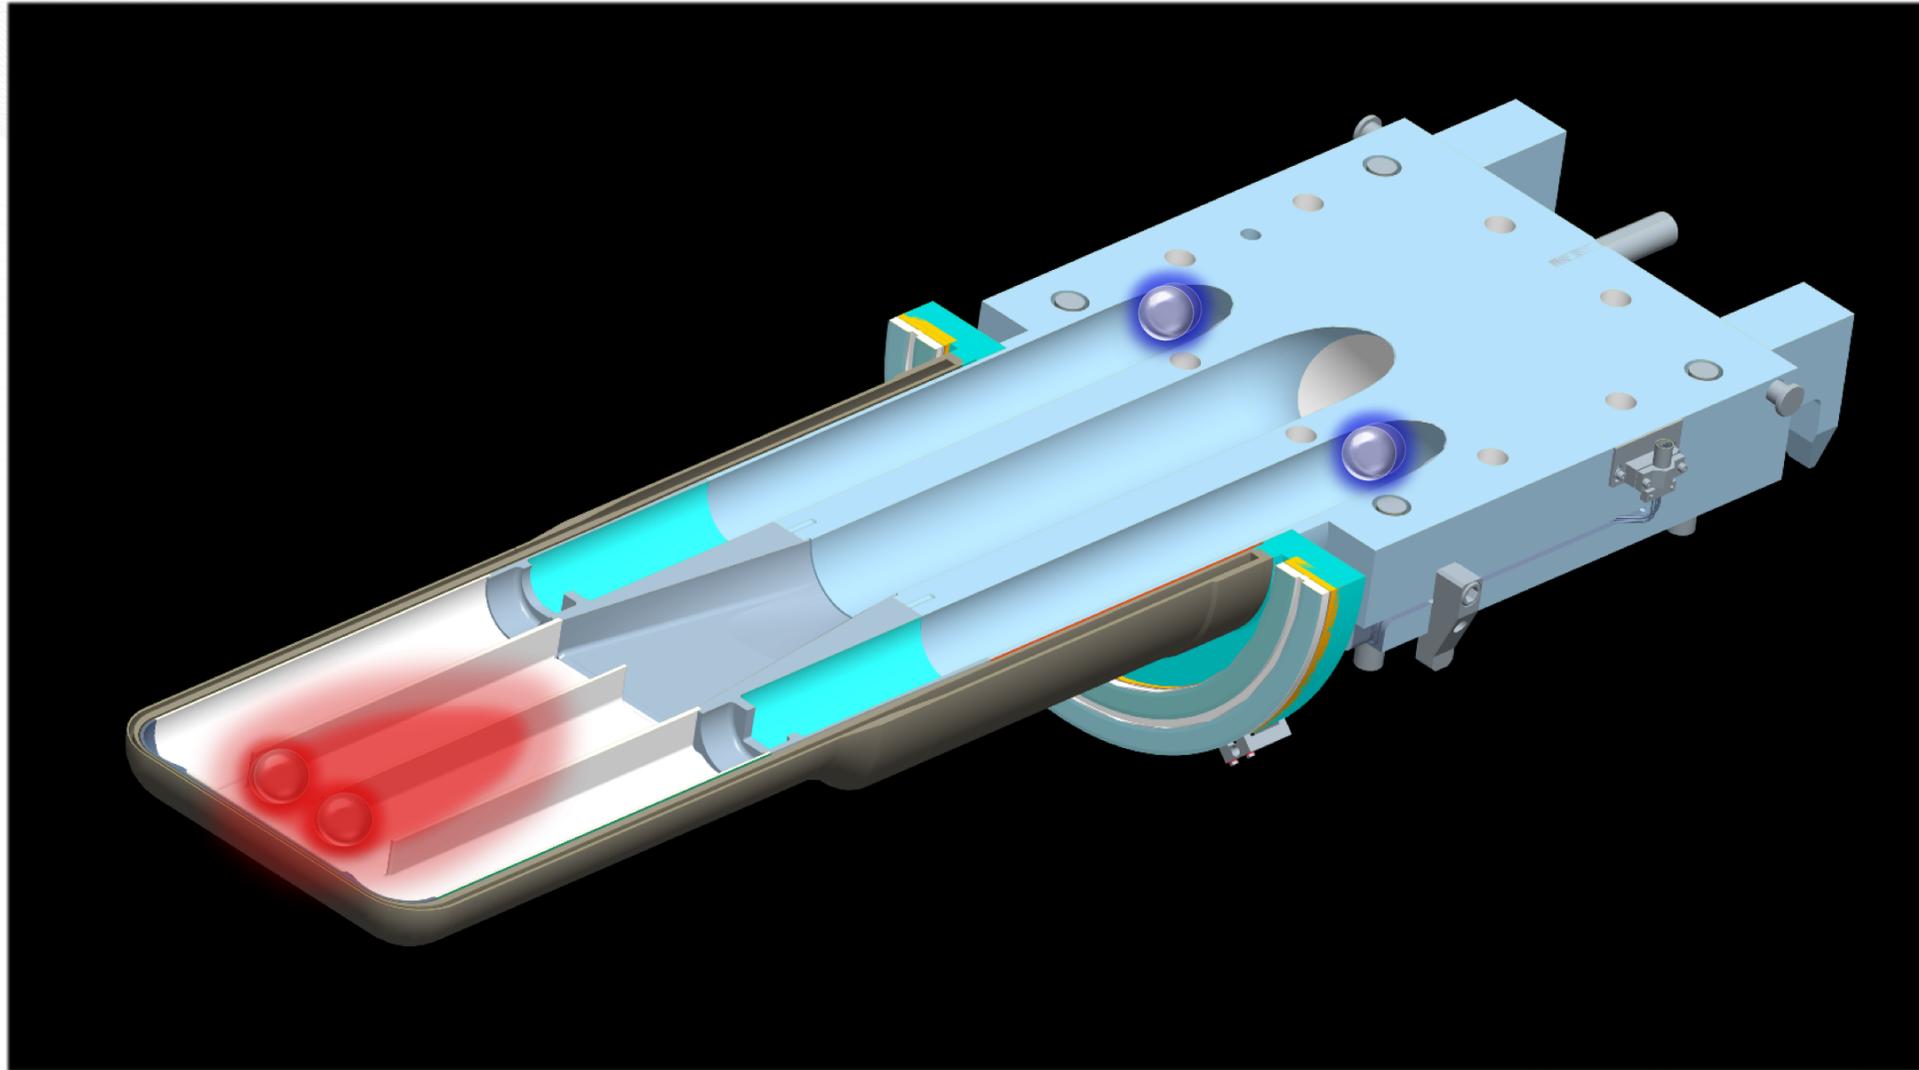
# Mercury enters through side supply passages and returns through the center return passage

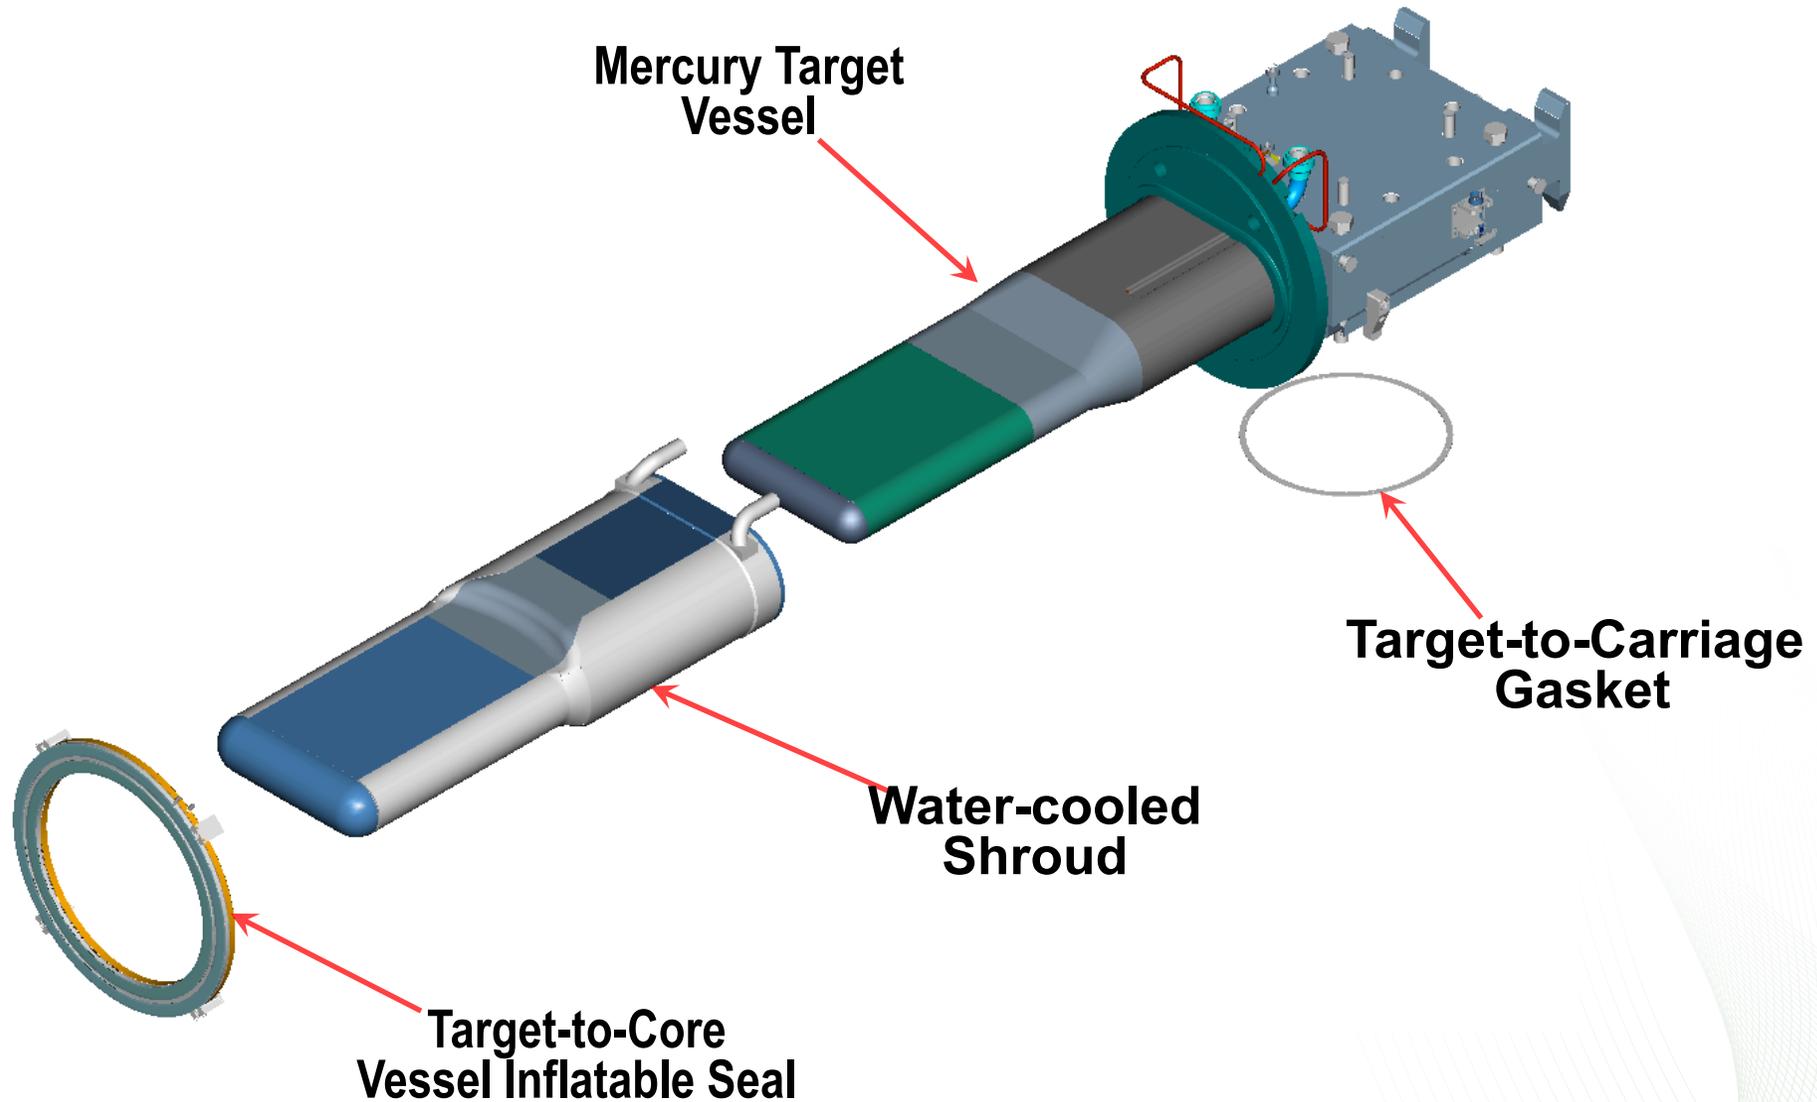
# SNS target is composed of two “vessels” welded to a manifold block

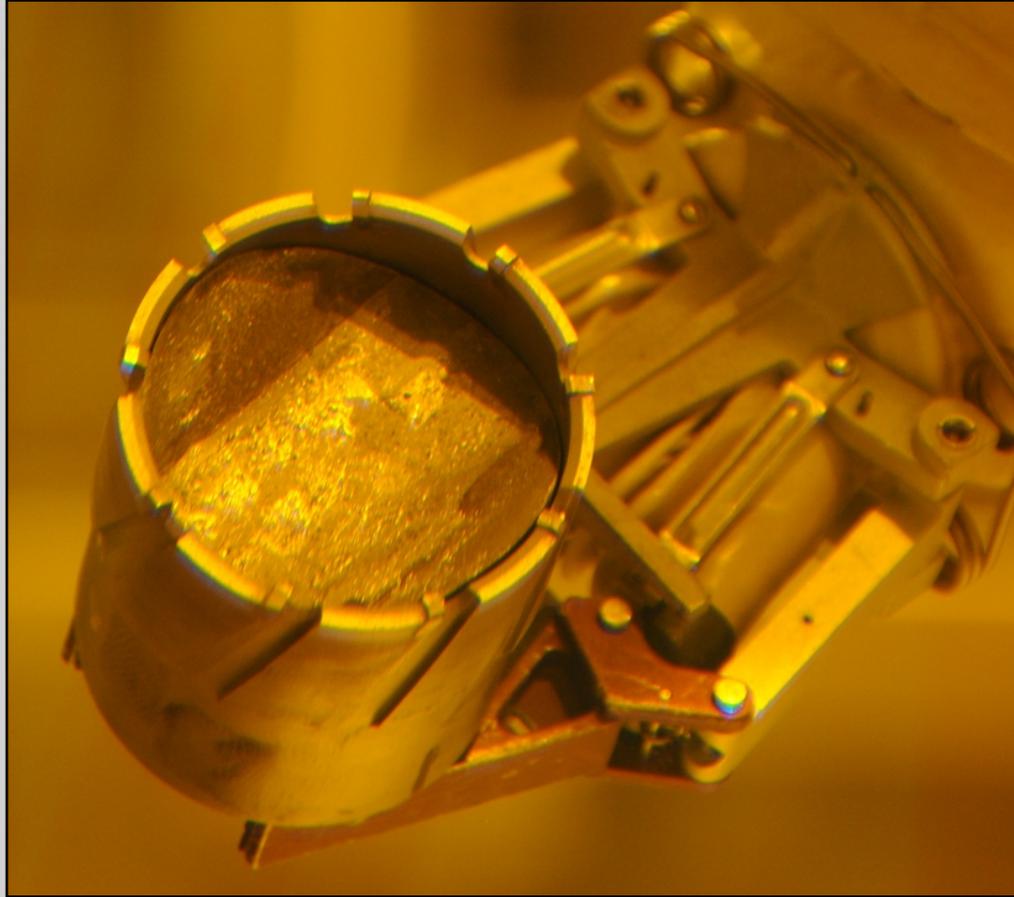
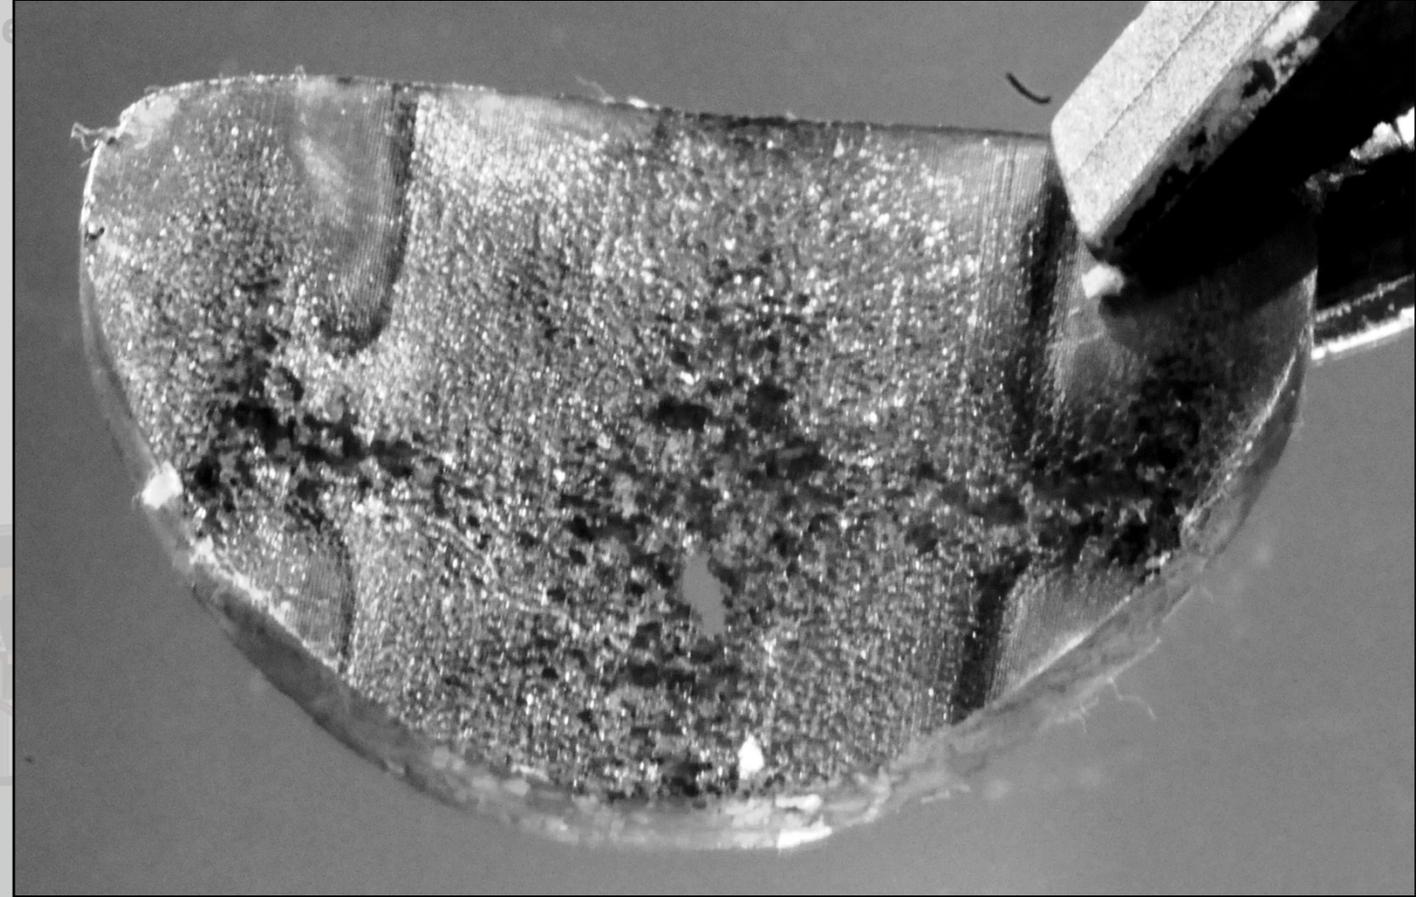
# Disk-shaped Specimens are Routinely Sampled from the Beam Entrance Region of SNS Targets After Service

Pneumatic  
Piston

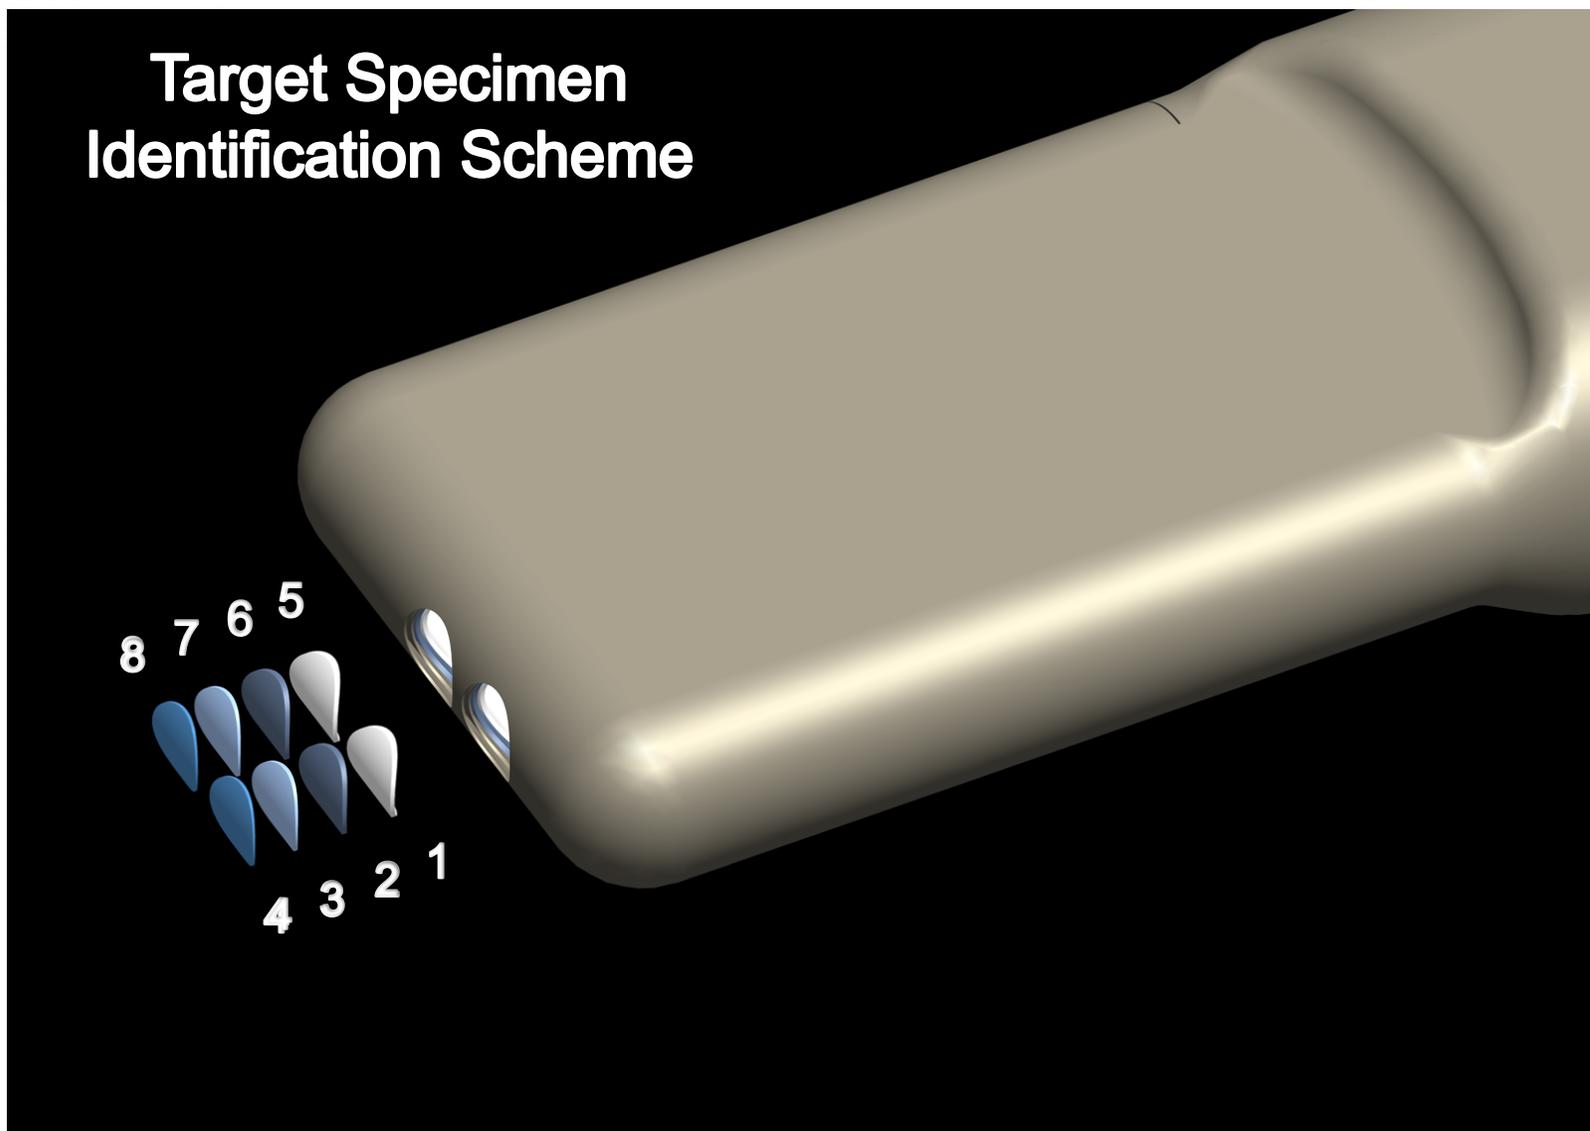
# Four disk-shaped specimens were removed from the target module by each cutter

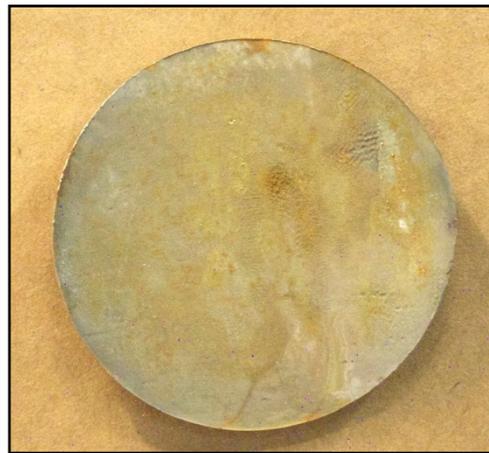
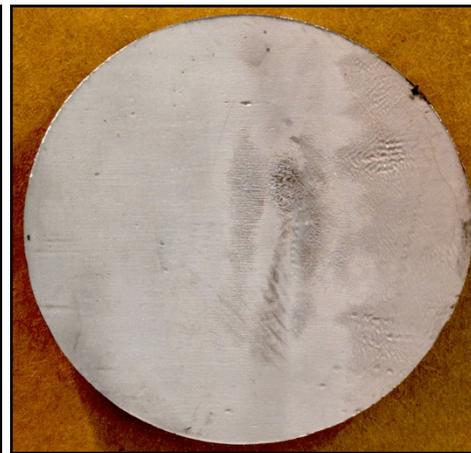
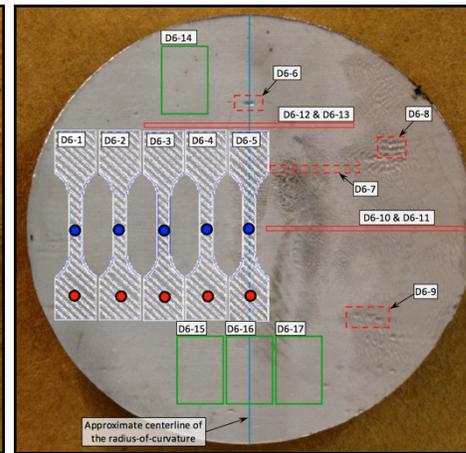
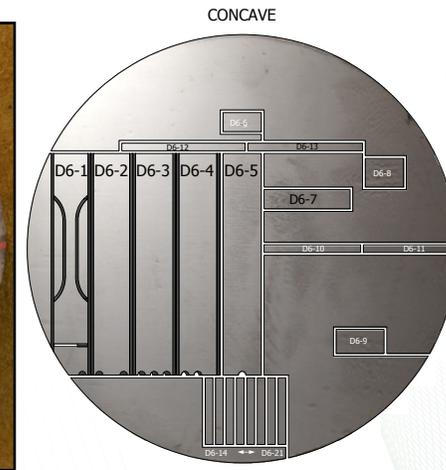
## Example: Disk 6 from Target 2

- The disks were cleaned in an ultrasonic bath and photographed; the images were used to produce specimen maps for each disk
- Specimen machining maps were produced for each disk and test specimens were machined via electrical-discharge machining (EDM)
- Several characterization techniques have been employed, including: tensile testing, hardness testing, SEM examination of cavitation pitting, surface replication/SEM examination, and inclusions characterization

**Before Cleaning**

**After Cleaning**

**Specimen Map**

**EDM Machining Map**

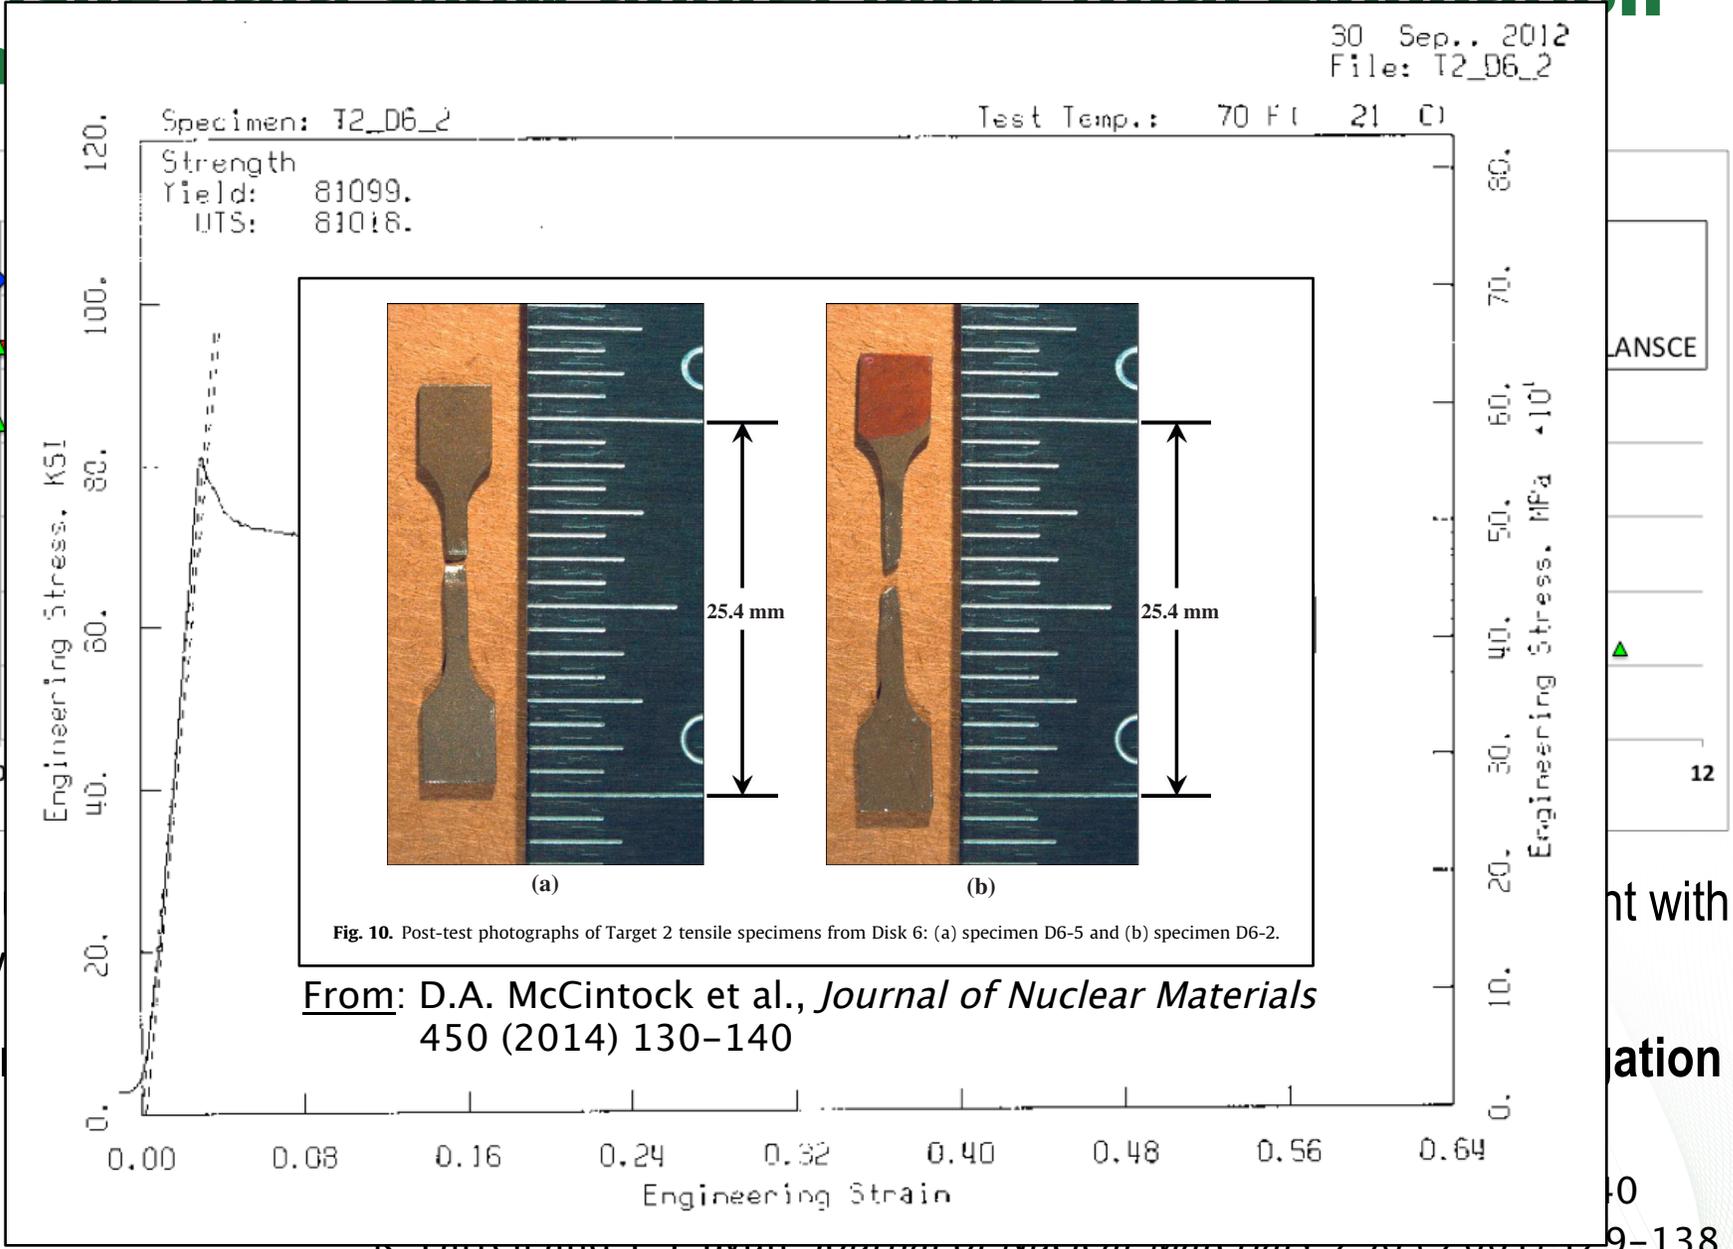
# Tensile data show appreciable total elongation

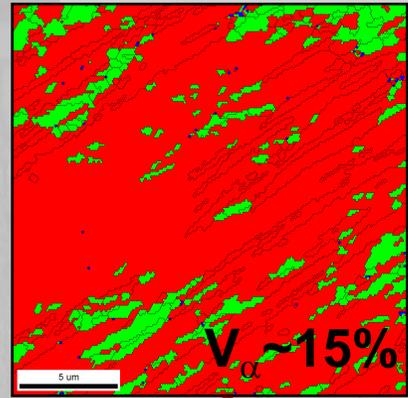
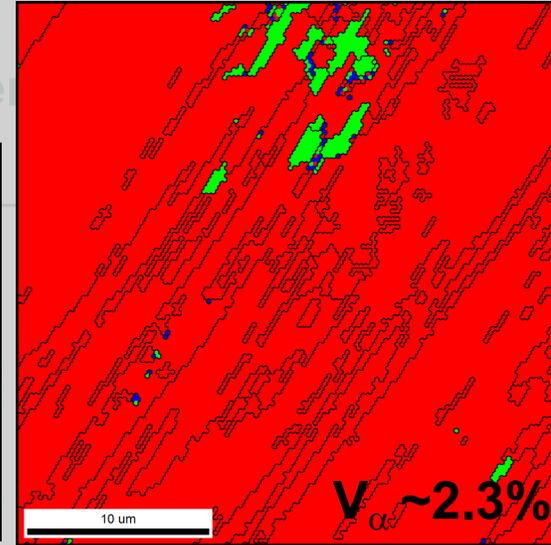
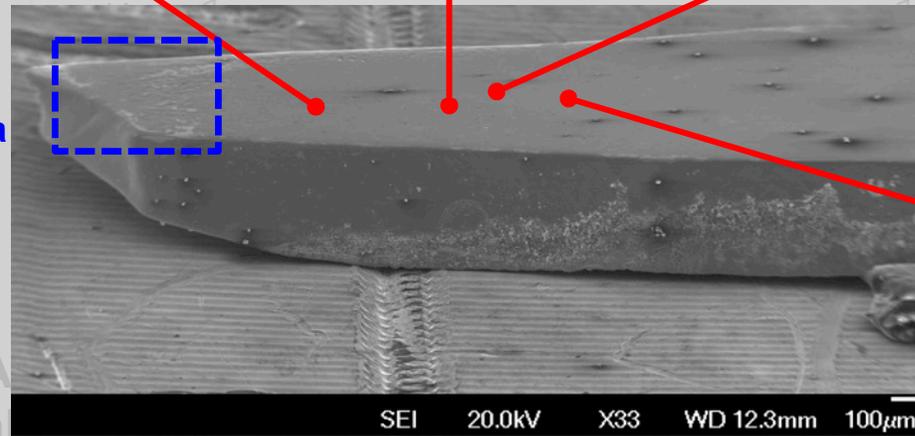
Scan #7, 2000x

# Inability to neck produces a “deformation wave” in highly irradiated stainless steel\*

For all maps:  
 $\gamma$ : Red;  
 $\alpha$ : Green;  
 $\epsilon$ : Blue.

No successful scans for this area

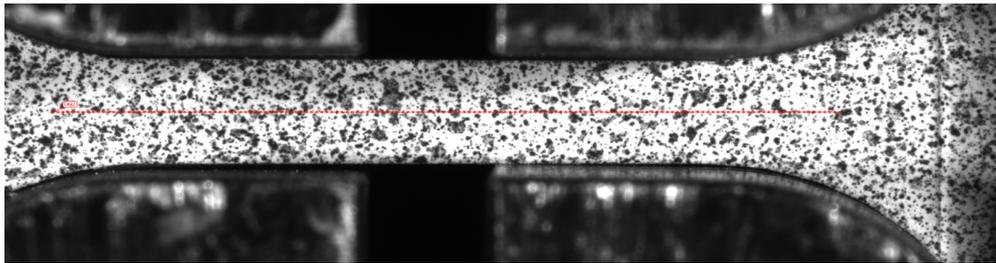
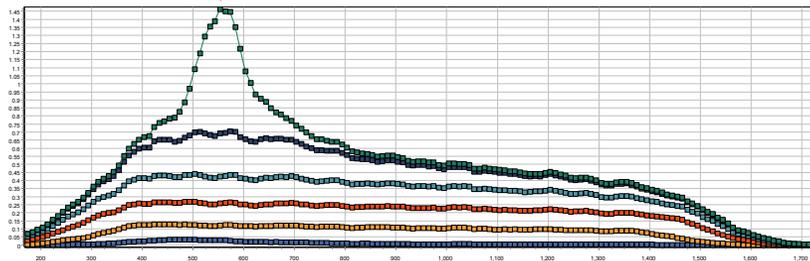
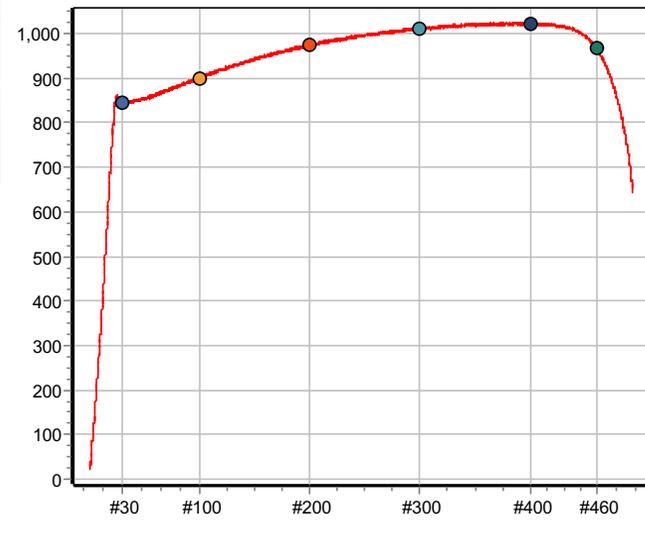
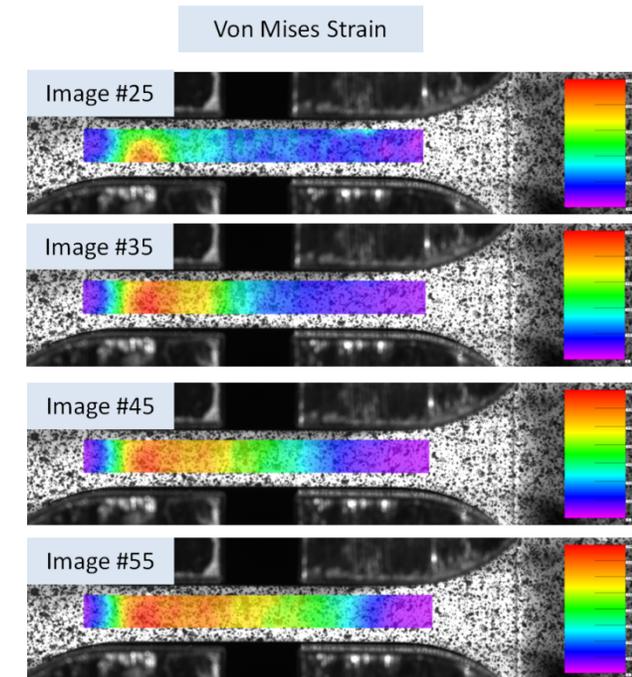
# Digital image correlation (DIC) is an extremely powerful tool for analyzing deformation behavior

- DIC allows for analyzing deformation localization in detail, calculating strain distribution along the specimen gauge, strain rate maps, etc.

Neck Formation

- Strain distribution (von Mises strain, Green-Lagrange strain tensor)
- Subset 63 pix. Raw data! No smoothing/manipulations.

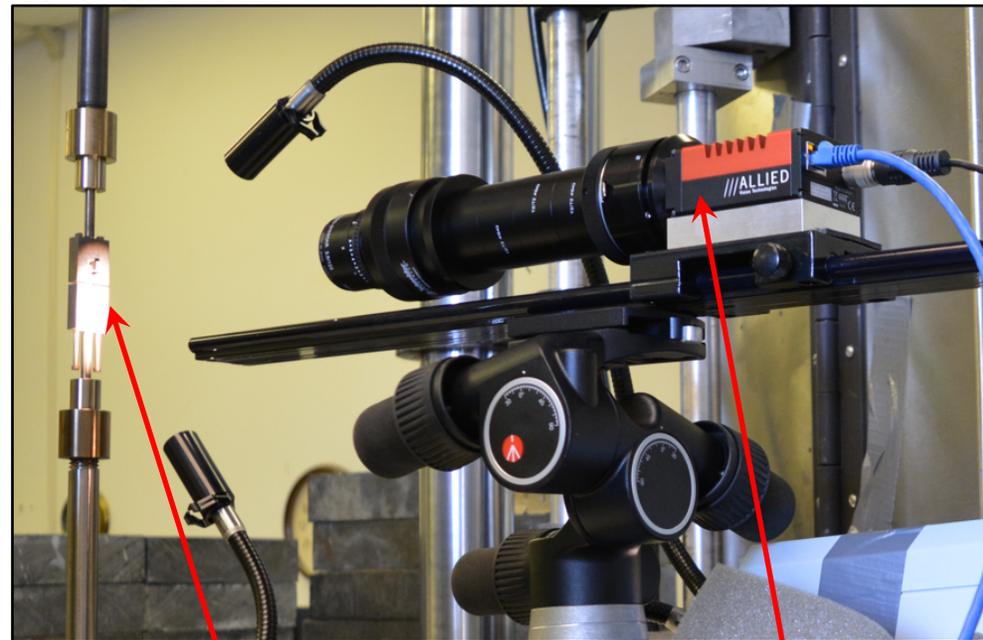
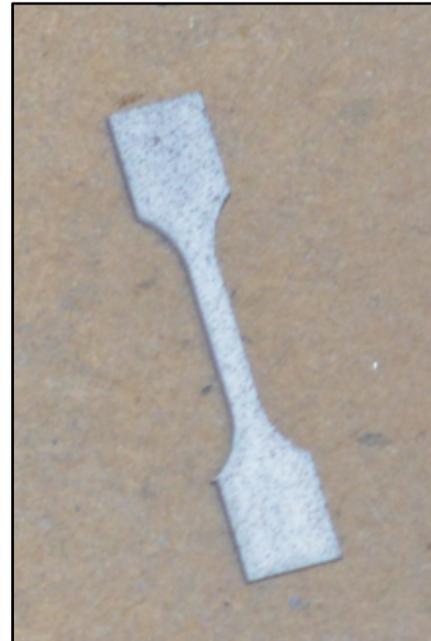
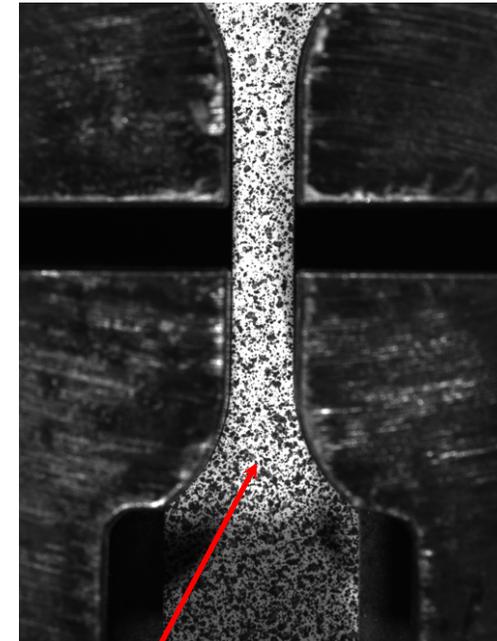
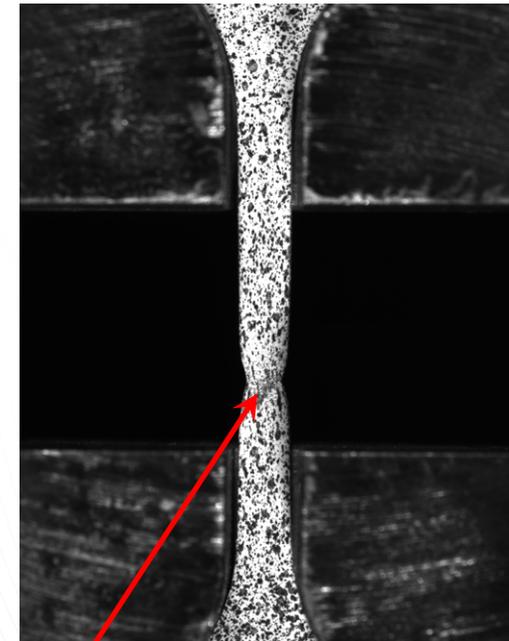
DIC Testing Setup

- Digital Image Correlation (DIC) was used to characterize specimen deformation behavior during testing
  - High-resolution camera captured one image per second during test
  - Image data reveals strain behavior of the entire specimen during test
- Tensile specimens were painted to provide contrasting features for analysis software to track and calculate displacements

Tensile Specimen

High-resolution Camera

Target 8 Specimen

Beginning of Test

Tensile Specimen in Testing Fixture

End of Test

Neck at Specimen Failure Location

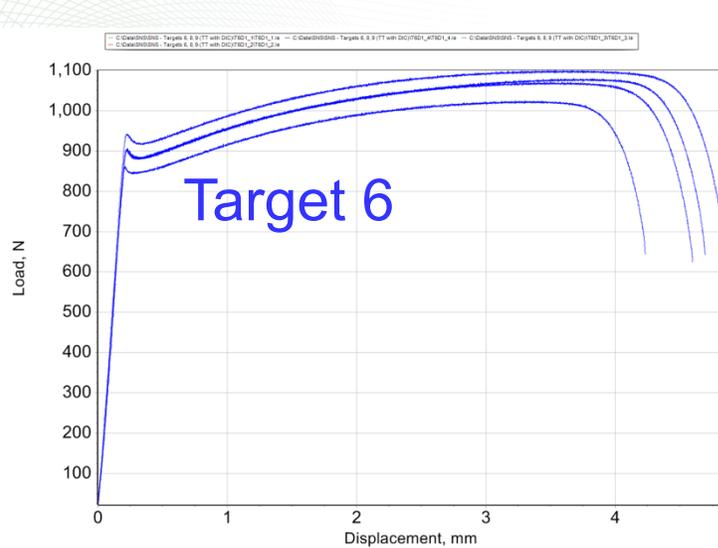
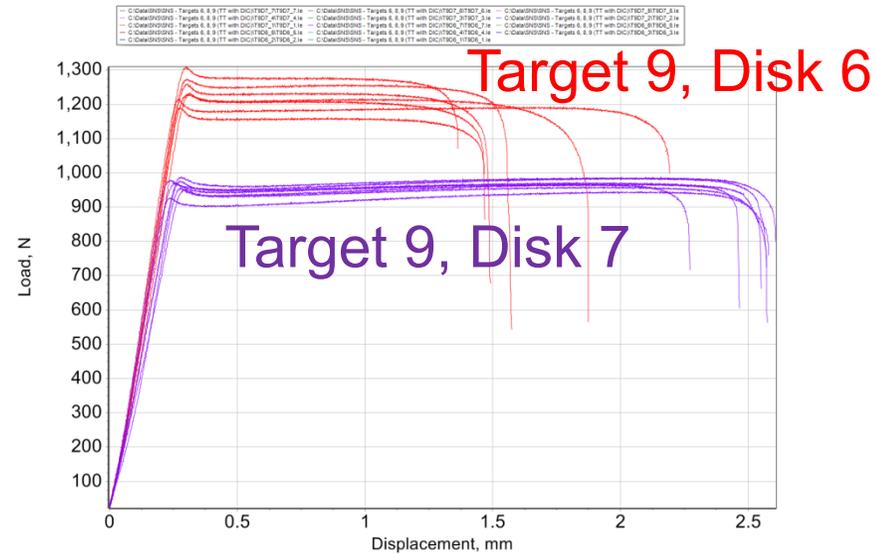
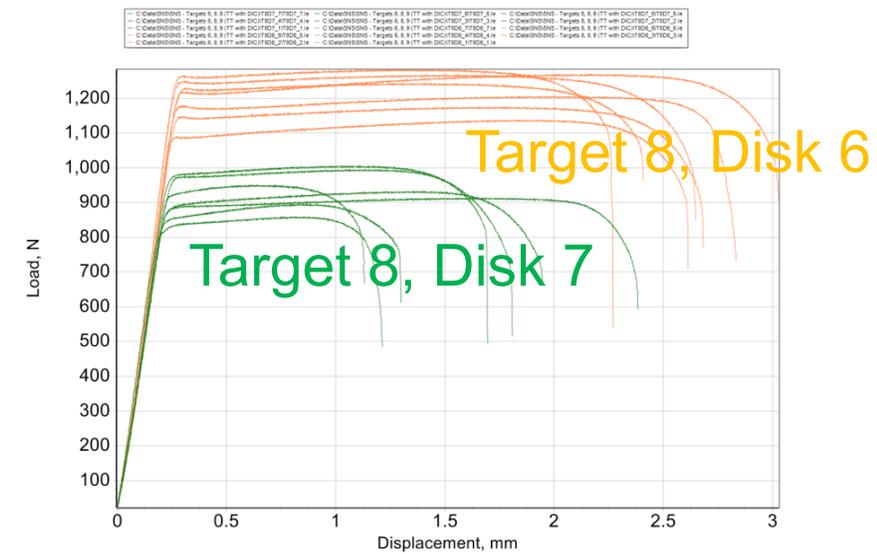
# Engineering stress strain curves show similar general deformation behavior

- Shapes of curves were quite similar, with a load drop shortly after yield
- Only Target 6 specimens (0.75 – 1.2 dpa) had appreciable strain-hardening after yielding

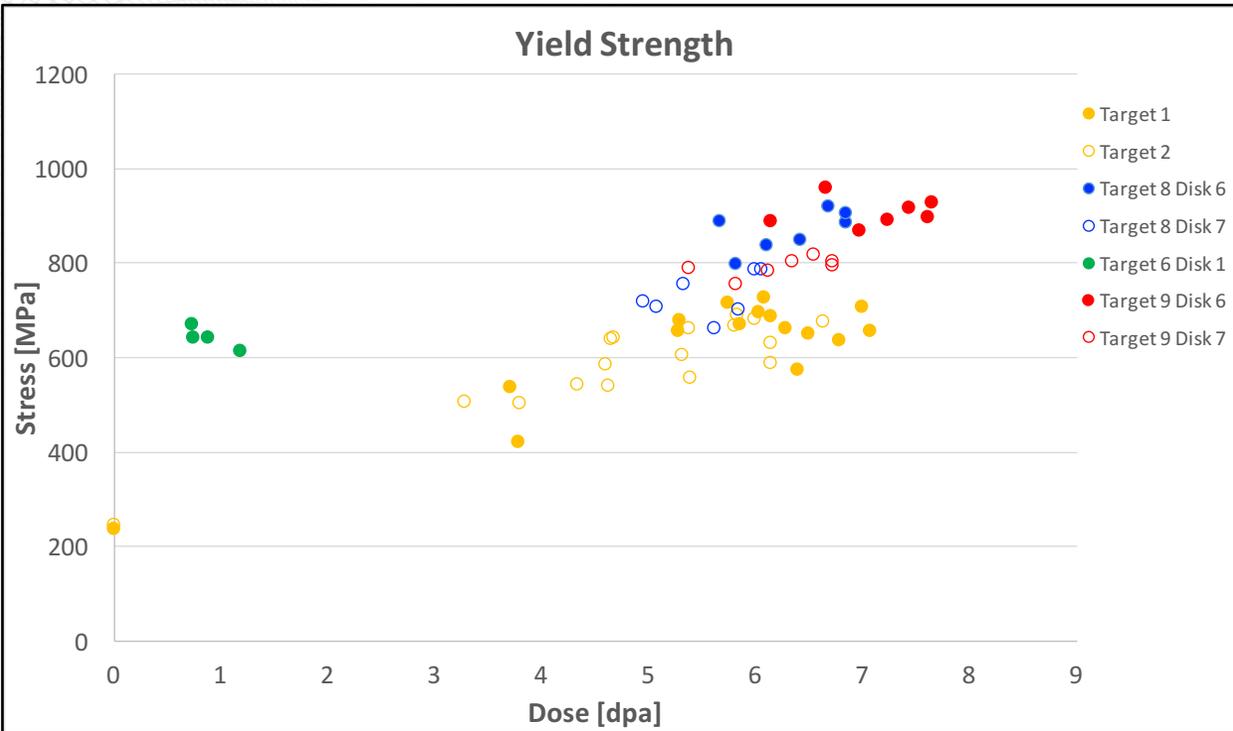
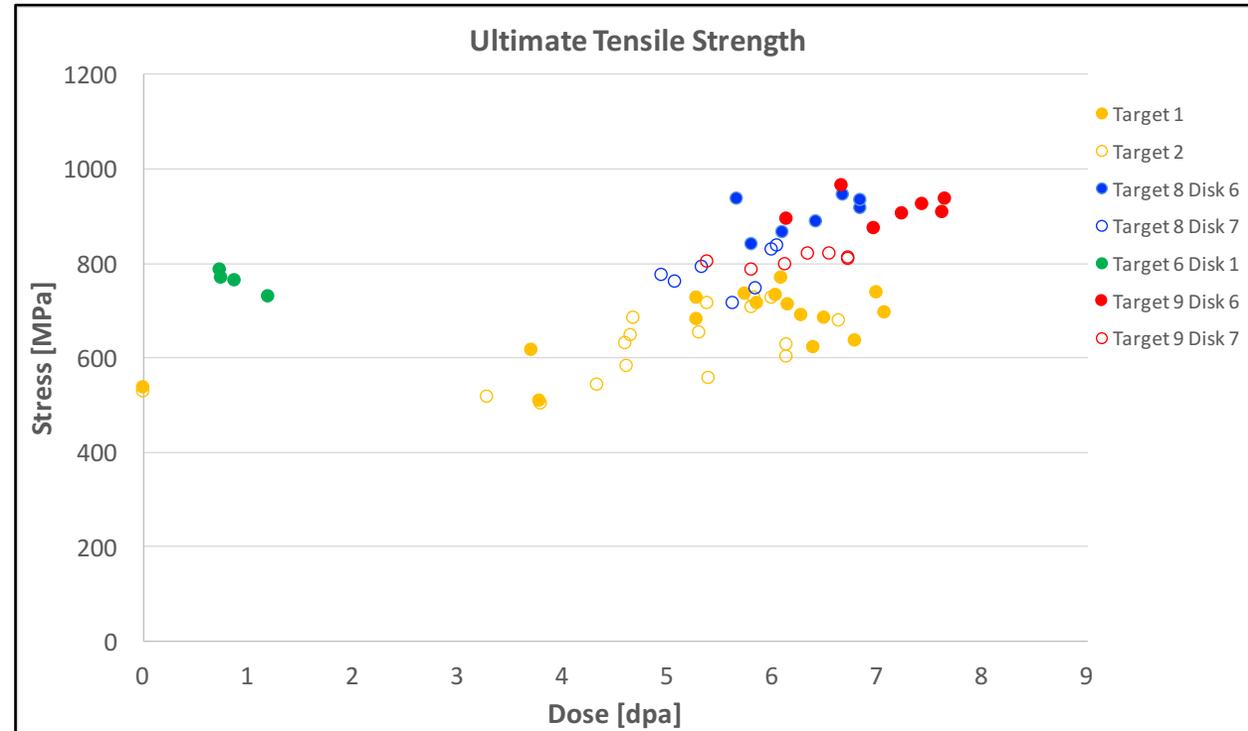
# Increases in yield and ultimate strengths were observed

- Typical “low temperature” hardening was observed

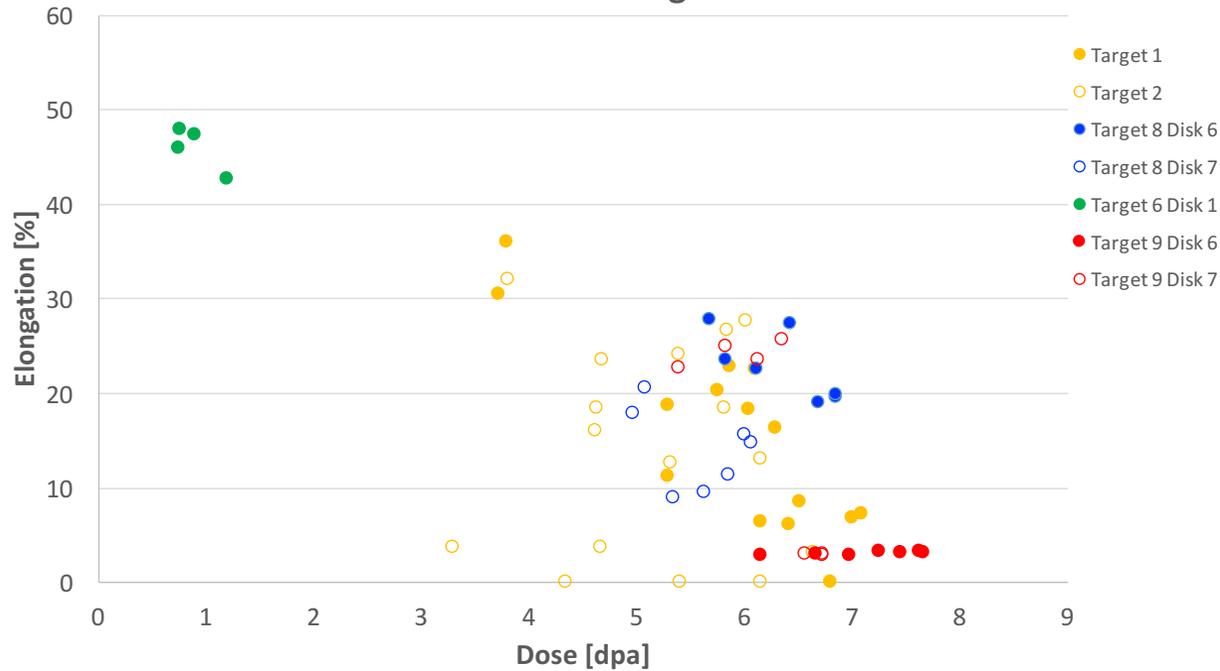
### Uniform Elongation

# Elongation results show appreciable ductility remained in 316L target material up to ~7.6

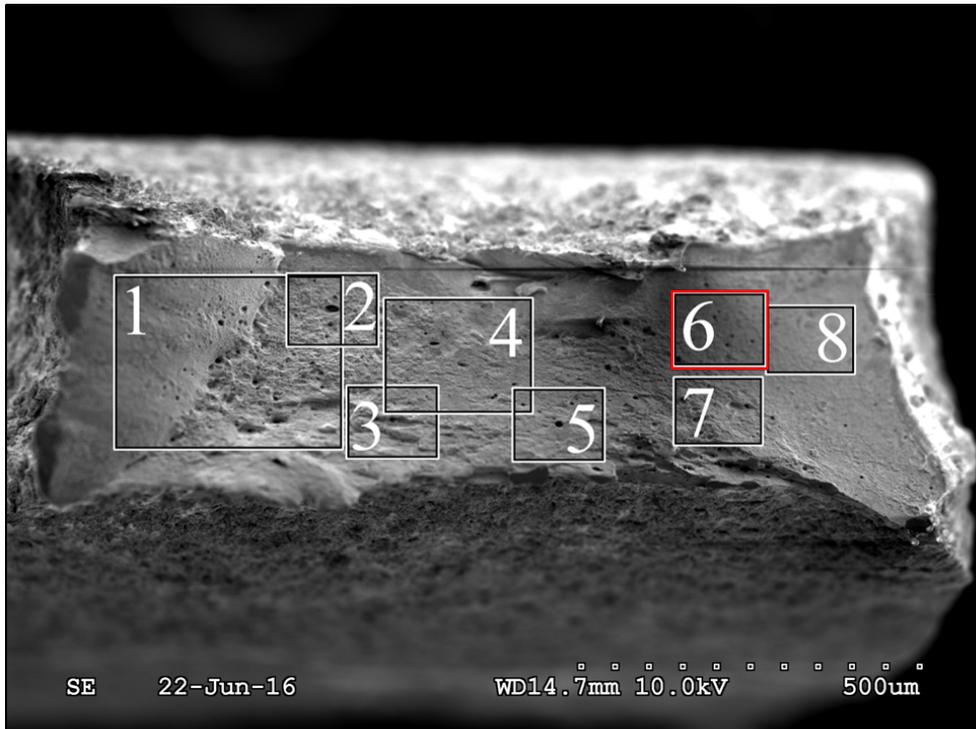
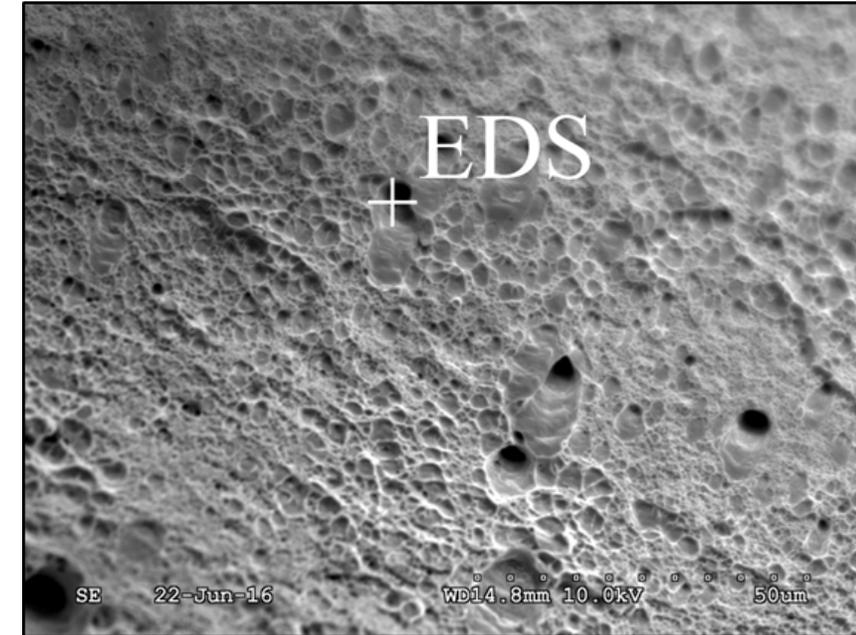
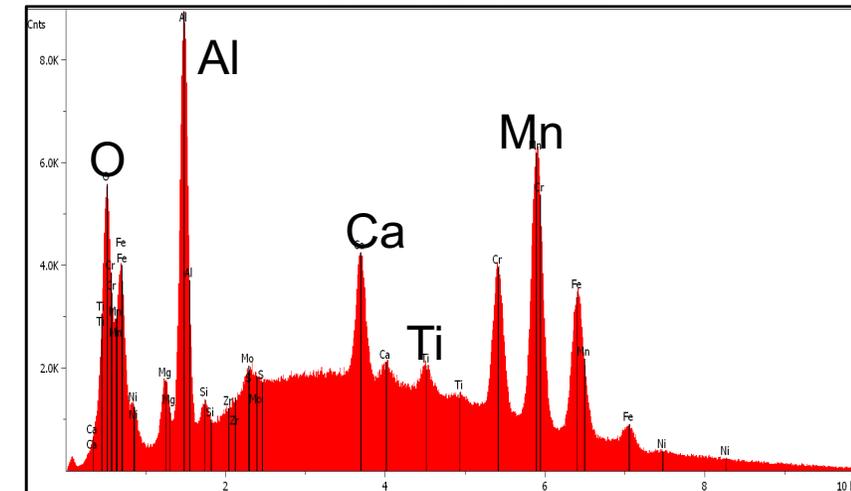
# Fracture surfaces were examined via scanning electron microscopy

- All specimens fracture surfaces were primarily ductile microvoid coalescence morphology
- Inclusions rich in manganese, calcium, aluminum, silicon and titanium were identified via EDS
