# Tensile properties characterization of irradiated AISI 316L from high-use target modules at the Spallation Neutron Source using digital image correlation

November 1, 2016

13<sup>th</sup> International Workshop on  
Spallation Materials Technology

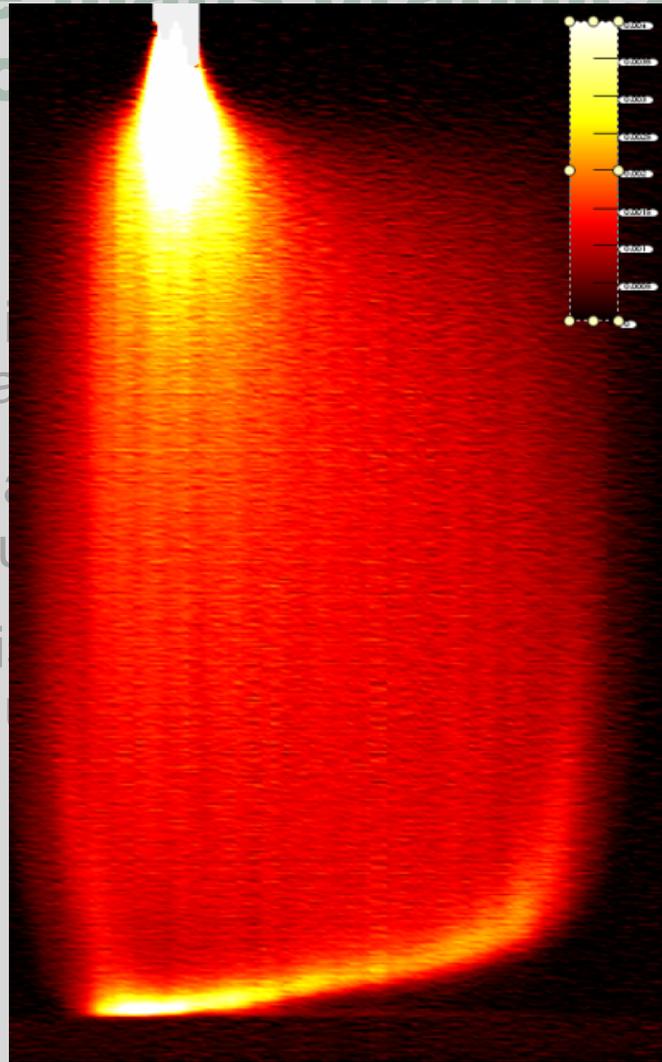
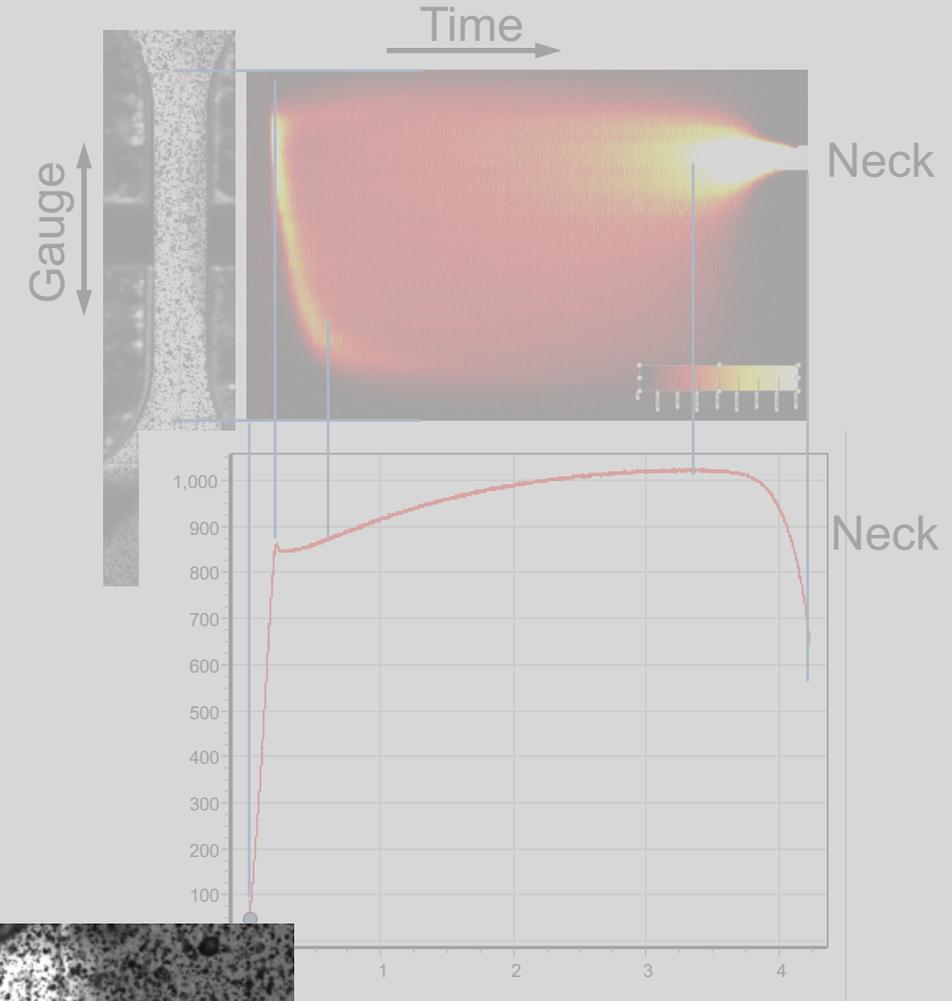
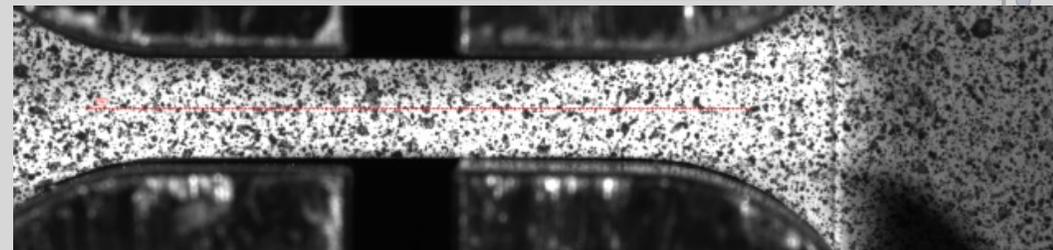
# Strain rate maps graphically illustrate the deformation of tensile specimens

- Strain rate maps illustrate the deformation of the gauge section during testing, and the propagation of deformation bands.
- Elastic strain region is visible as a region of practically zero strain rate value.
- Neck evolution is also clear via the localized deformation in some area red.

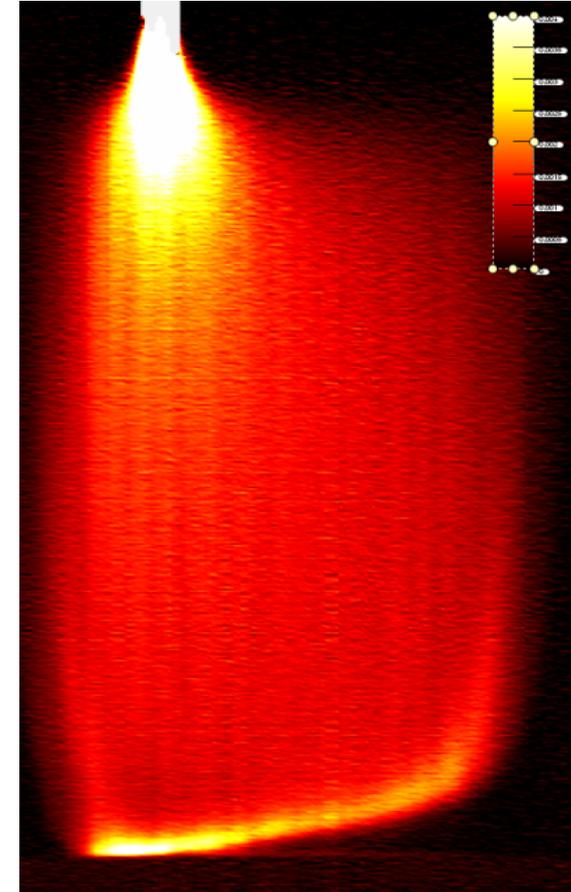
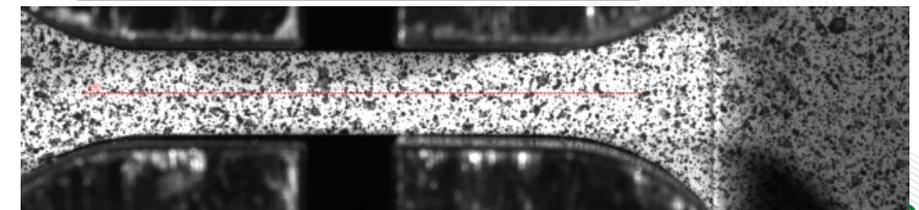
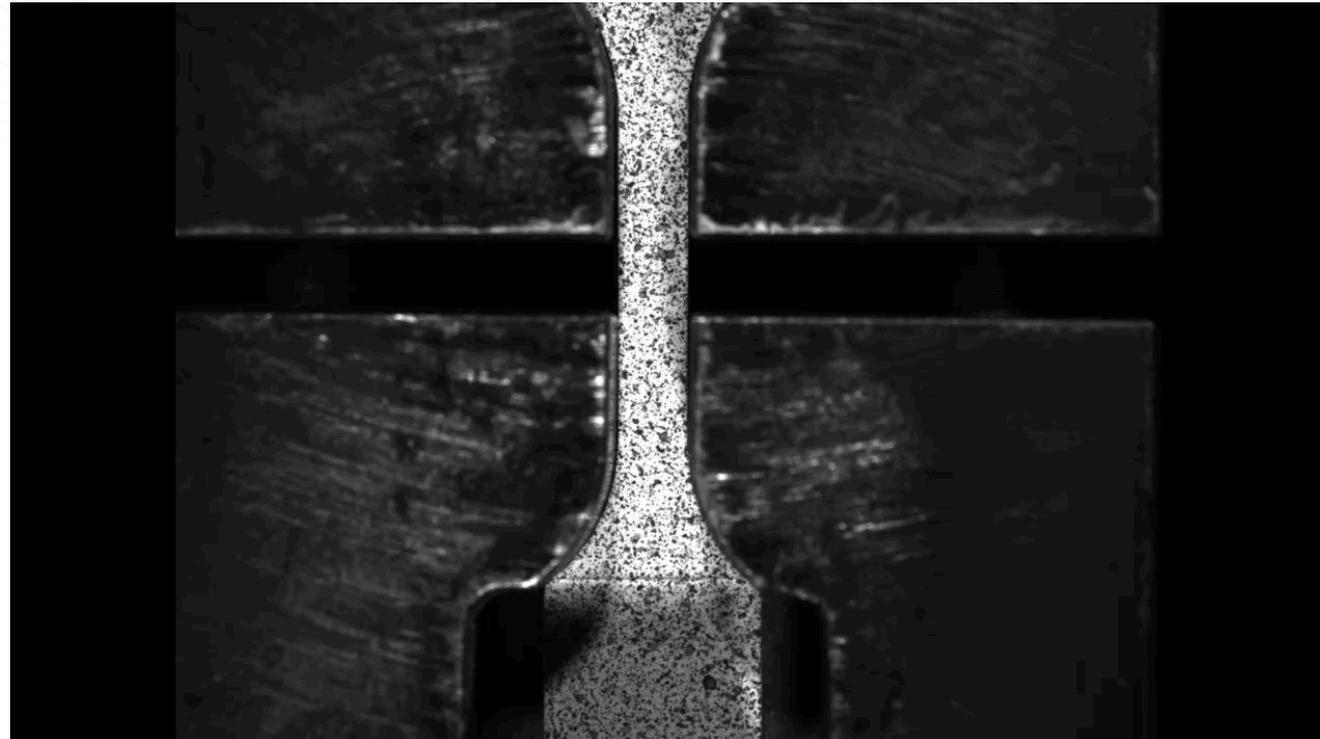
Target 6, D9-1, TE = ~13%

# Specimens from Target 6 demonstrated moderate deformation band behavior

- At the beginning of test some Target 6 specimens displayed moderate deformation band behavior

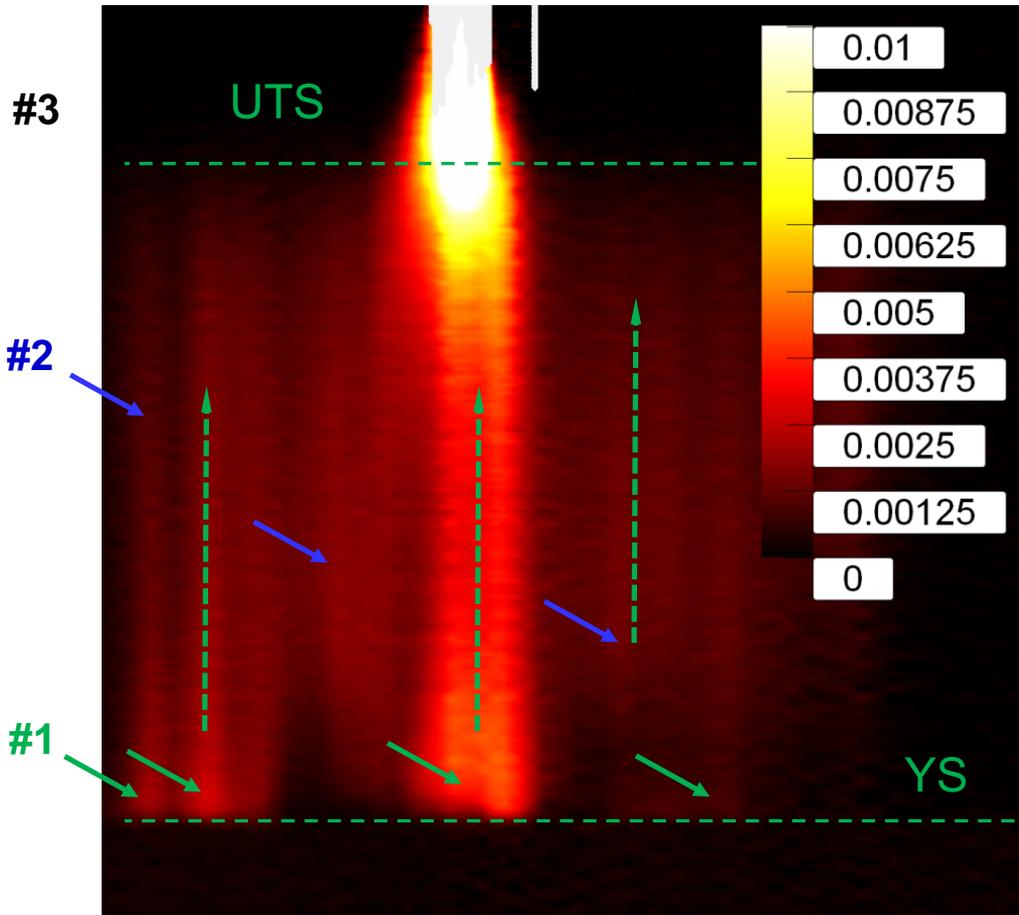
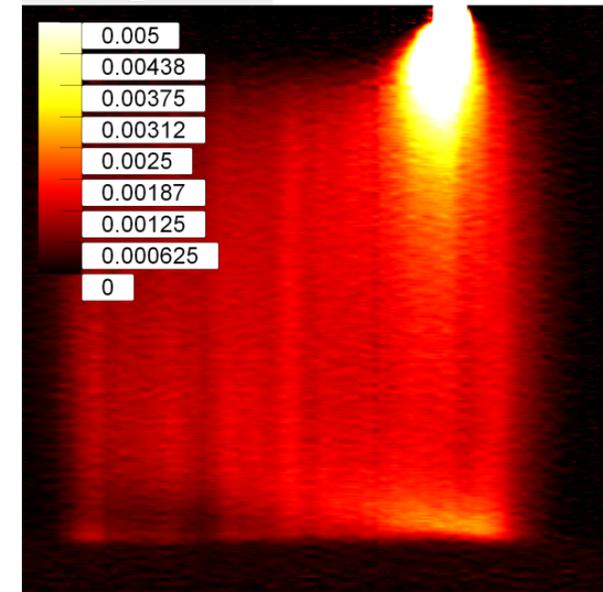
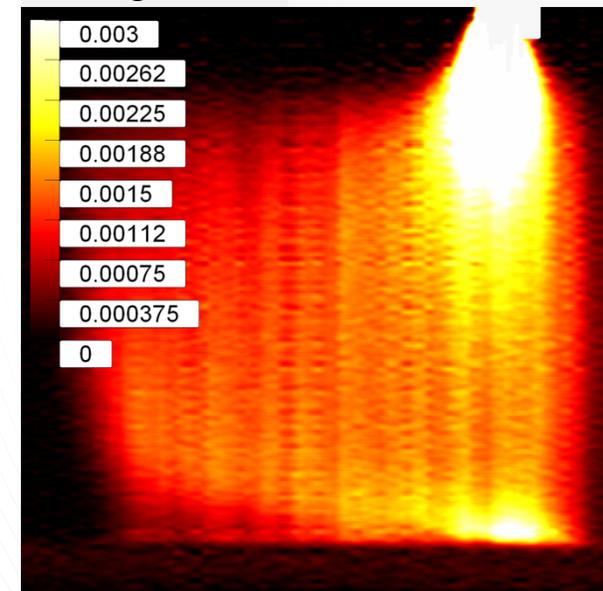
# Target 8 specimens displayed localized and banded deformation behaviors

## Events:

#1. Several deformation “spots” appeared immediately after YS.

#2. “Spot” activity did not remain the same during the test. Some “spots” decayed, and new became active.

#3. At the UTS point, all active strain areas (except one) disappeared. The survived area becomes a neck.

- No Luders-like band movement was observed.
- Plastic strain tended to localize in few limited areas.
- Only part of the gauge was involved in deformation resulting in TE~20-25%.

Target 8, D6-6, TE = ~36%

Target 8, D6-1, TE = ~39%

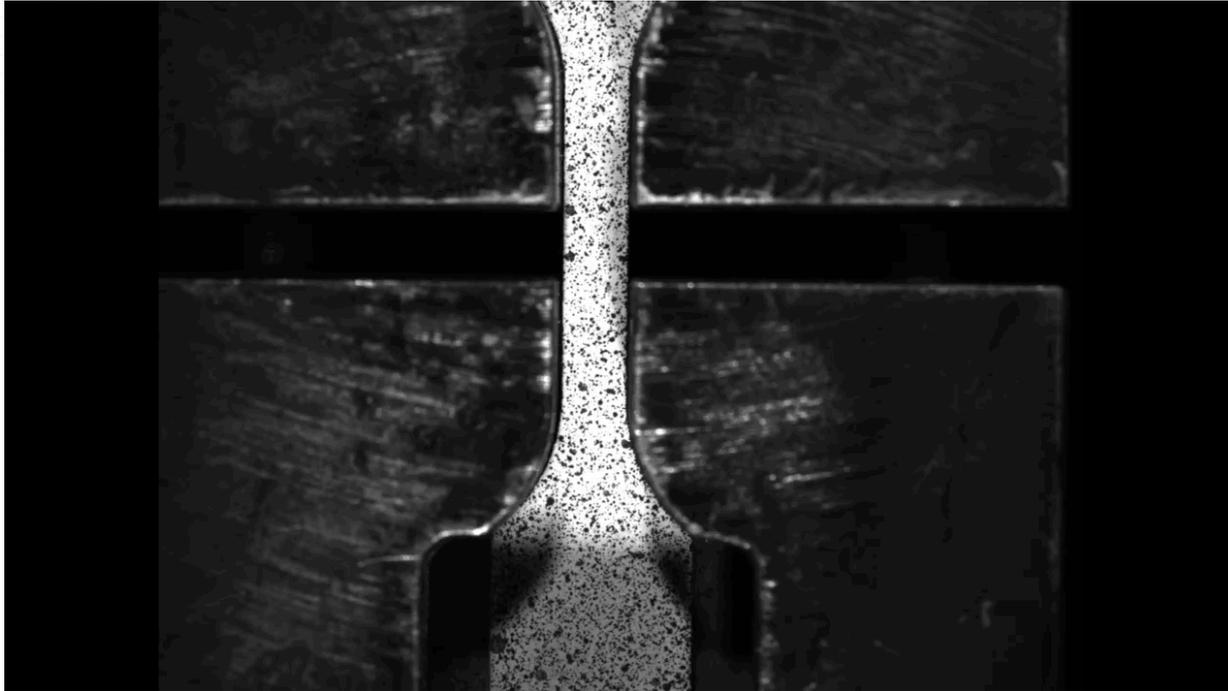
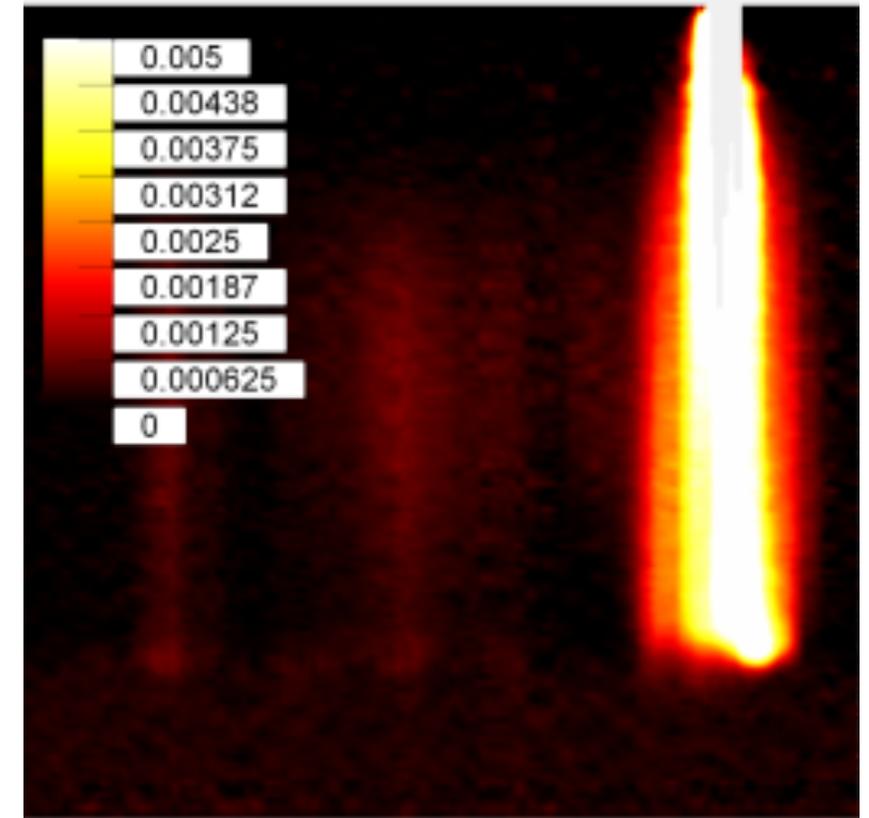
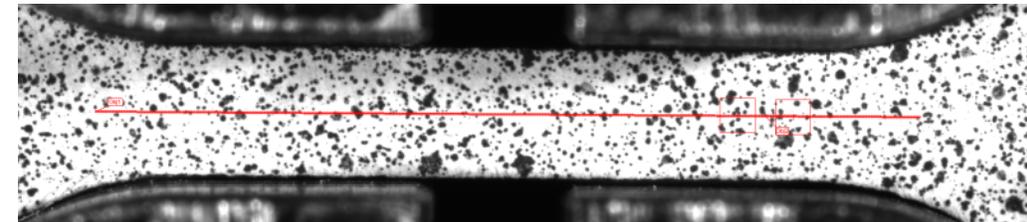
Target 8, D7-2 (5.3 dpa), TE = ~13%

# Target 8 specimens displayed highly localized deformation

- Some Target 8 specimens displayed highly localized deformation
- Significantly reduced total elongation value

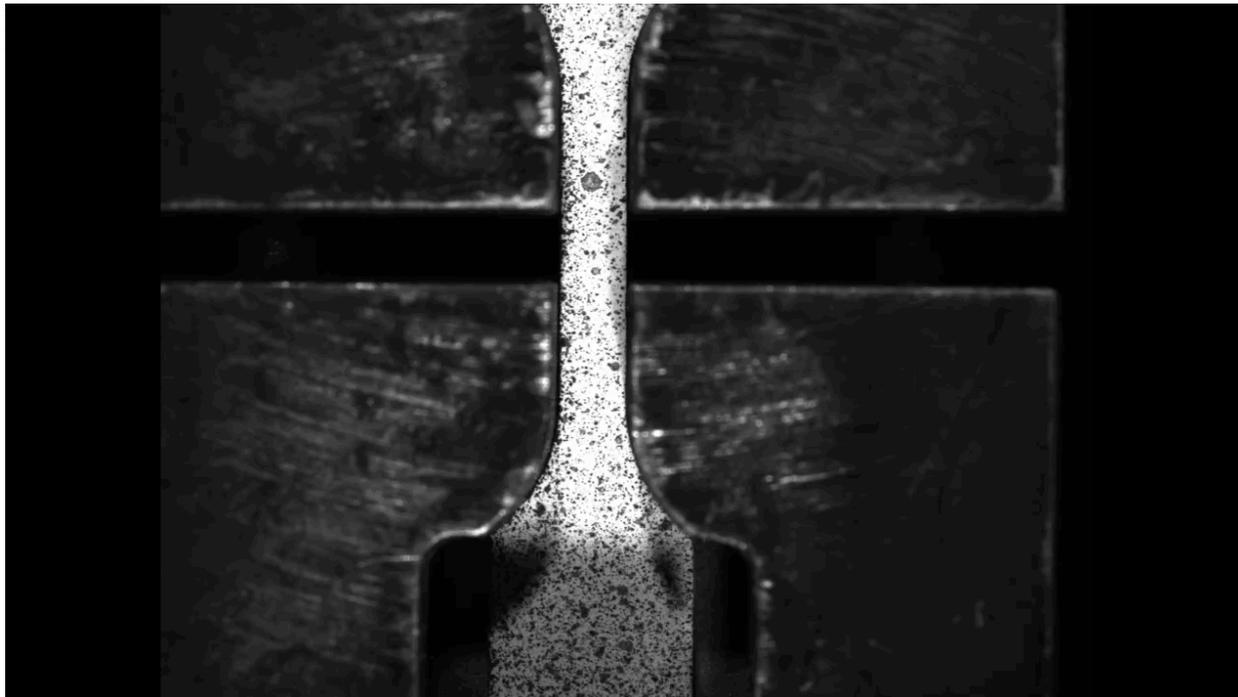
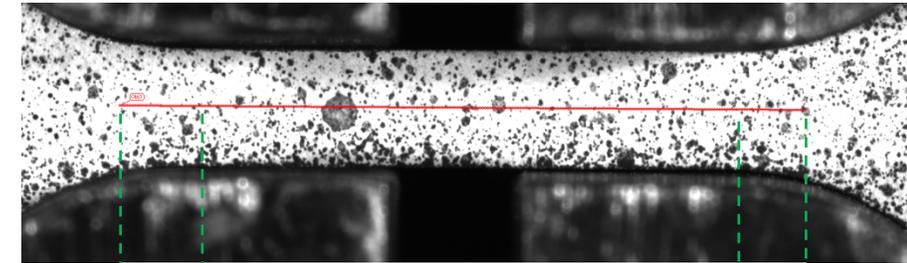
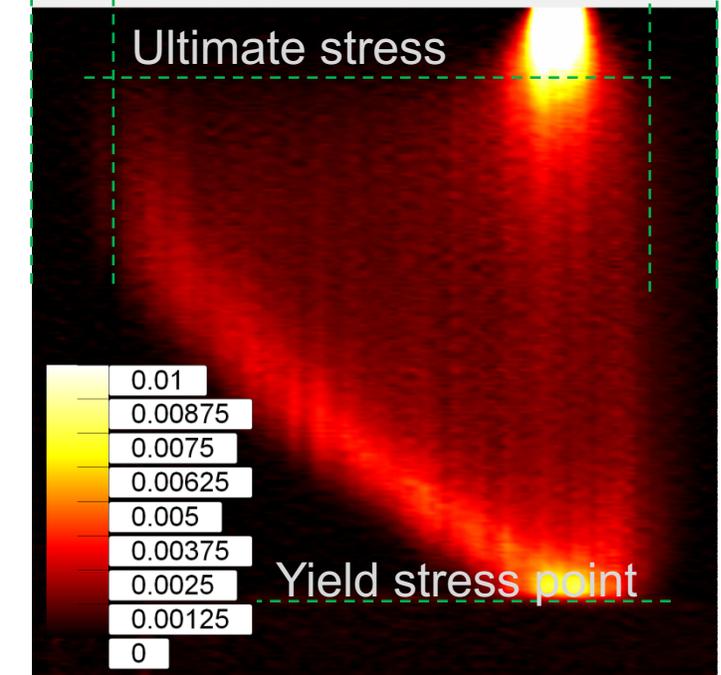
Target 9, D6-1 (6.1 dpa), TE = ~28%

# Behavior of Target 9 specimens was varied and peculiar

- Local plastic deformation was initiated at the right side of the specimens
- Strain hardening rate was high enough to stimulate Lüders band propagation along the specimen gauge section length

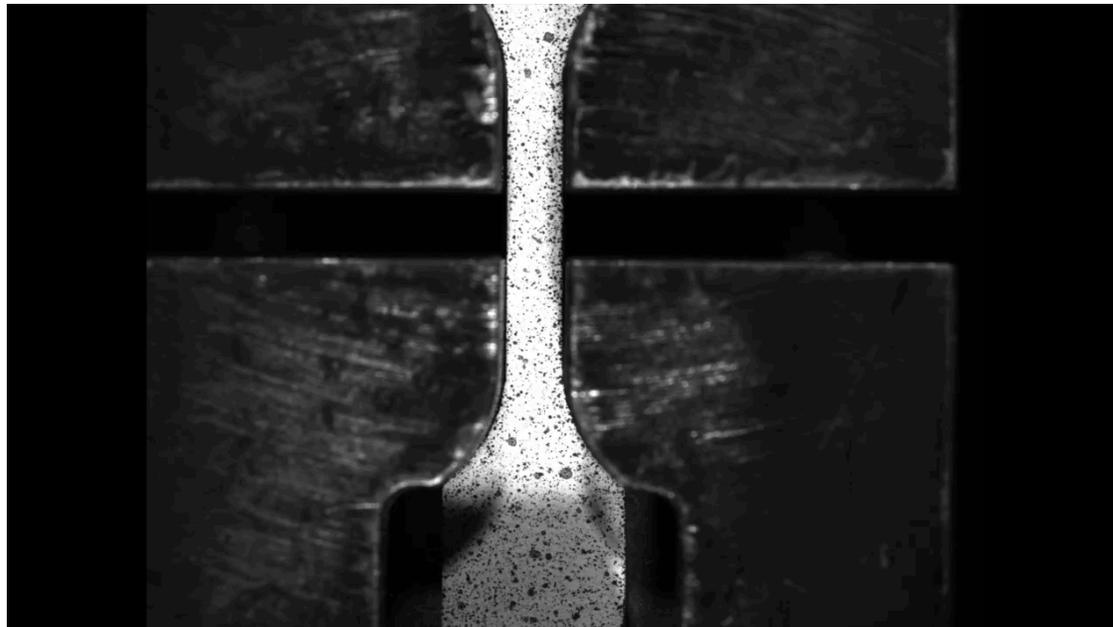
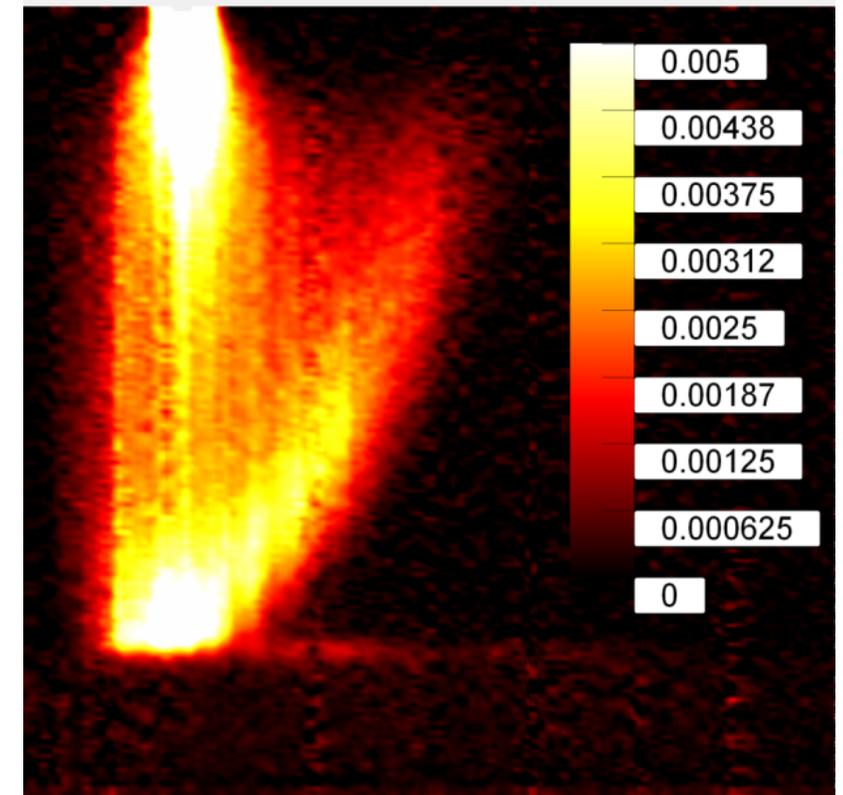
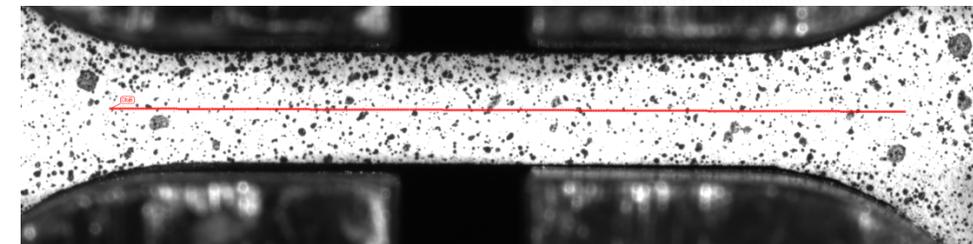
Target 9, D6-2 (7.0 dpa), TE = ~19%

# Deformation bands on some specimens only propagated across half of gauge section

- Local plastic deformation was initiated at the left side of the specimens
- However, strain hardening rate was not high enough to support Lüders band movement
- The band propagated only part of the gauge and decreased in amplitude

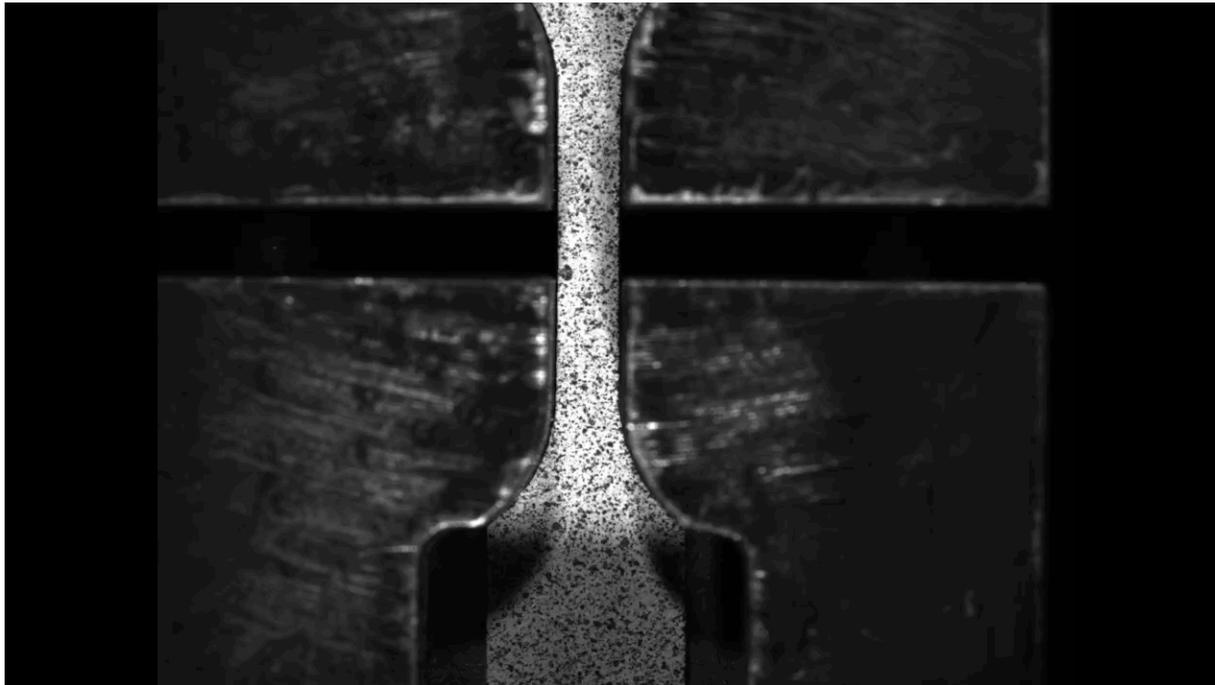
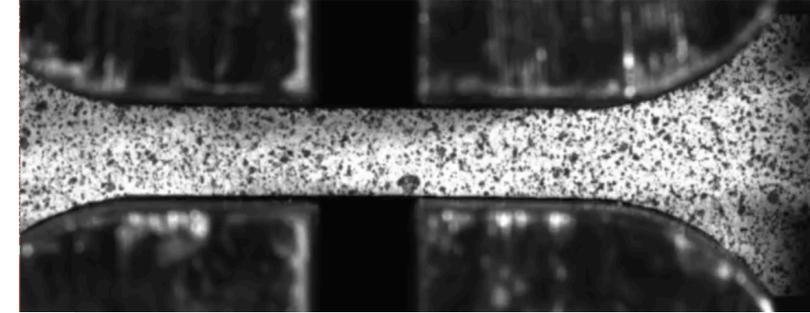
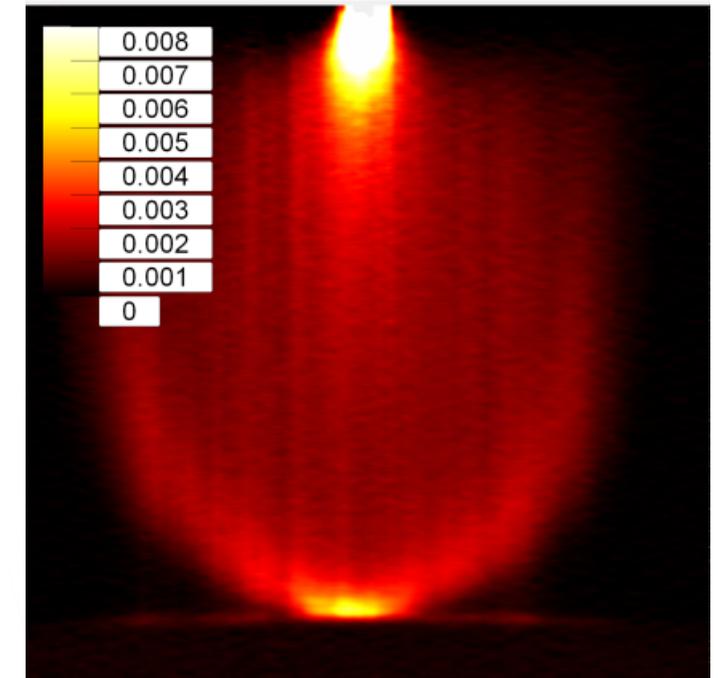
Target 9, D7-1 (5.8 dpa), TE = ~33%

# Dual deformation bands originated and terminated in center of gauge section of D7-1 from Target 9

- Two deformation bands originated at the center of the gauge section
- Bands propagated outward and consumed gauge section

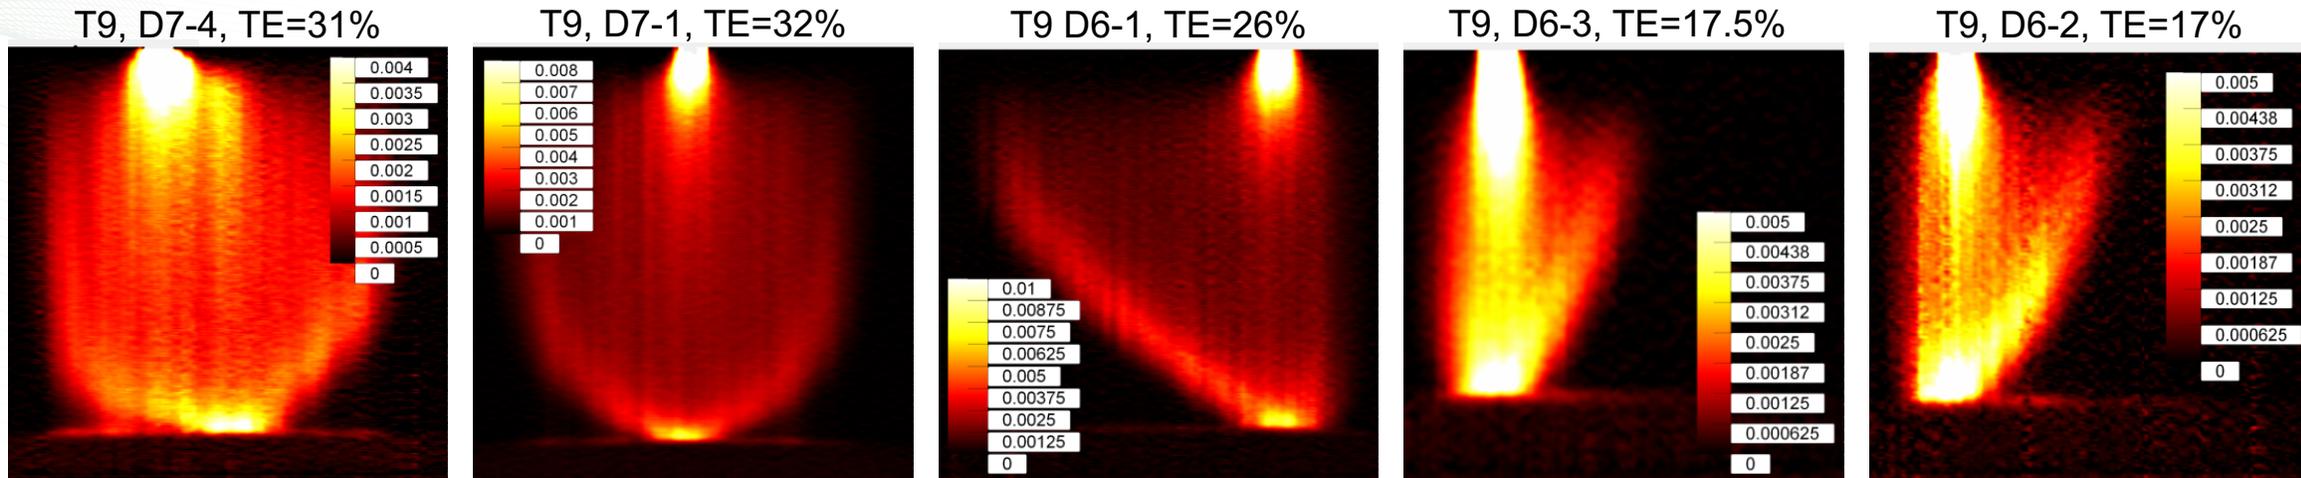
# Examples of deformation behavior of Target 9 specimens

- Several different behaviors lead to significantly different measured properties
- But “traditional” metrics don’t seem to capture the true (ductile) behavior of the material

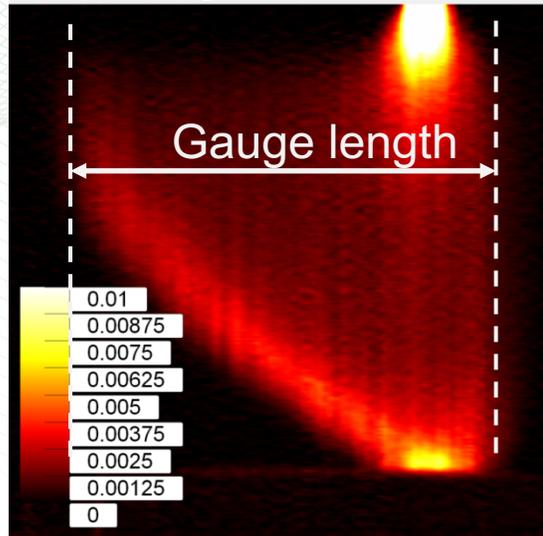
Target 9, D6-1

Band passed along all the gauge (TE~26%).

Therefore, total elongation seems to be correct.

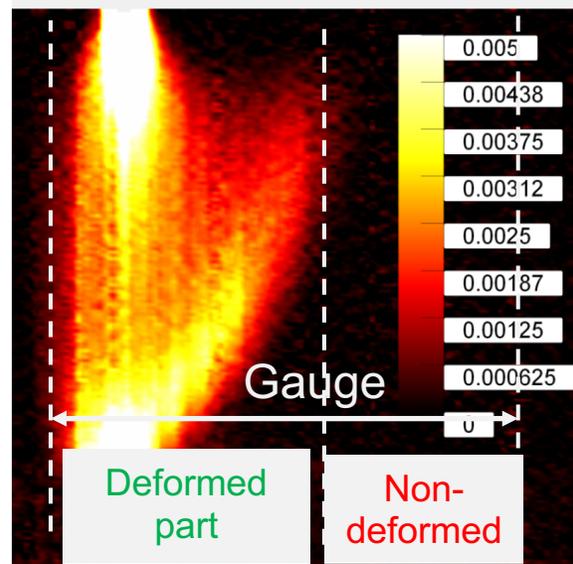
Target 9, D6-2

Band passed only ~60% of the gauge (TE~17%).

Therefore, total elongation value appears to be underestimated.

Simplified approach might be just to correct the ductility values, taking into account the non-deformed gauge length:

$$TE[\text{corrected}] \approx TE [\text{observed, 17\%}] * (1/0.6) \approx 28\%.$$

The estimated value is in good agreement with the result for fully-deformed specimens.

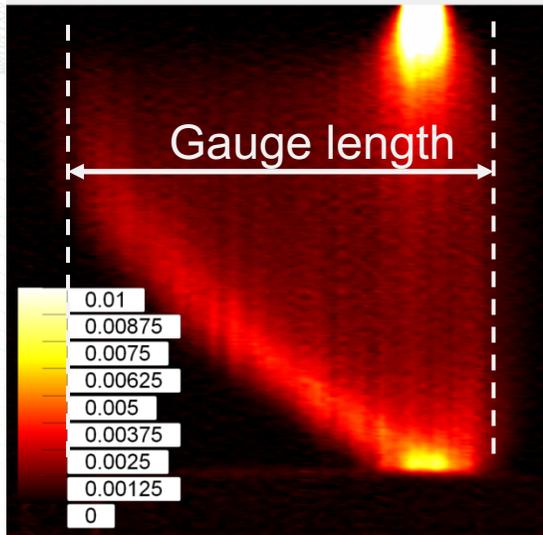
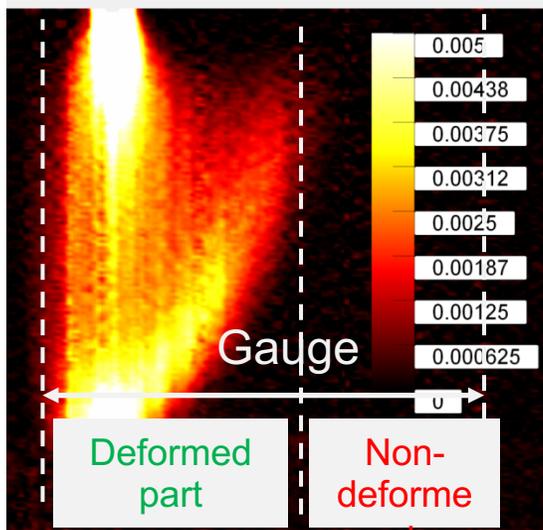
# Estimating real ductility using expected uniform elongation

- The concept discussed above may be further improved by employing simple constitutive equation analysis.
- During tensile testing, necking occurs when hardening rate becomes less than acting stress:

$$d\sigma/d\varepsilon \leq \sigma \quad [1]$$

- Swift equation,  $\sigma = k \times (\varepsilon - \varepsilon_0)^{0.5}$  [2] provide good true stress approximation. Differentiating this equation and using [1] it is easy to show that:

$$\varepsilon_{EUD} = 0.5 (1 - 2\varepsilon_0).$$

- $\varepsilon_{EUD}$  (expected uniform deformation) may be easily estimated using DIC-obtained true stress – true strain curves.

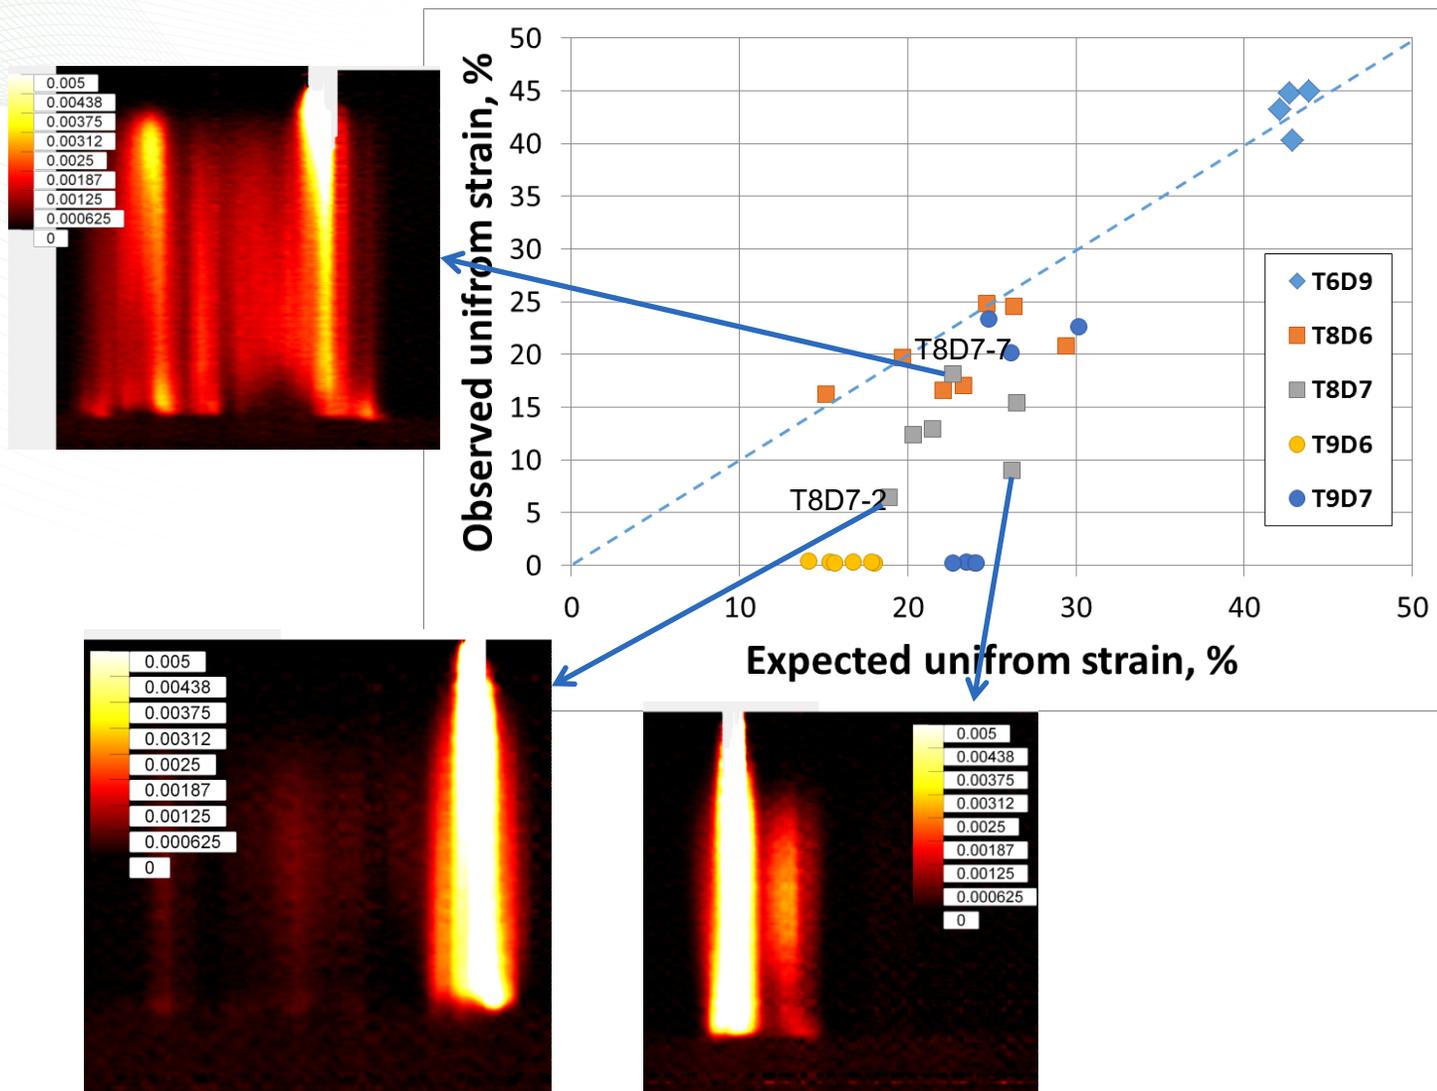
# Expected vs. observed uniform ductility

Experimental and calculated uniform elongation (UE) values were compared for the tested specimens.

One may see the low-dose (T6D9) specimens demonstrated good agreement between the expected and experimental UE values.

At the same time many specimens showed much smaller UE compared to the expected ones.

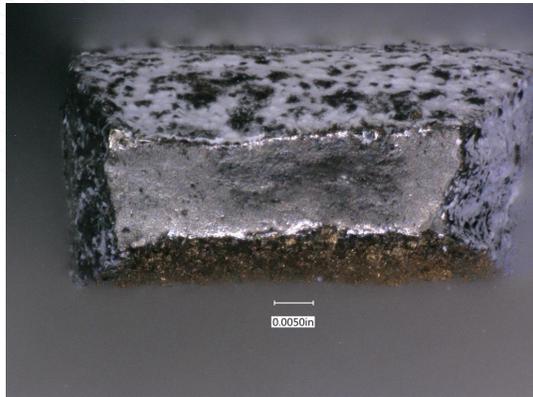
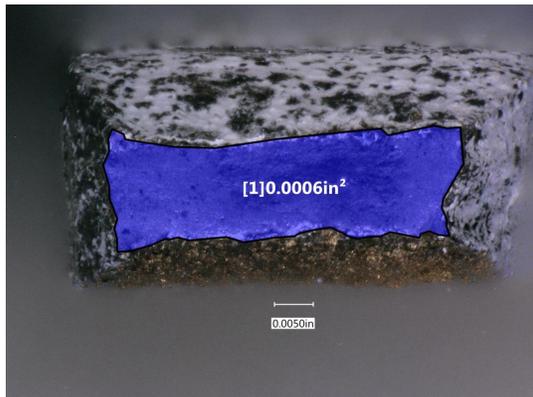
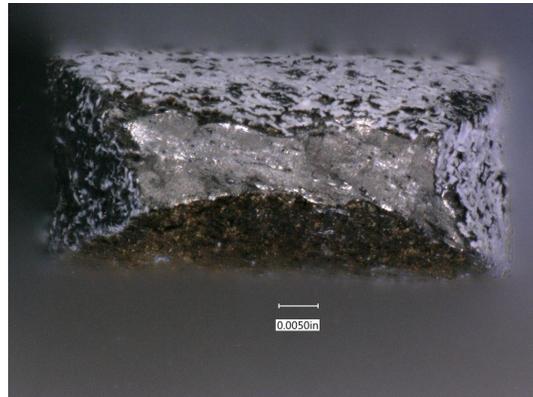
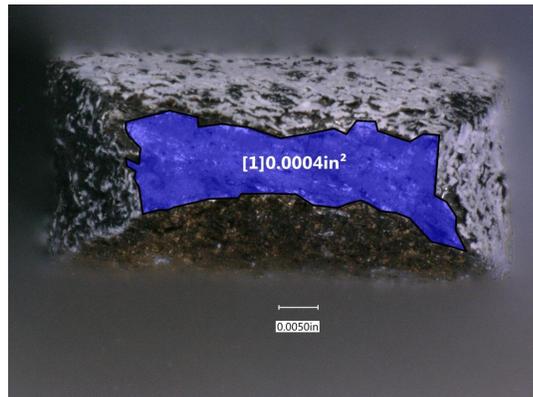
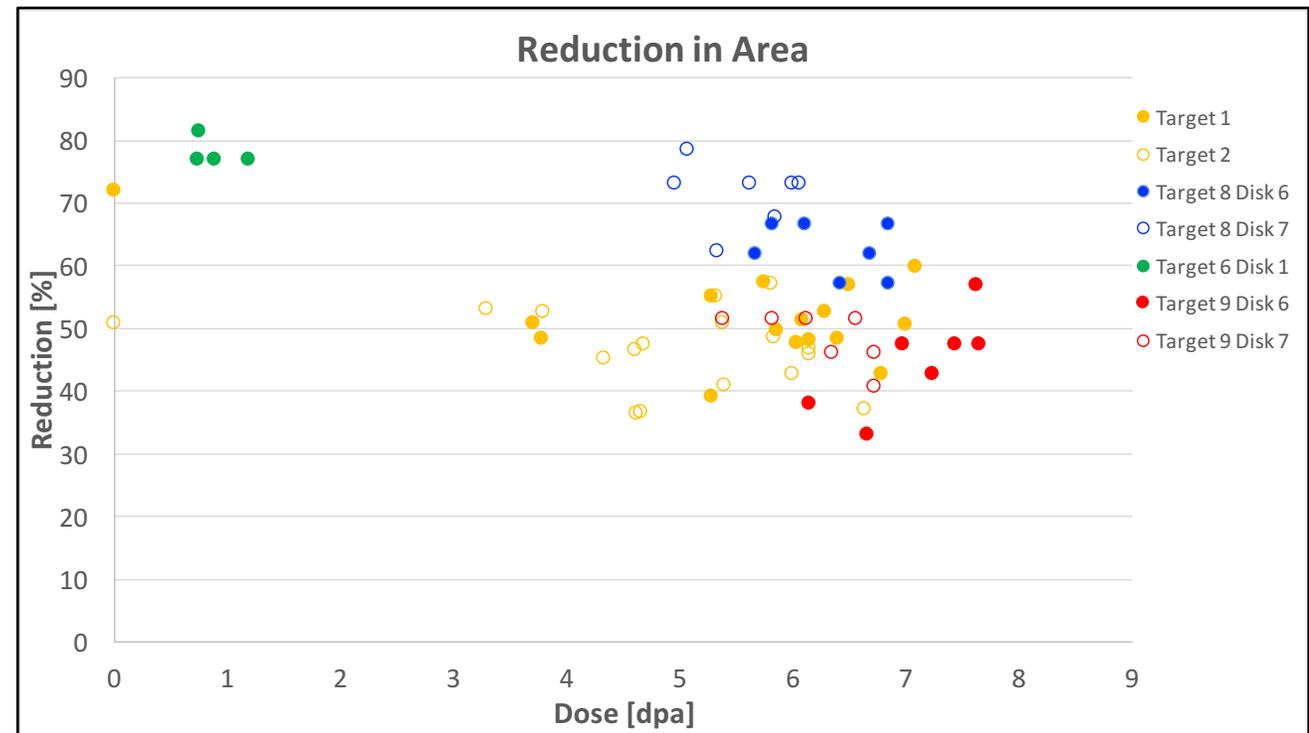
# Reduction in area might be a better indicator of ductility instead of elongation

- Final area was measured for all specimens after testing using digital image analysis

T8 D7-3

T8 D7-7

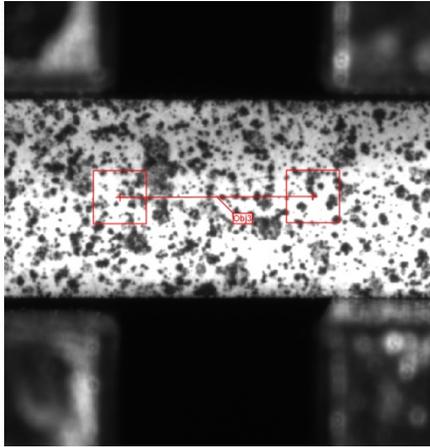
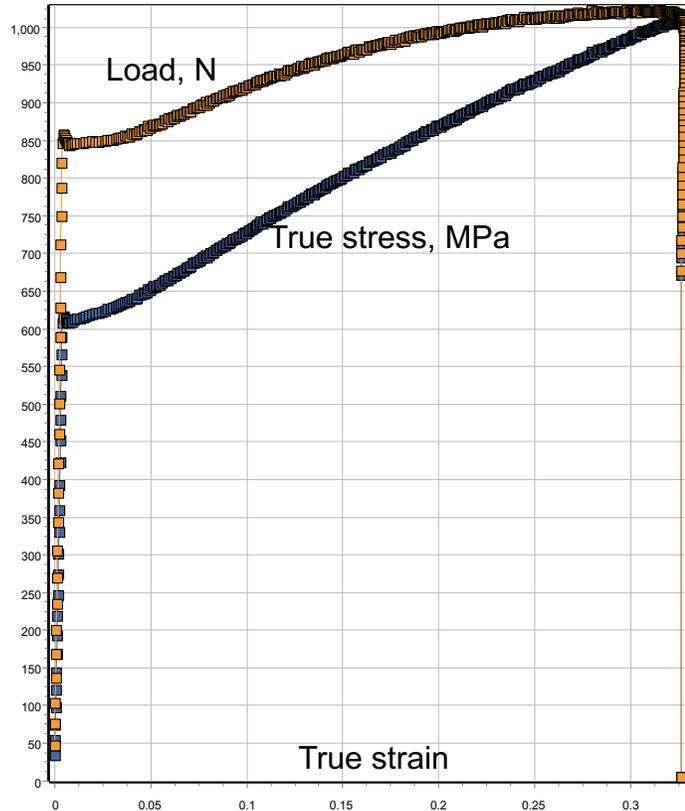
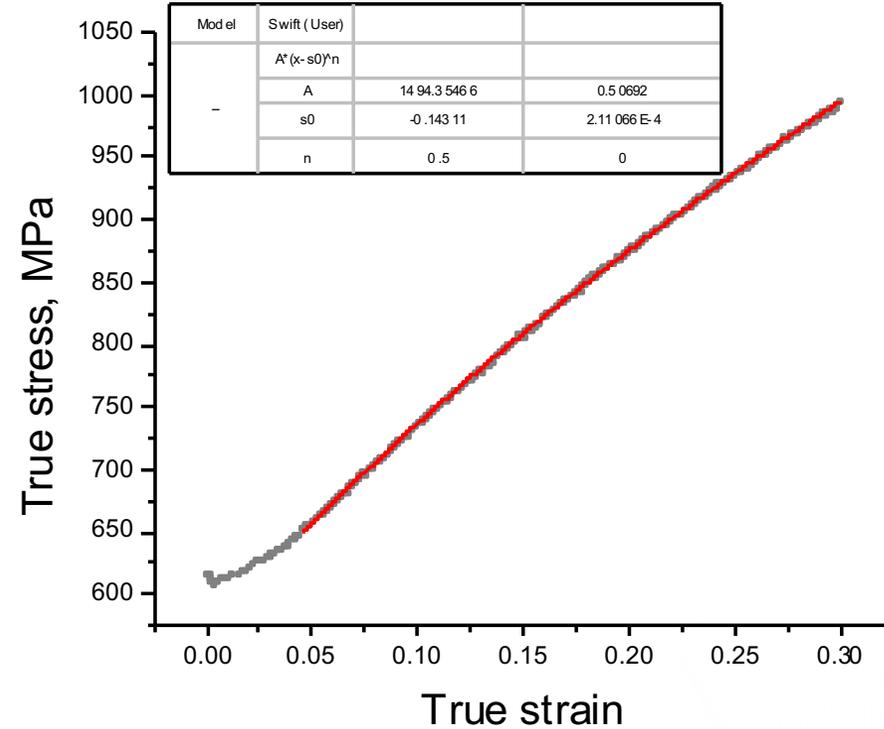
# Strain hardening behavior (T6D1\_1)

“Usual” Swift equation.

True stress–true strain curves may be calculated for all specimens.

The curves reflect real (acting) plastic deformation behavior and strain hardening.

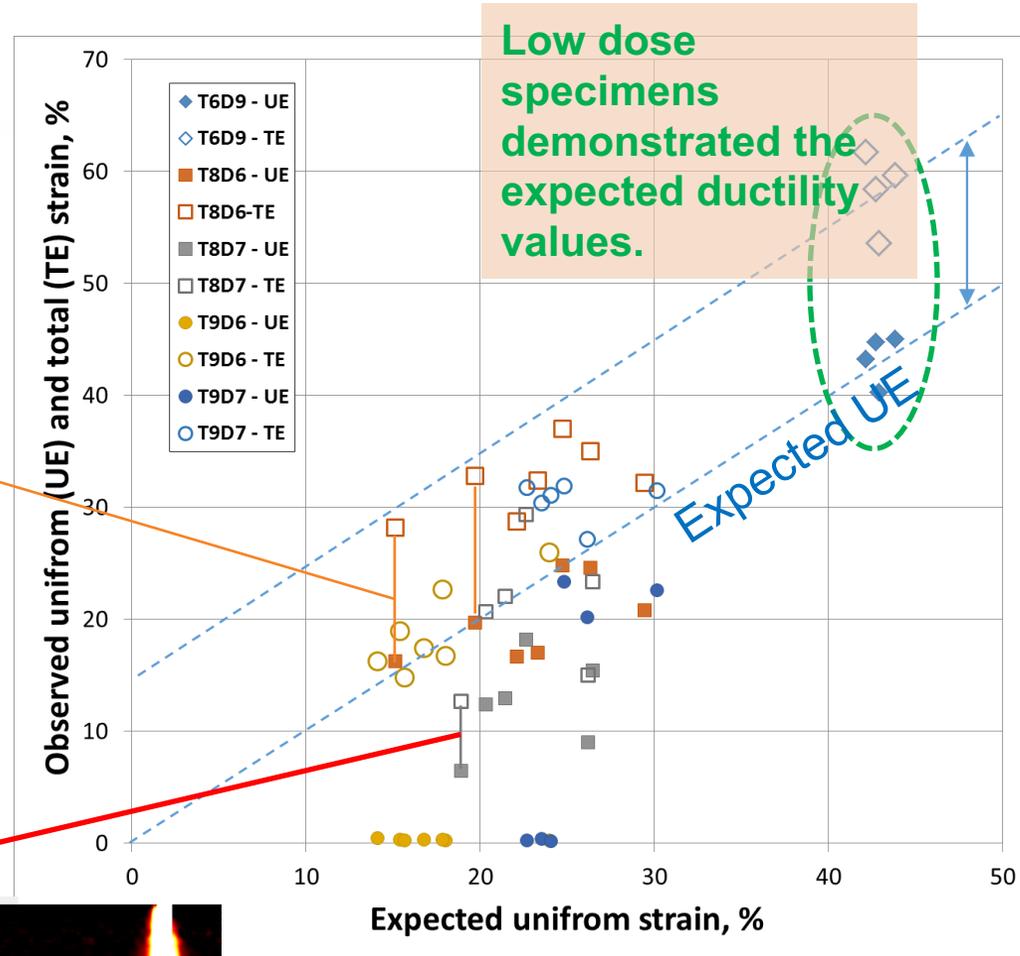
# Expected vs. observed ductility

Some irradiated specimens fully realized the ductility resource

However, many objects showed very small ductility due to the early strain localization.
