Post irradiation examination of the MEGAPIE samples at JAEA(2)

**S. Saito^a, K. Kikuchi^b, K. Suzuki^c, Y. Hatakeyama^c,
S. Endo^c, M. Suzuki^c, N. Okubo^d, K. Kondo^d**

- The world's first megawatt-class lead-bismuth target, MEGAPIE (MEGAWatt Pilot Experiment) was successfully finished in 2006.
- The target was dismantled and post irradiation examination (PIE) samples were prepared at PSI hot-lab.
- The samples were shipped to each institutions including JAEA and PIE works have being performed.

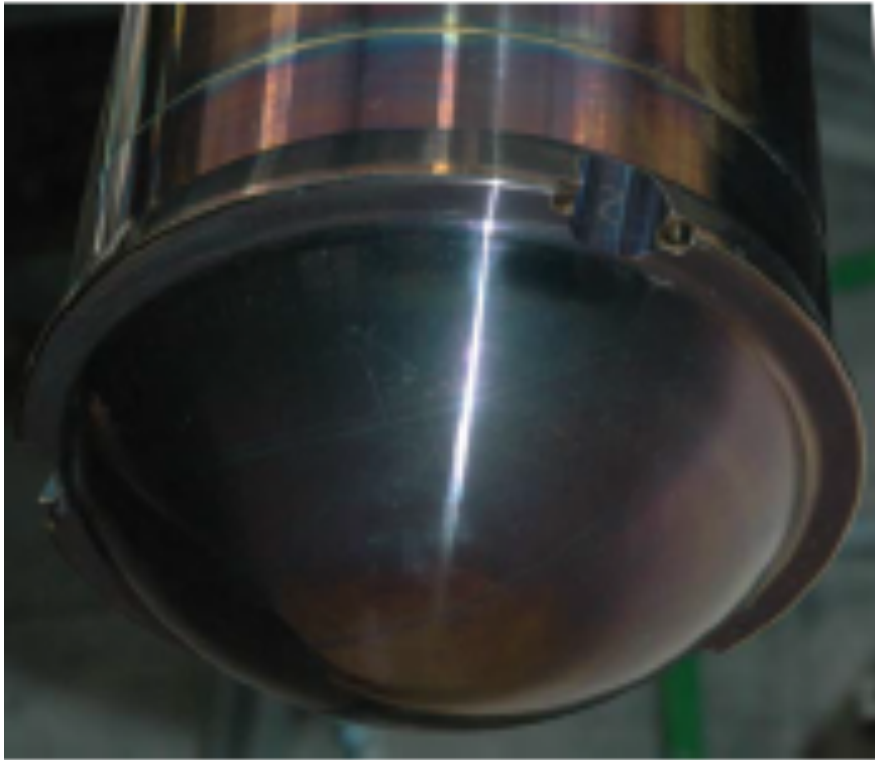
JAEA samples : Beam window
Flow guide tube (FGT)
All samples were prepared without LBE.

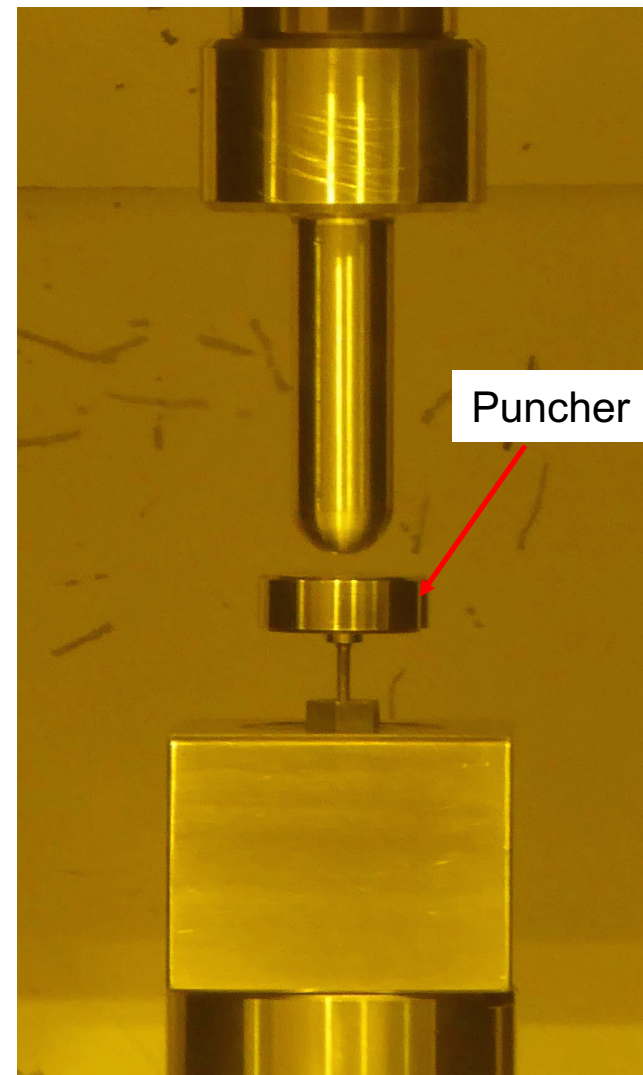
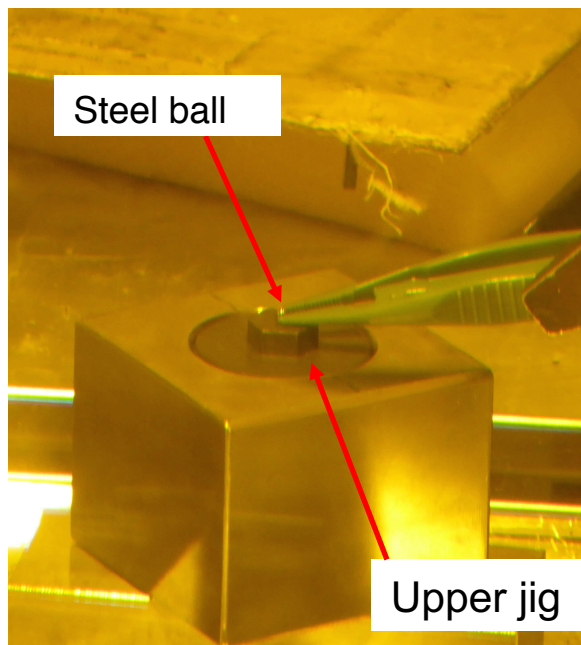
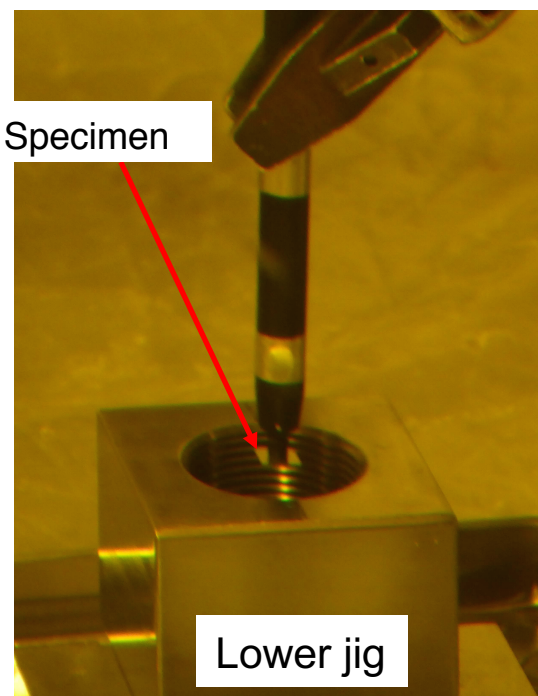
Experimental (2) -SP test -

Test conditions of SP test.

- Materials : T91, SS316L
- Specimen size : 8 mm X 8 mm X 0.5 mm
- Steel ball : $\phi 2.4$ mm (2.381 mm, 3/32inch)
- RT in air
- Cross-head speed: 0.1 mm/min. (6×10^{-4} /s)
- Measurement : Load, Displacement

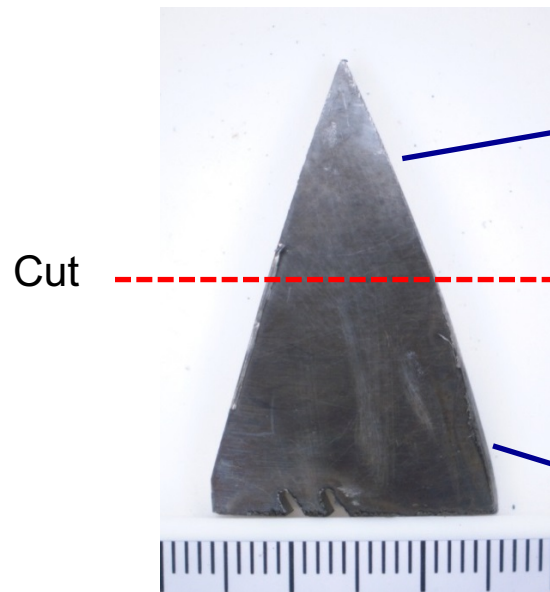
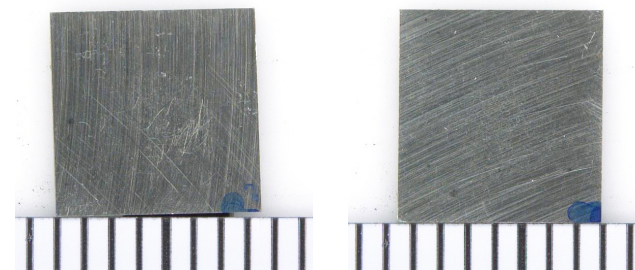
Spitze (T91, Beam window)

Surface observation

- Mounting
- Polishing
- Etching

Cross sectional observation

Cutting, Polishing →

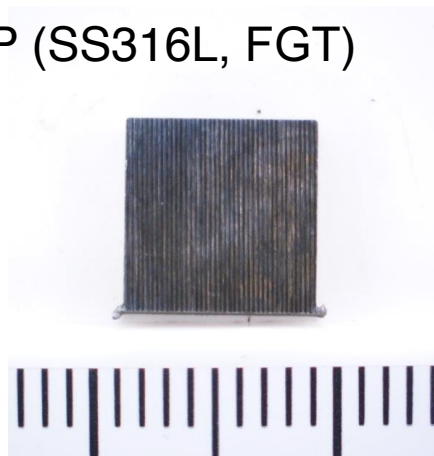
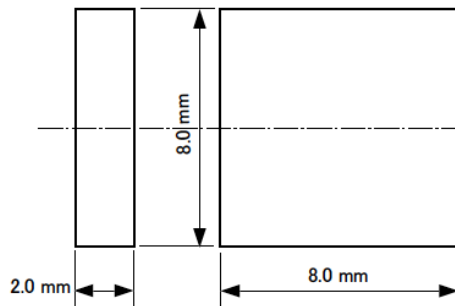
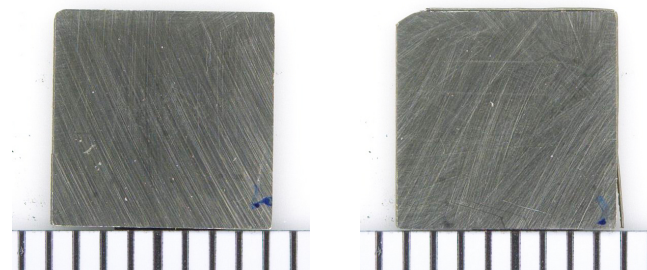
OM/SP (SS316L, FGT)

Polishing →

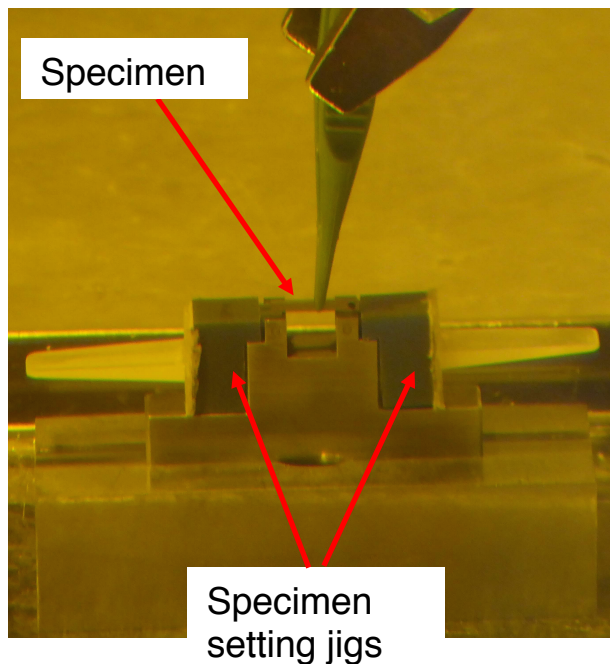
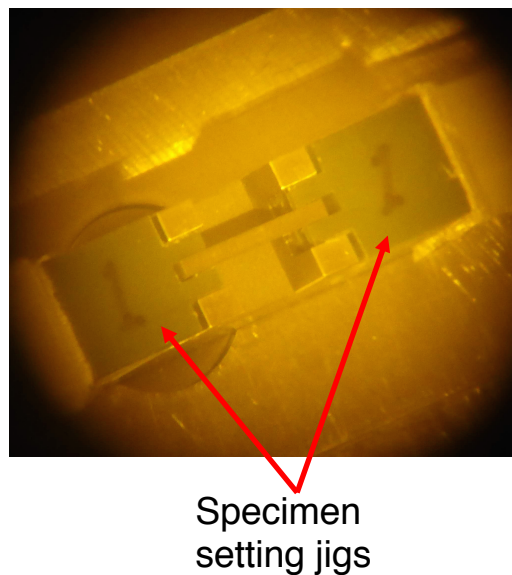
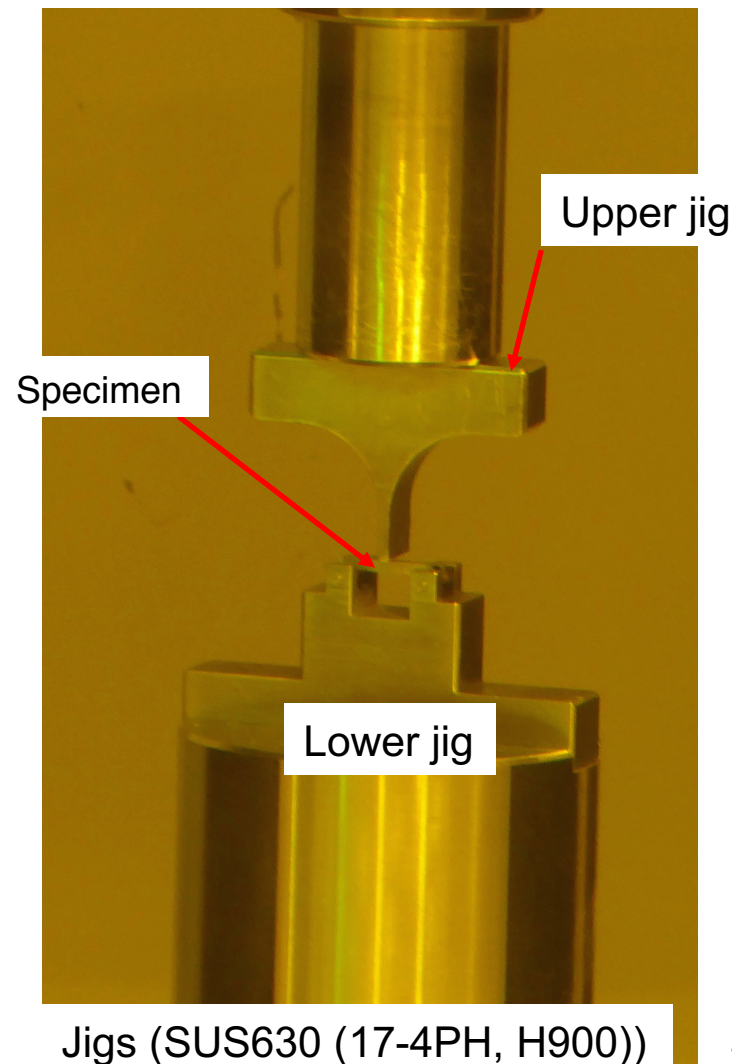
2. Experimental (4) -Three point bending test-

Test conditions of bending test.

- Materials :SS316L
- Specimen size : 1.4 mm X 2.0 mm X 16 mm (without notch)
- Span : 13 mm
- RT in air
- Cross-head speed: 0.5 mm/min. ($3 \times 10^{-3}/s$)
- Measurement : Load, Displacement

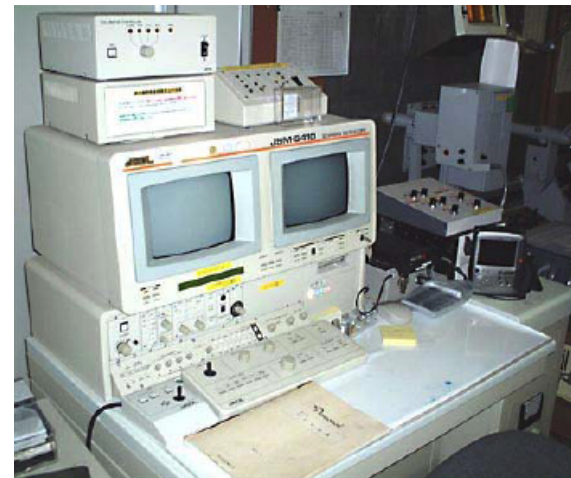
- SEM : X50~X2000
- OM : X50, X400
- Inner side and outer side

JEOL JSM-5410

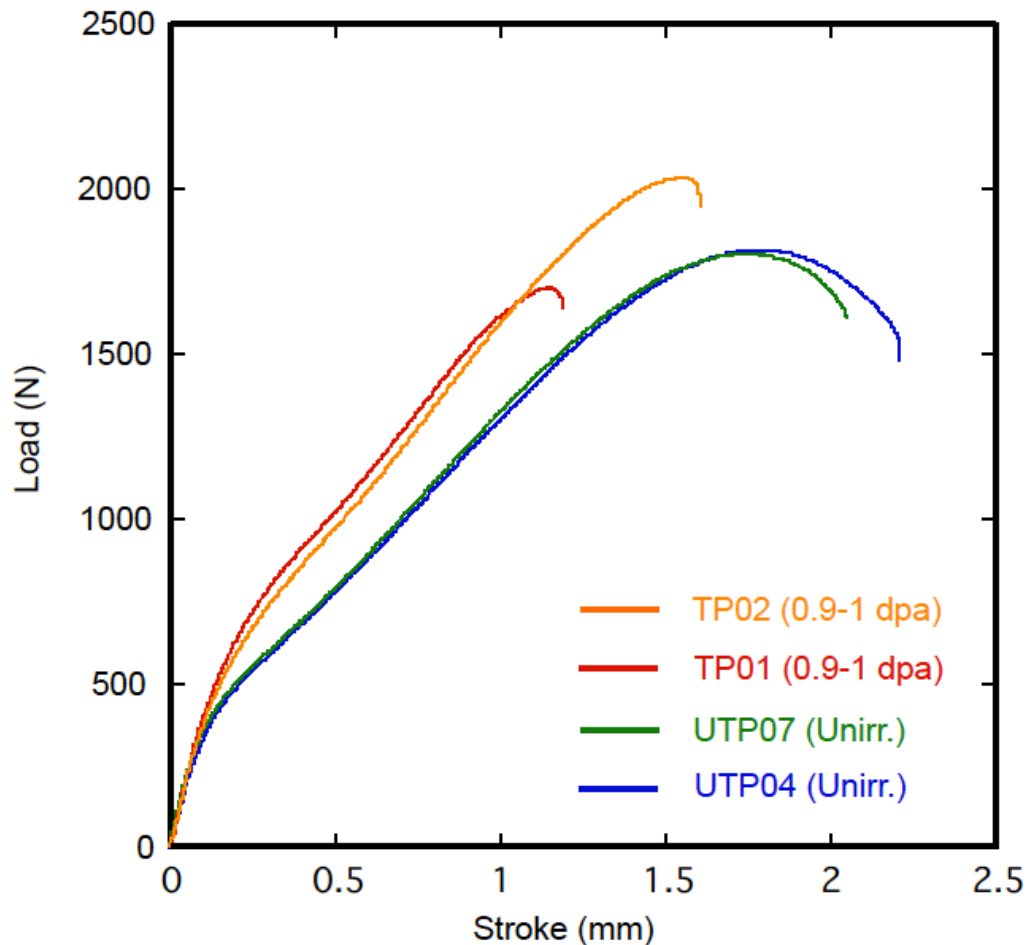
T91 (Beam window), RT tests

- Irradiation hardening and degradation of ductility.

- SP fracture energy, deflection at fracture and estimated J_{IC} value decreased.
- Dispersion of the irradiated data.

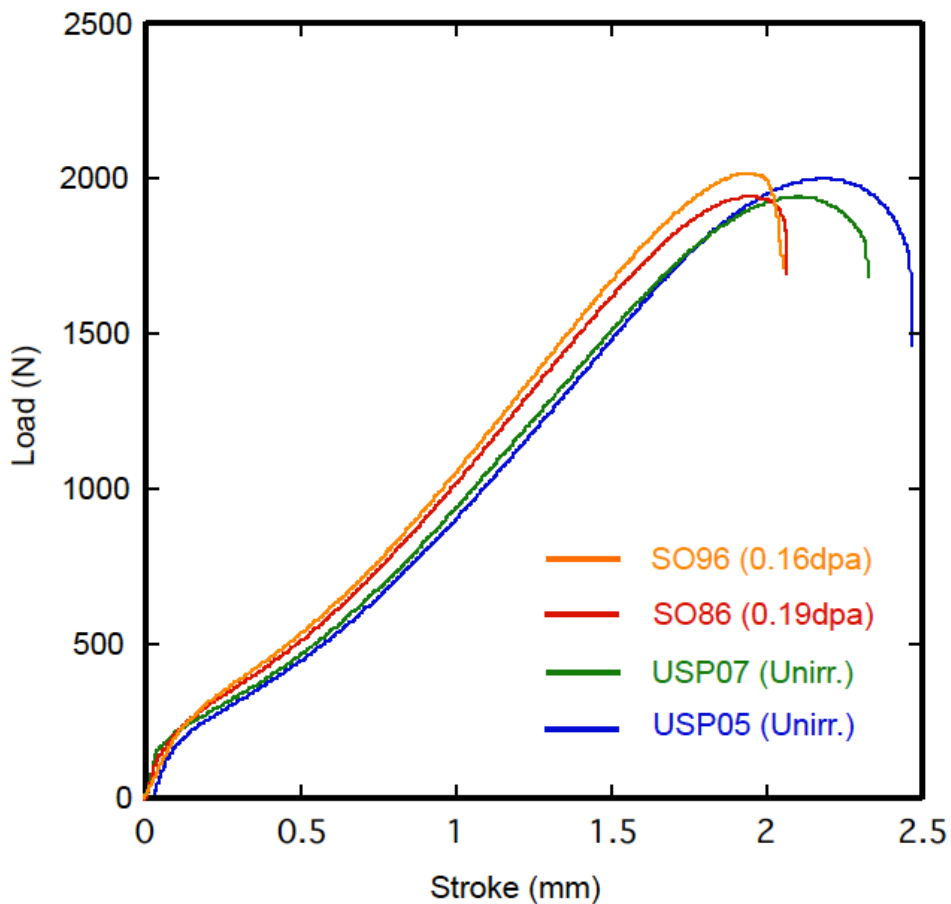
SS316L (FGT), RT tests

- Irradiation hardening and degradation of ductility
- Max load are almost same.

- SP fracture energy, Deflection at fracture decreased.

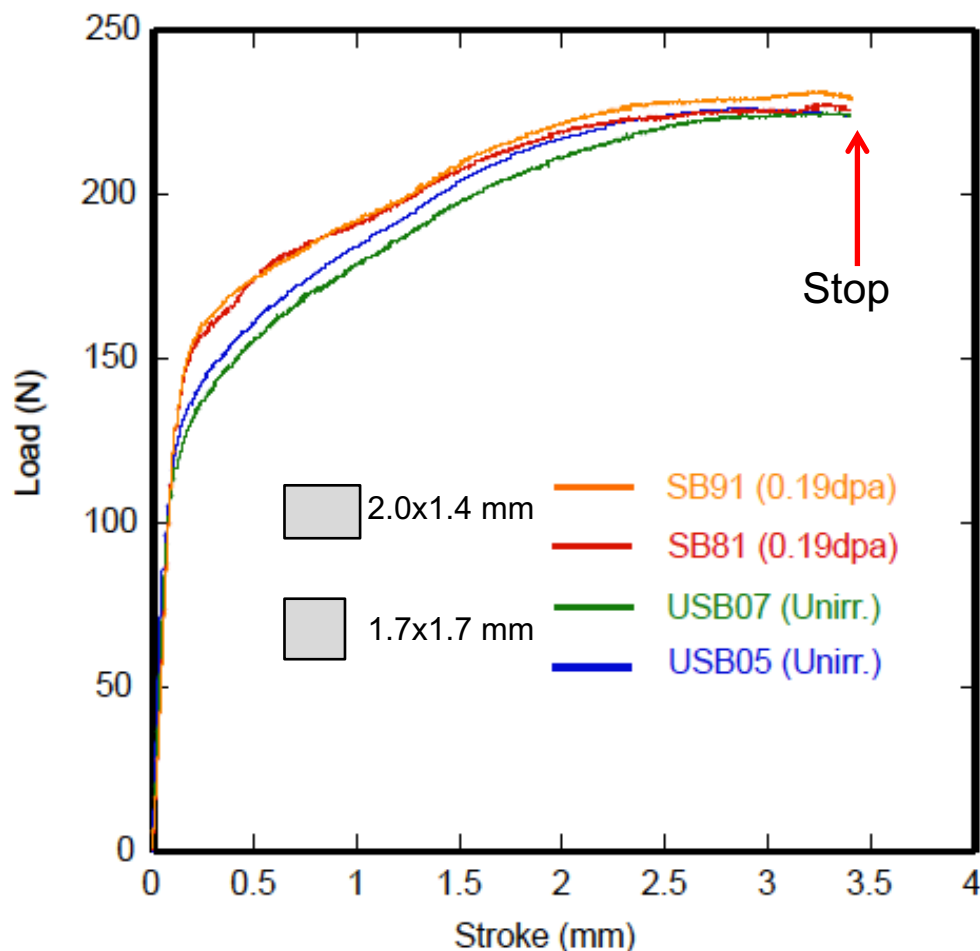
SS316L (FGT), RT tests

- Size of cross section are different.
- Irradiation hardening are observed.
- Cracks were not observed.

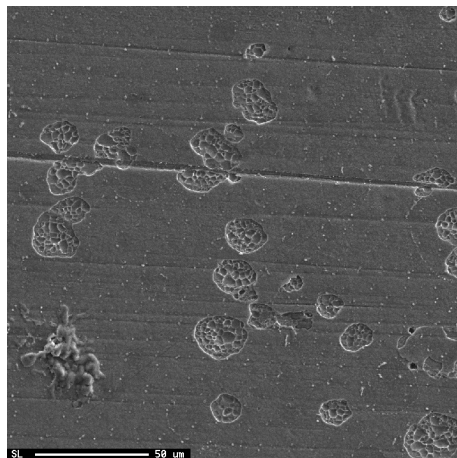
Inner surface (SEM)

Spitze (T91)

- Cracks inside of the pits
- No cracks around the pits.

- BW (T91); Cracks inside of the pits, no cracks around the pits.
- FGT (SS316L); At surface, corrosion and cracks were not observed.

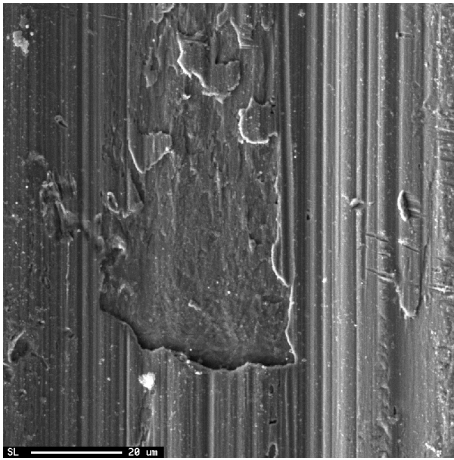
Inner surface (SEM)

FGT (SS316L, SO85)

- No evidence of corrosion
- Cracks were not observed for both side.

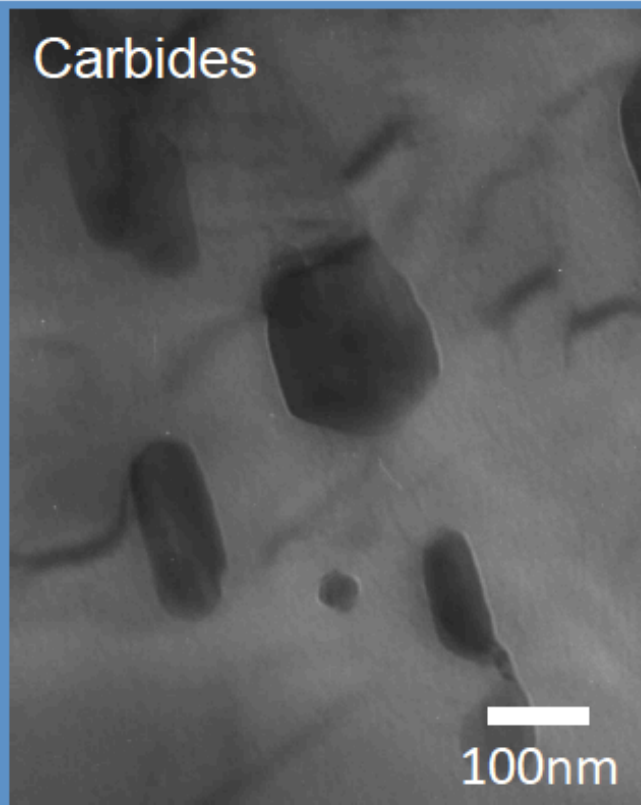
0.81 dpa, 252°C
(ID:TE04)

Typical irradiation microstructure of T91

BF image with $g=011$ near $z=111$

- 0.81 dpa : carbides and network dislocations
- 1.98 dpa : dislocation loops.

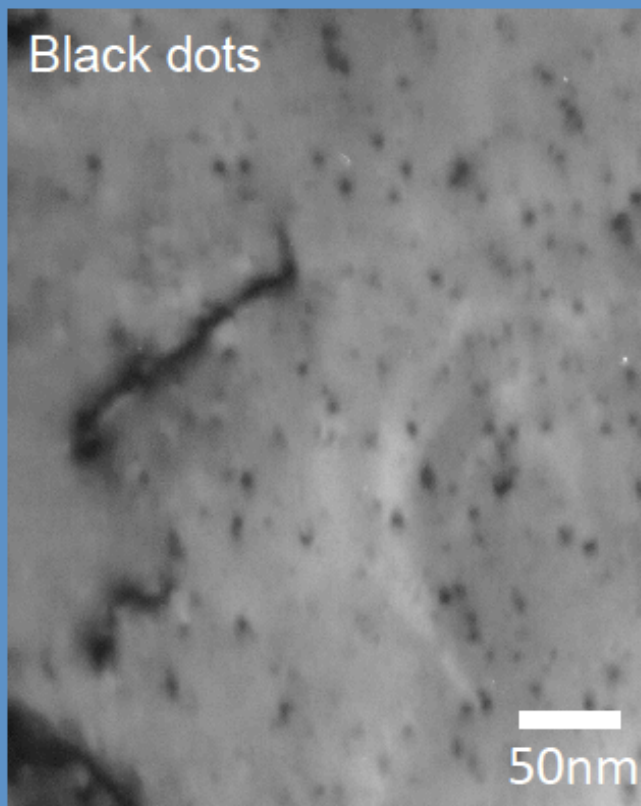
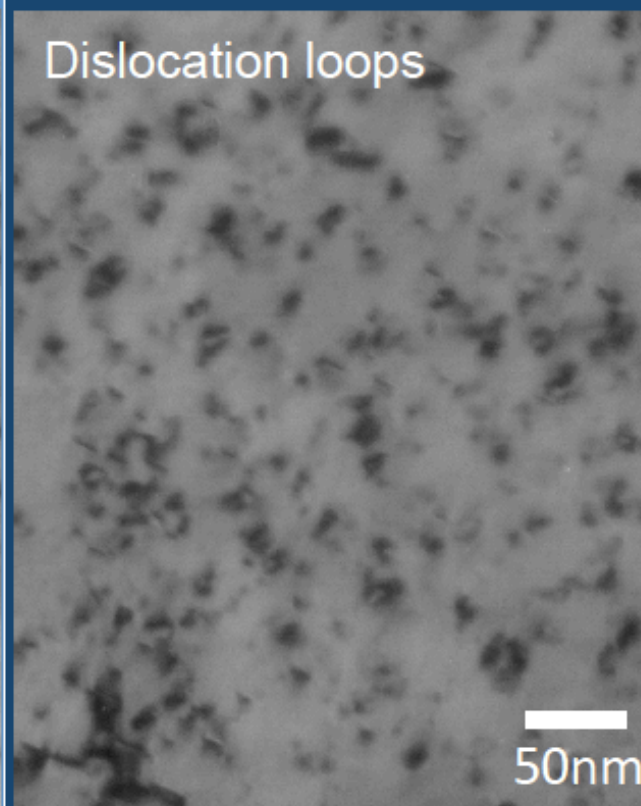
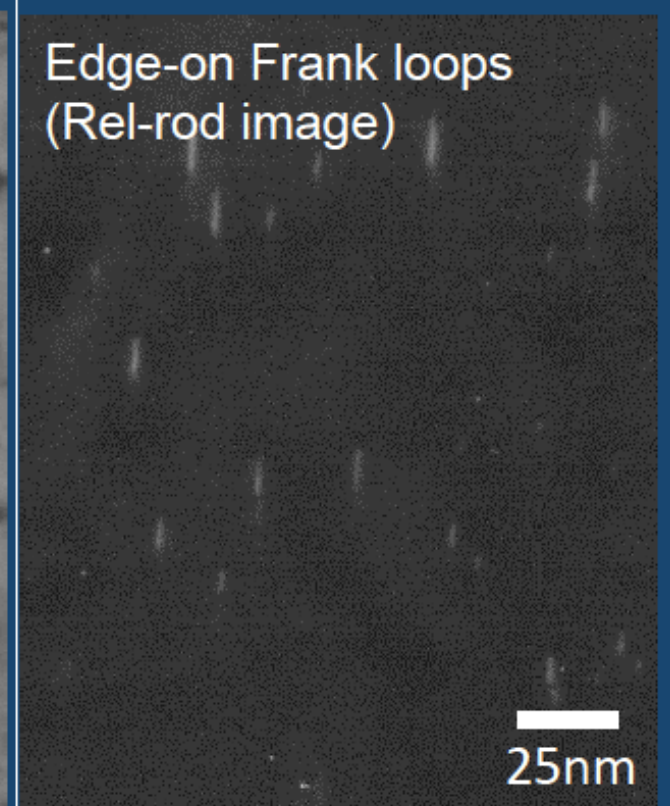
Typical irradiation microstructure of 316L SS

BF image with $g=200$ near $z=011$

Rel-rod streak image

0.19 dpa, 341°C
(ID:SE64)

1.57 dpa, 308°C
(ID:SE54)

- 0.19 dpa : network dislocations and black dot defect clusters
- 1.57 dpa : coexistence of black dots and dislocation loops (Frank loops)
