Annealing effect on the microstructure and hardness of irradiated tungsten

Barbara Horvath¹, Yong Dai¹, Yongjoong Lee²

¹ Paul Scherrer Institute

² European Spallation Source

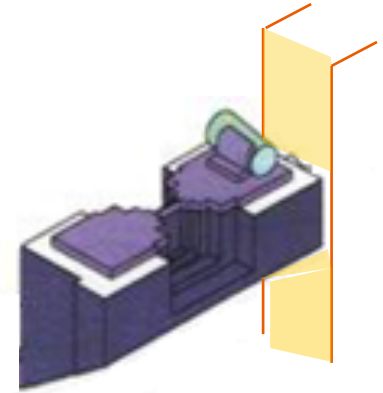
FIB sample development

- The reduction of the sample size reduces the activity
- Sample lifted out internally by a micromanipulator $8 \times 8 \mu\text{m}^2$ and 200 nm thick lamella is milled.

Creating a TEM sample with FIB:

- a) etching around the sample,
- b) transferring the sample to the TEM grid, thinning the membrane

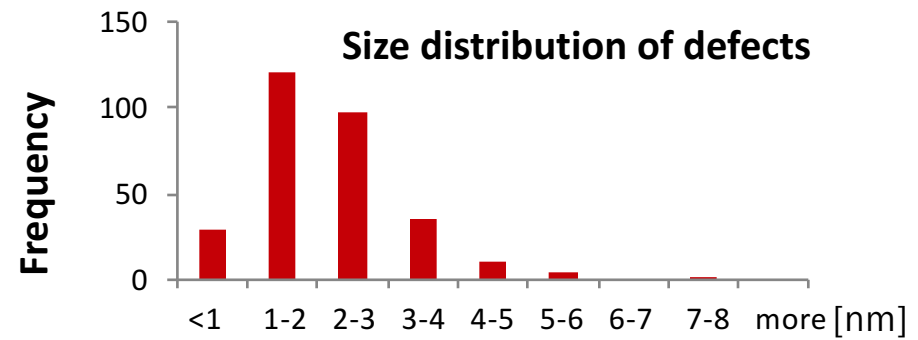
Defect clusters: aggregation of interstitial atoms through displacement damage

Dislocation density: $1.9 \times 10^{13} \text{ m}^{-2}$

Cluster density: $3.2 \times 10^{23} \text{ m}^{-3}$

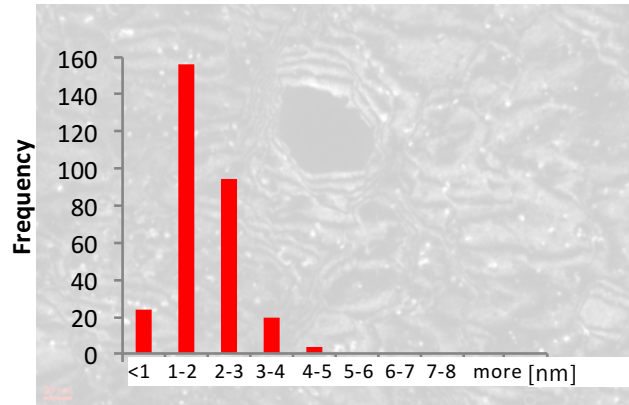
Before annealing:

Counting clusters according to their sizes
