# Second Target Station Project: Cylinder Moderator Prototype Manufacturing Report

**S07030200-TRT10000-R00**

**CYLINDER MODERATOR PROTOTYPE MANUFACTURING REPORT**

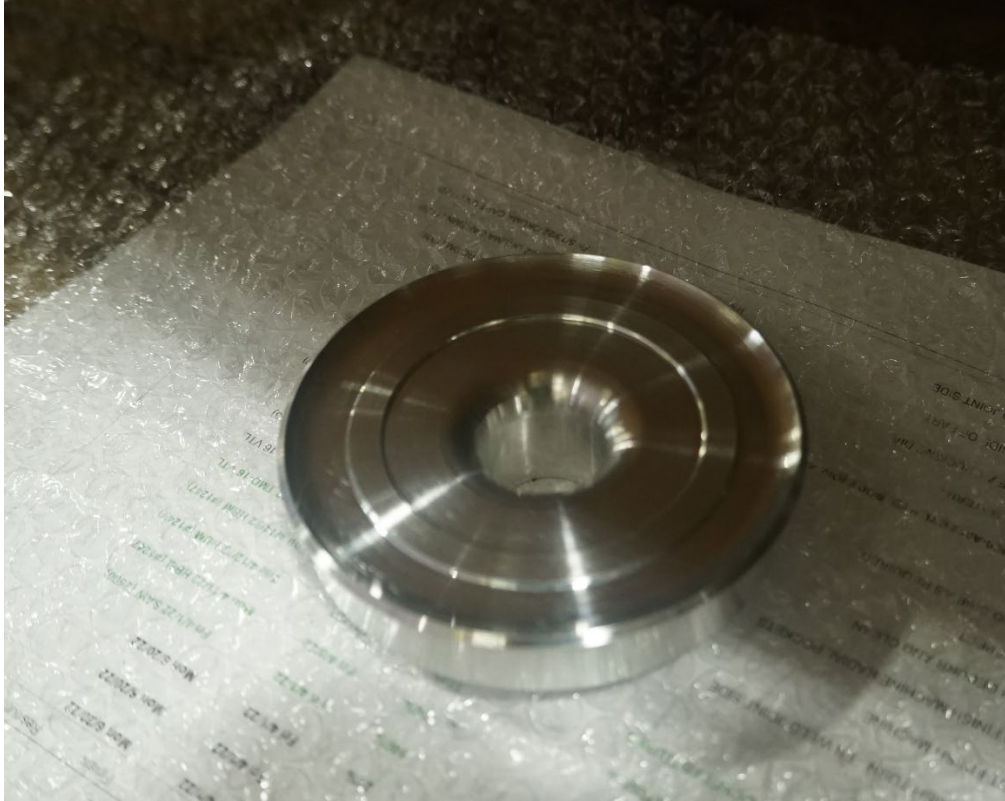
Vacuum vessel lid finished with lathe work and ready for milling of pockets.

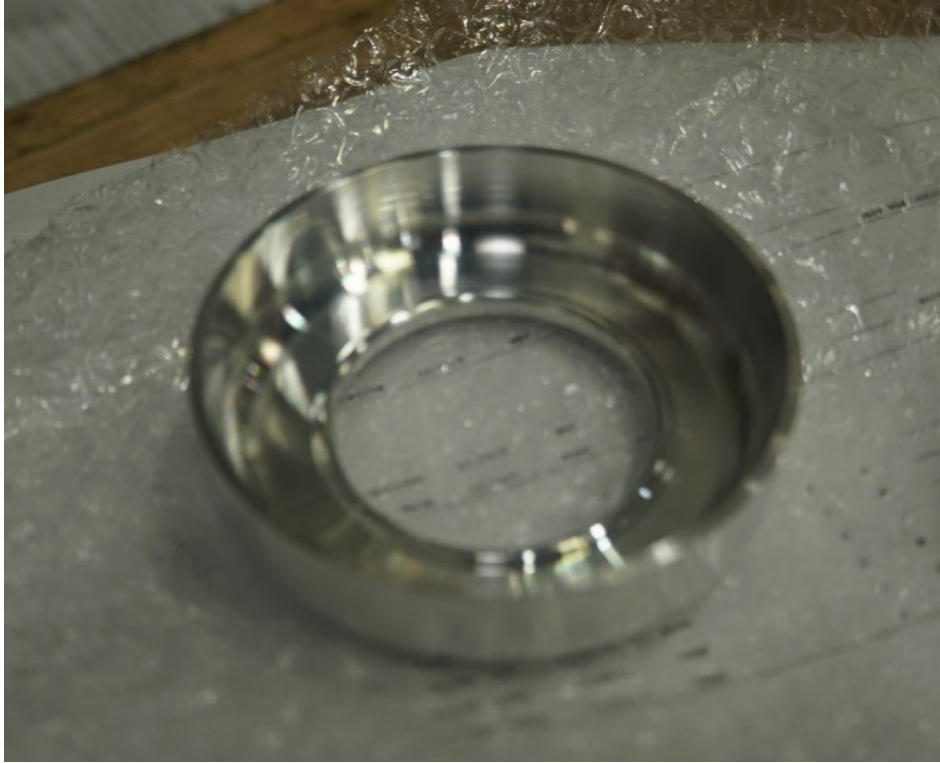
Finished sample hydrogen vessel body.

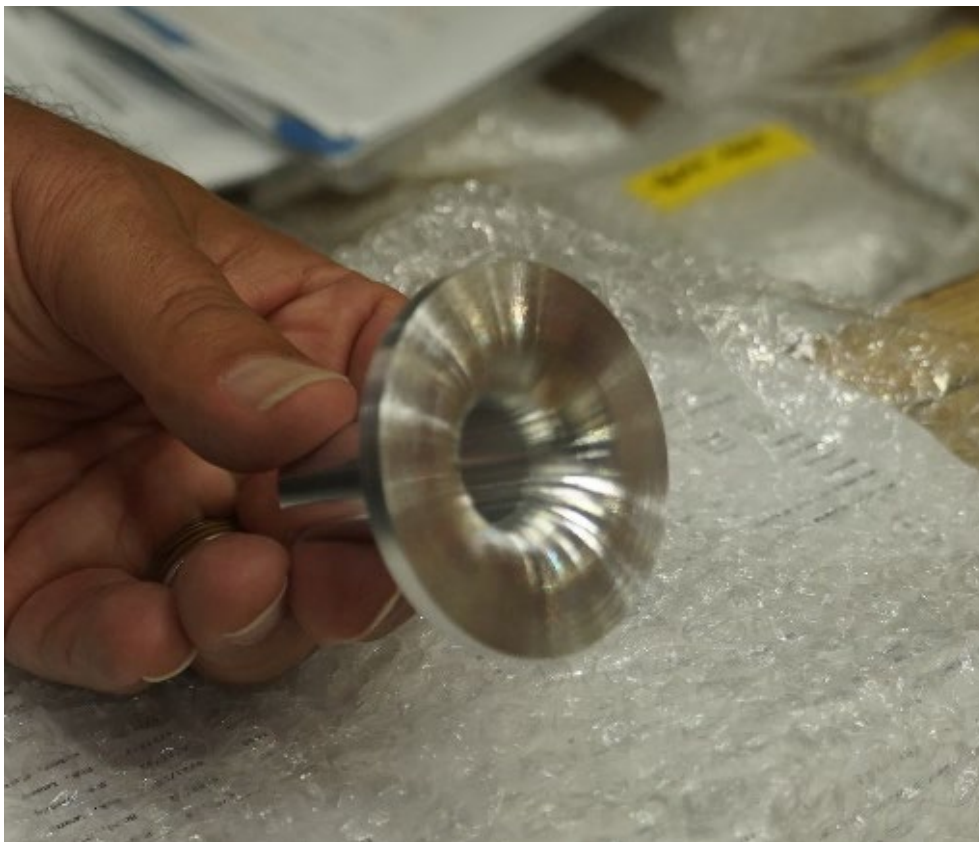
Finished sample hydrogen vessel lid.

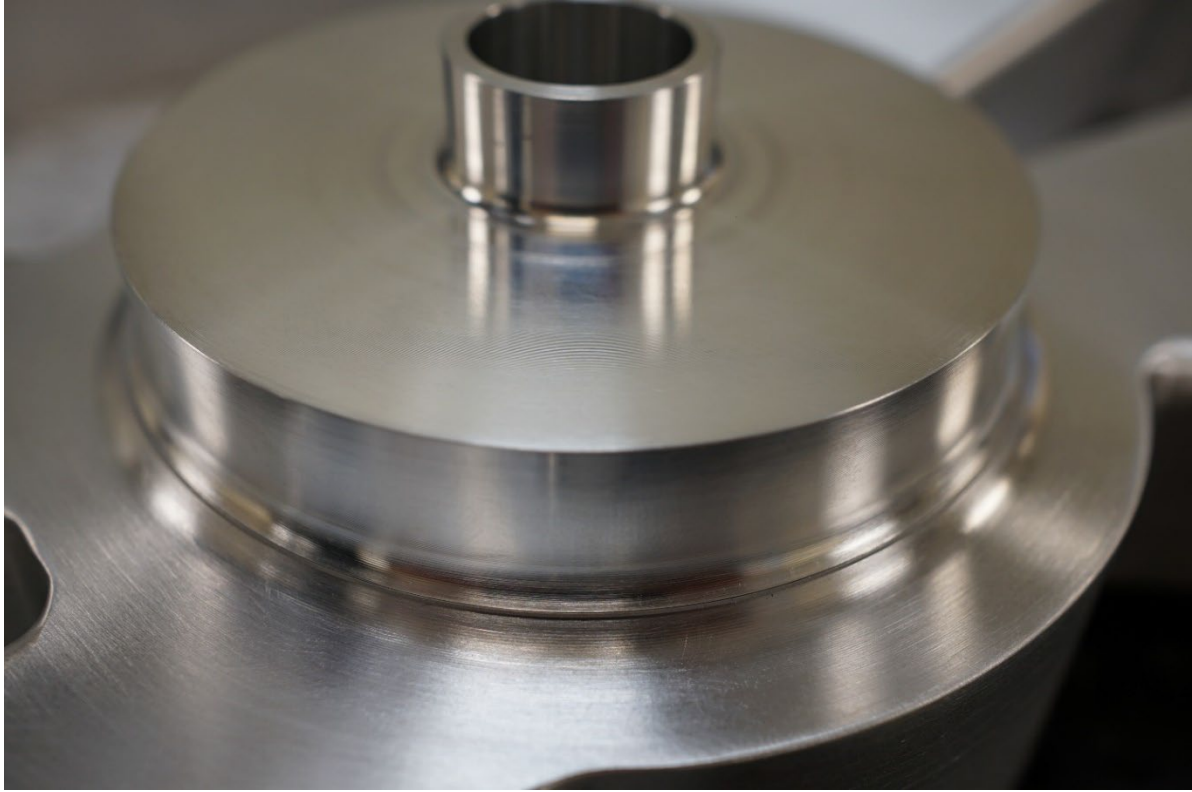
Testing fit up of vacuum vessel body to lid at receipt.

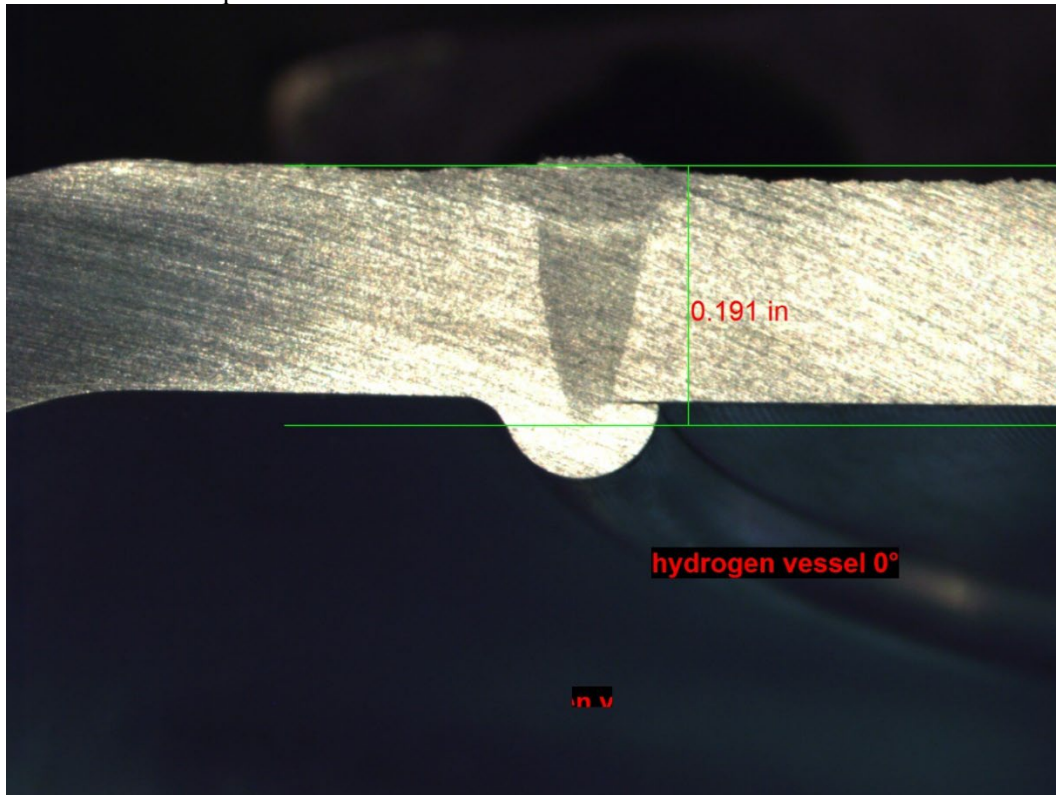
Hydrogen vessel weld section at start of weld.

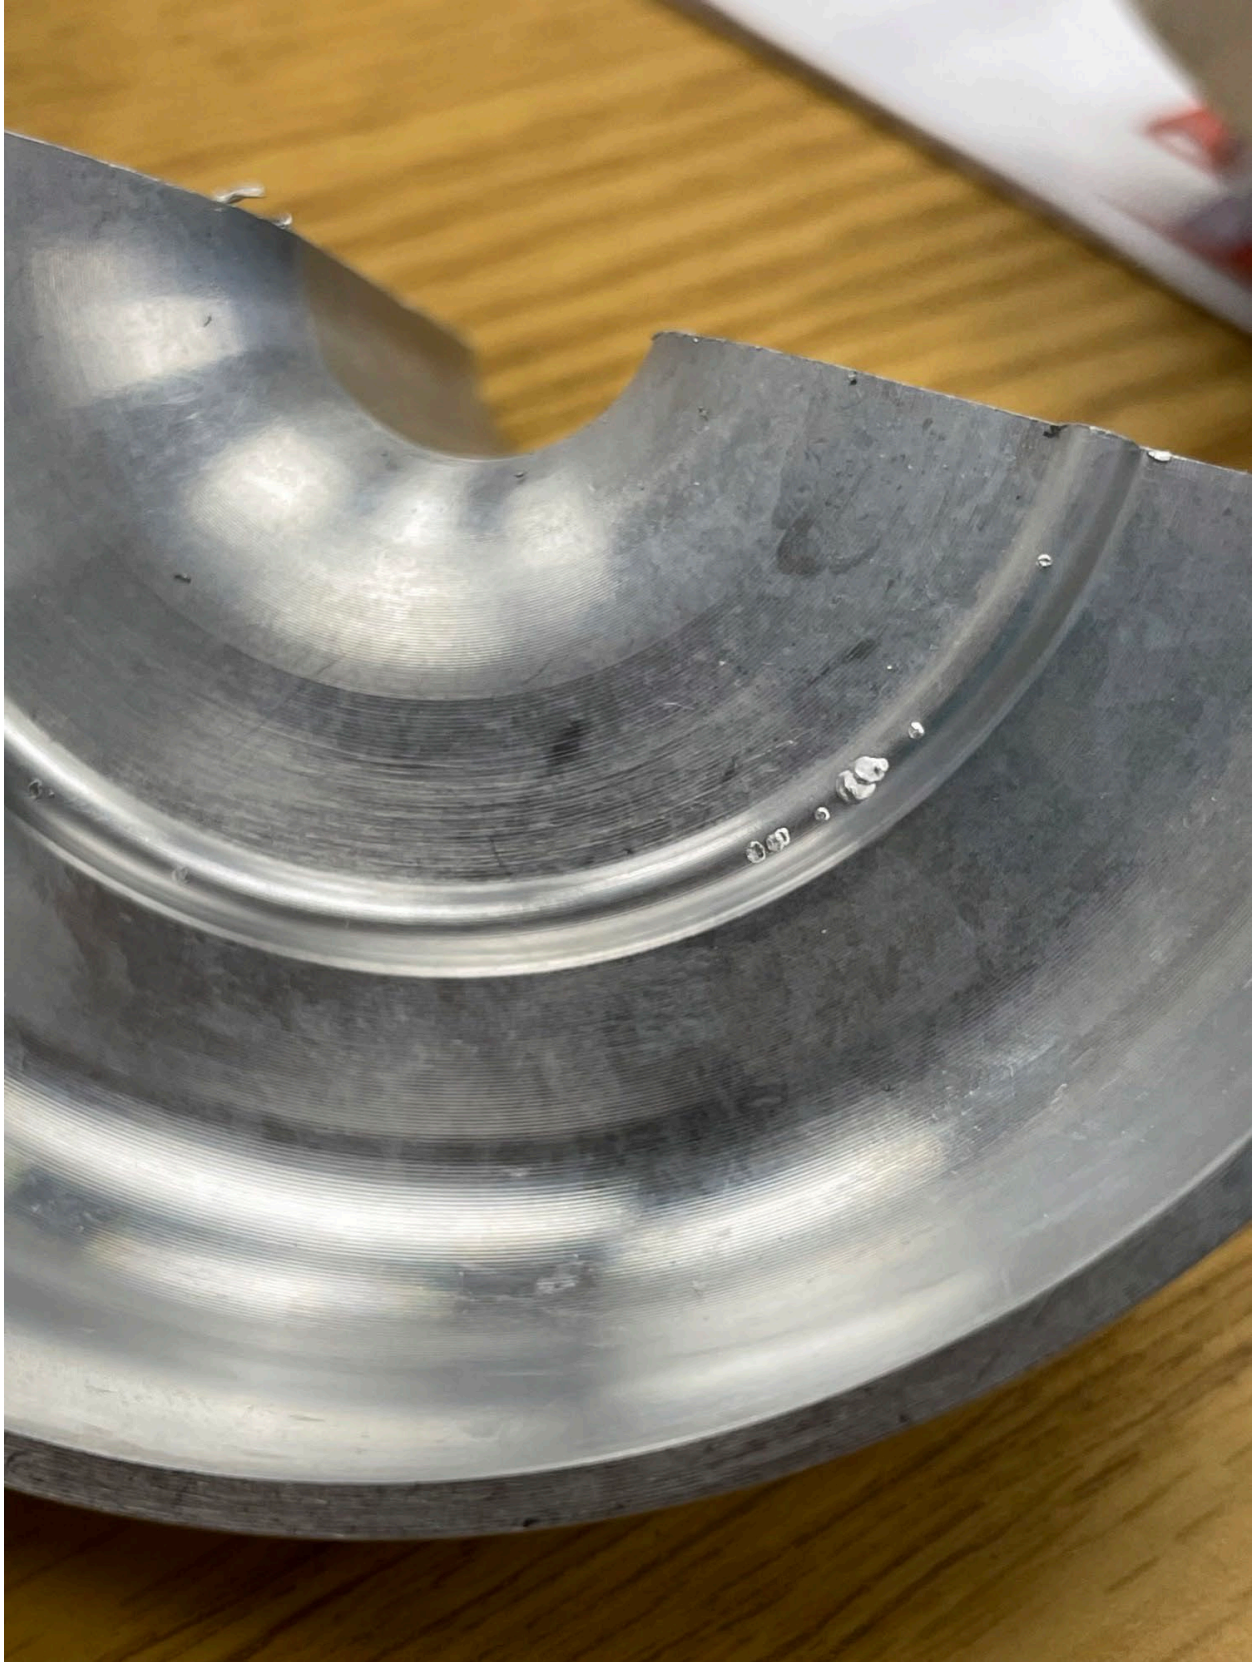
The only issue revealed was some minor over penetration through the weld backers which could lead to arc strikes on adjacent surfaces. Rather than develop more complicated welding programs or remachine parts with larger backers, other mitigation techniques were used to prevent arc strikes as detailed in the prototype welding sections. In the future, the vacuum vessel weld backer should certainly be made larger and hydrogen vessel weld backer enlargement should be considered.

Intermittent over penetration of hydrogen vessel sample weld.

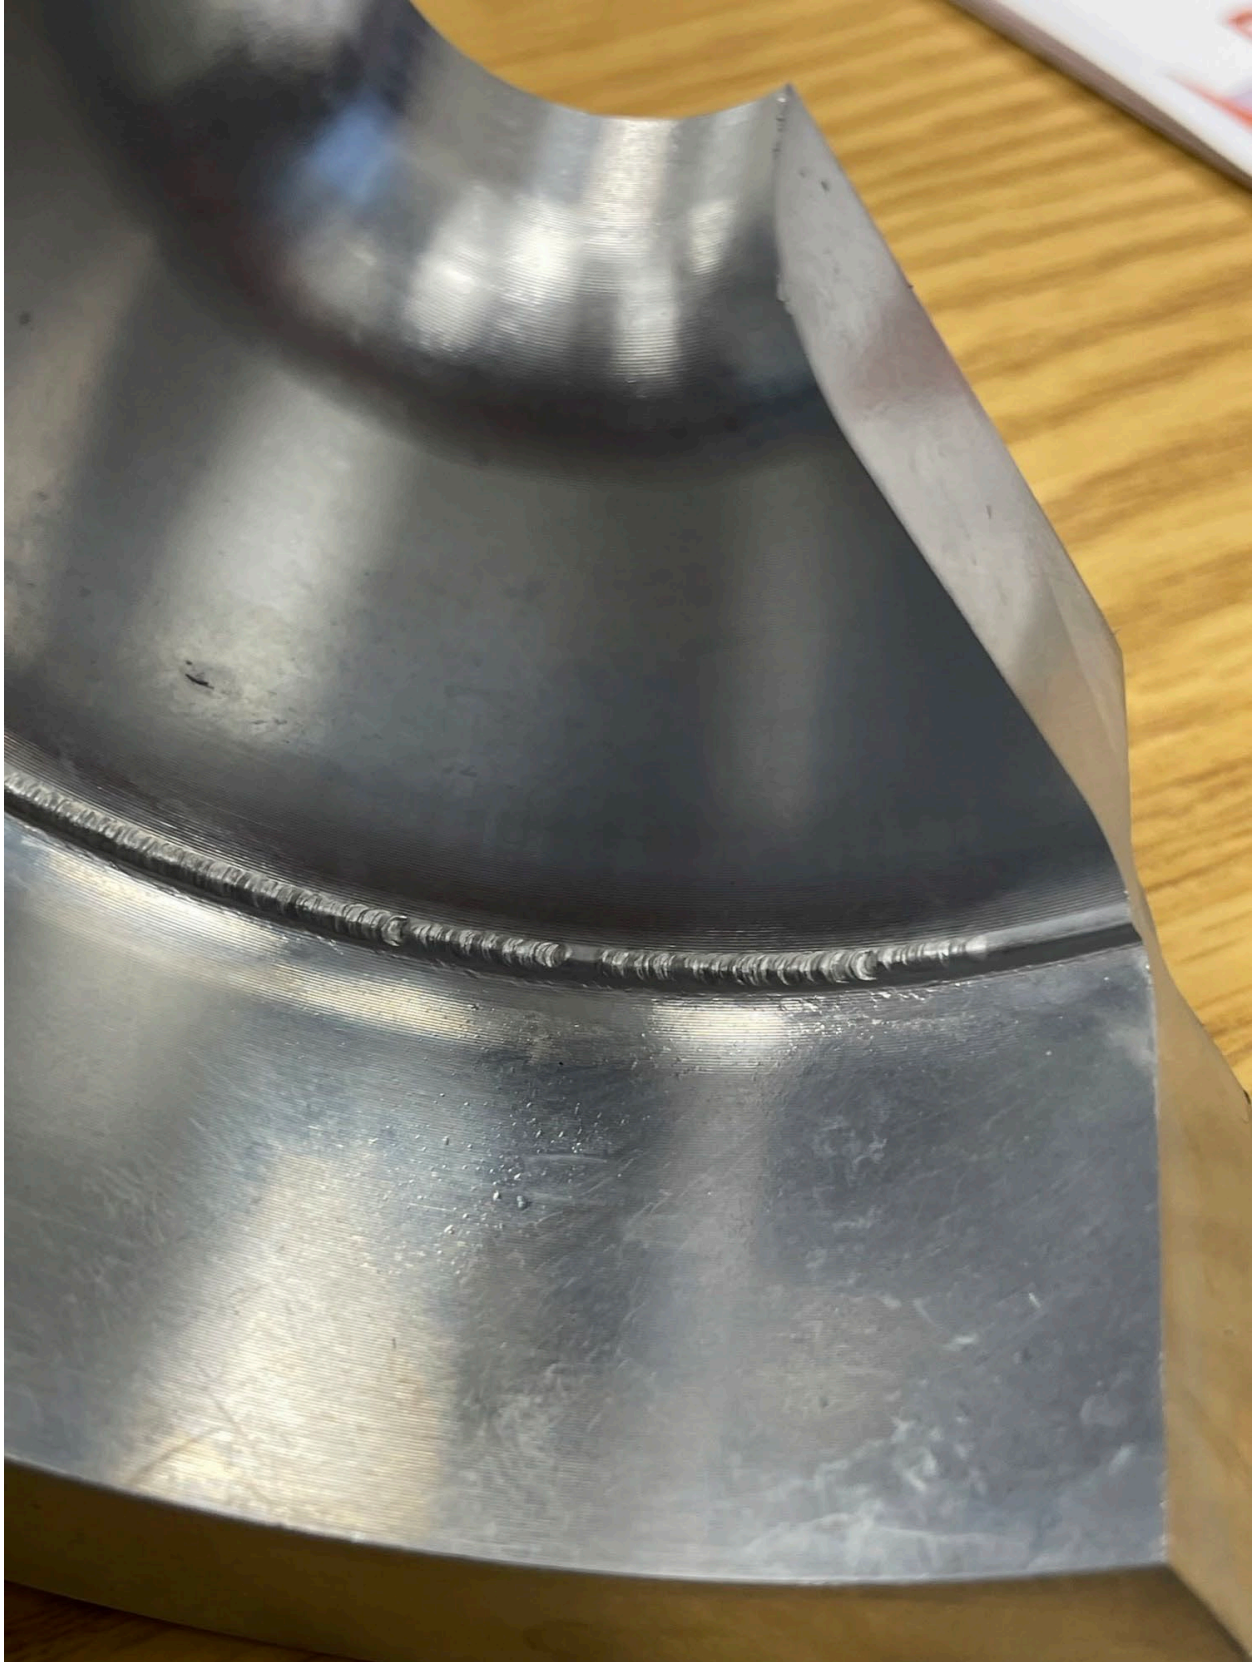
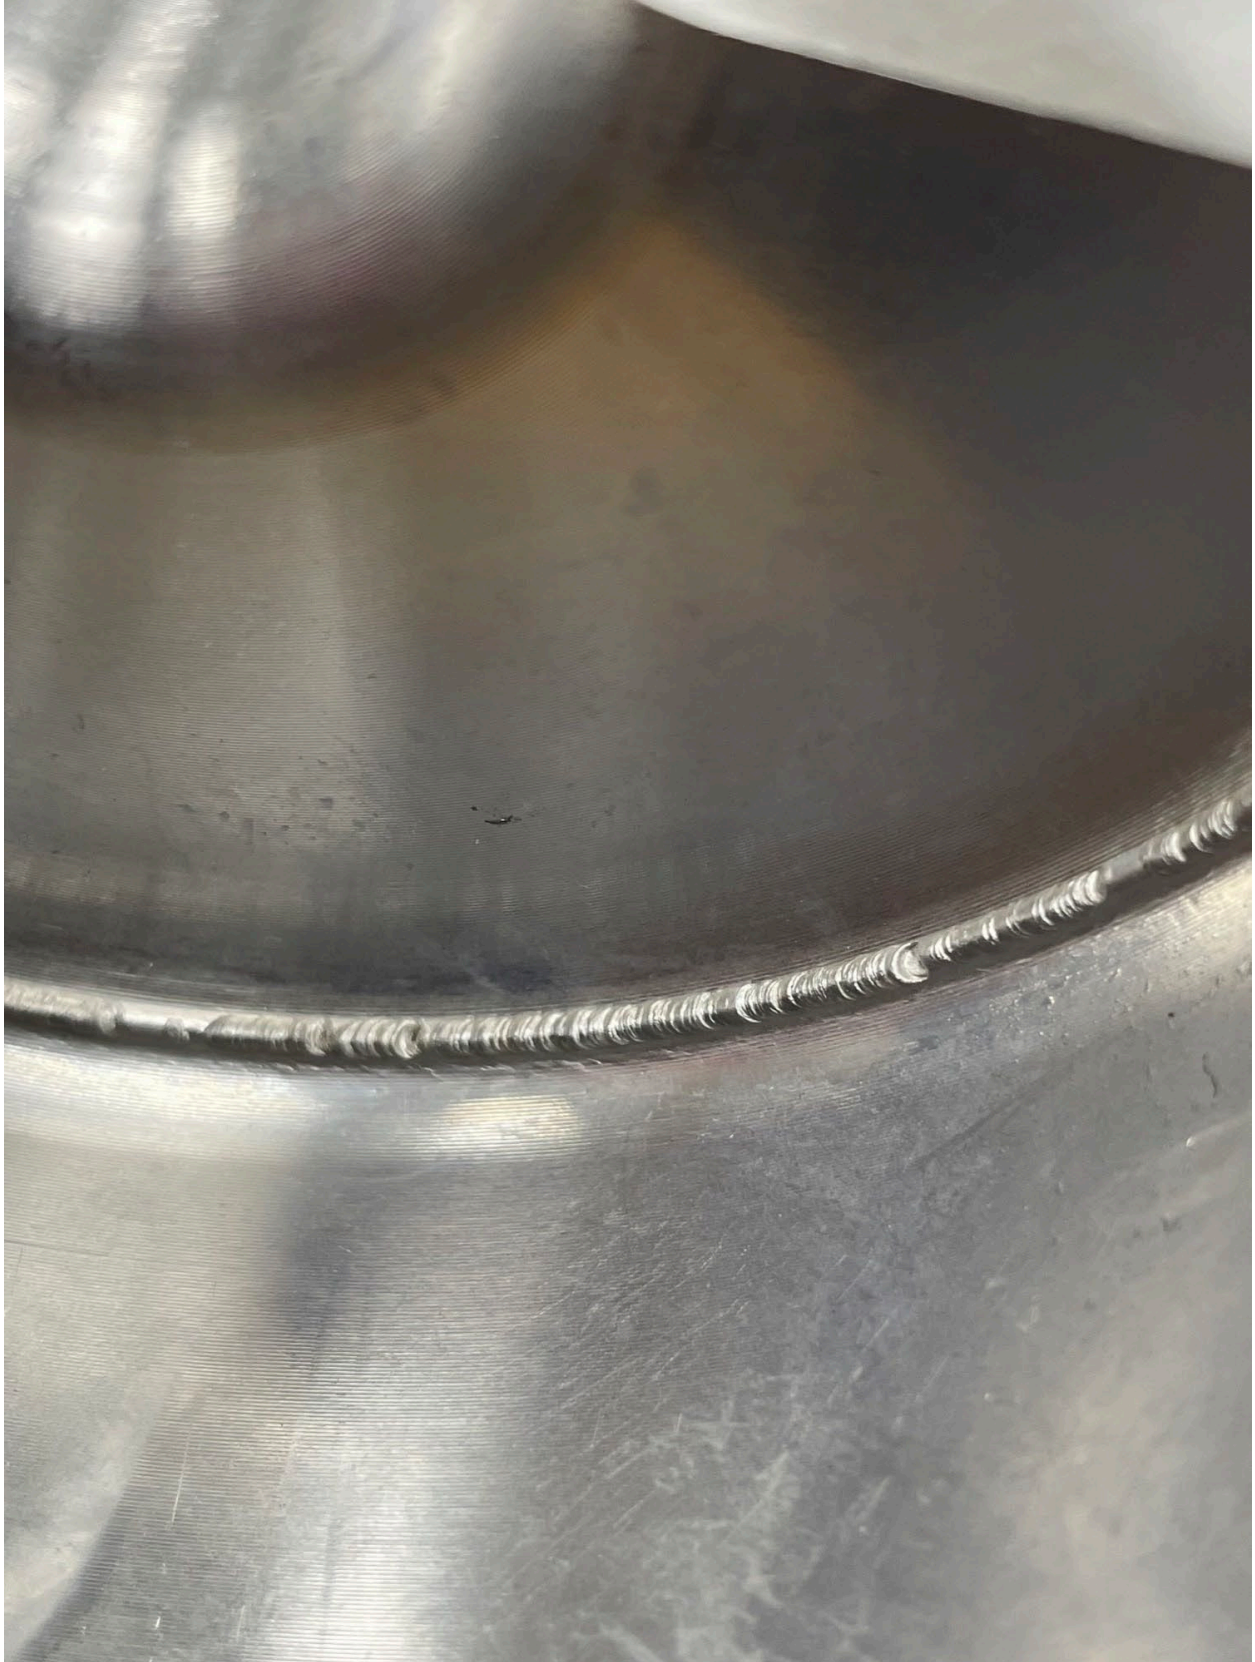
Over penetration of vacuum vessel weld backer resulting in melting of backer.

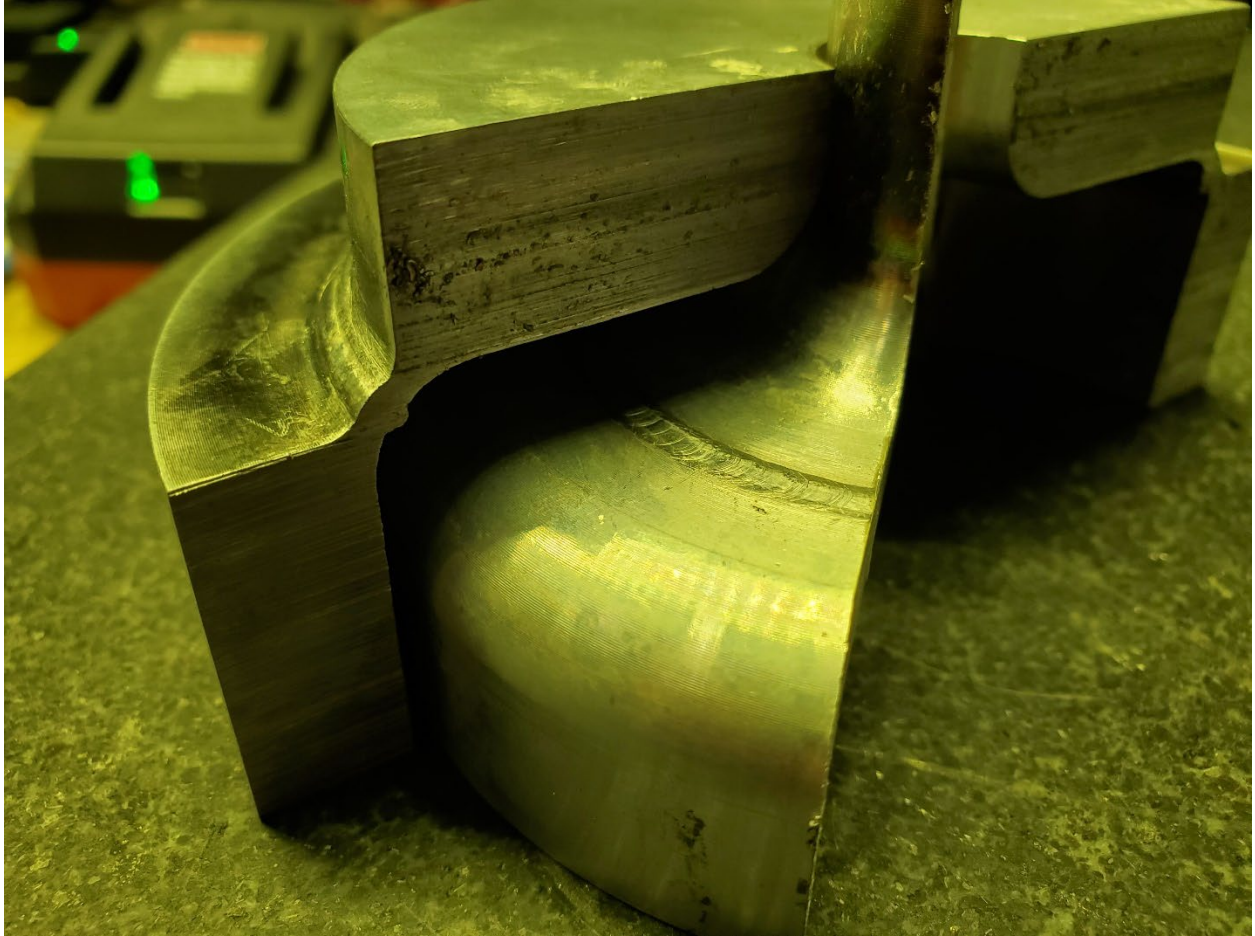
Already welded sample hydrogen vessels were placed inside sample vacuum vessel welds during welding to determine the effect of overpenetration.

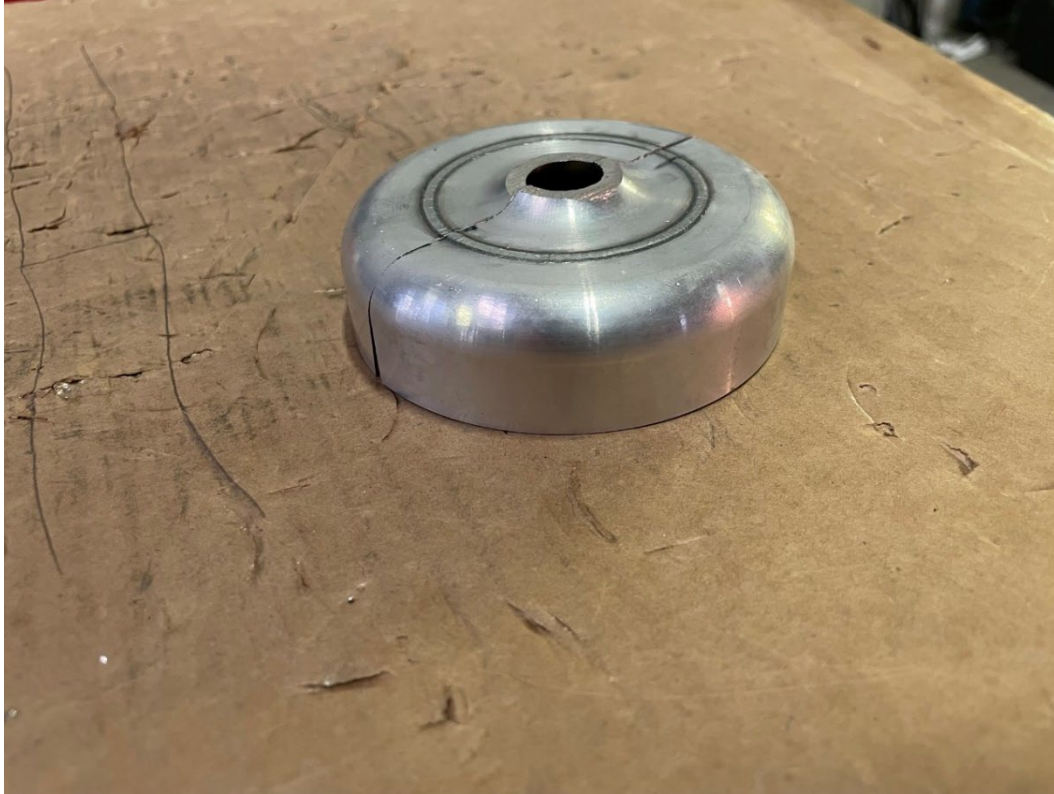
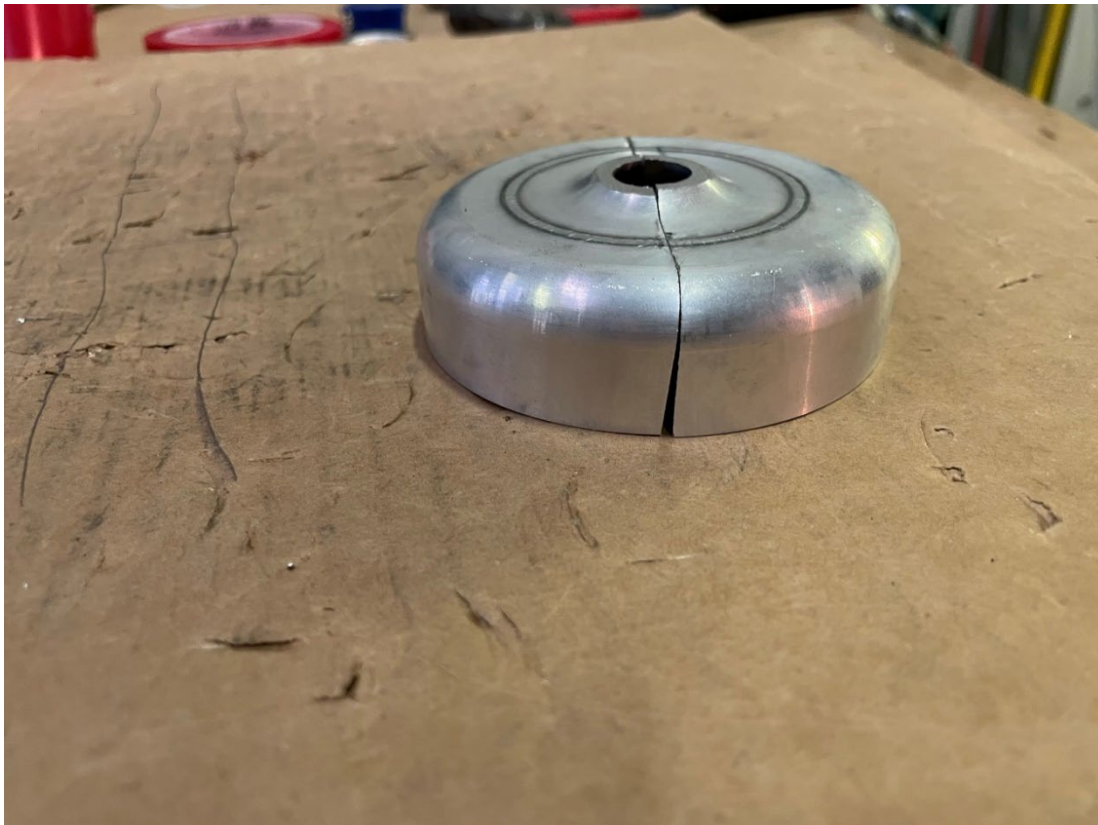
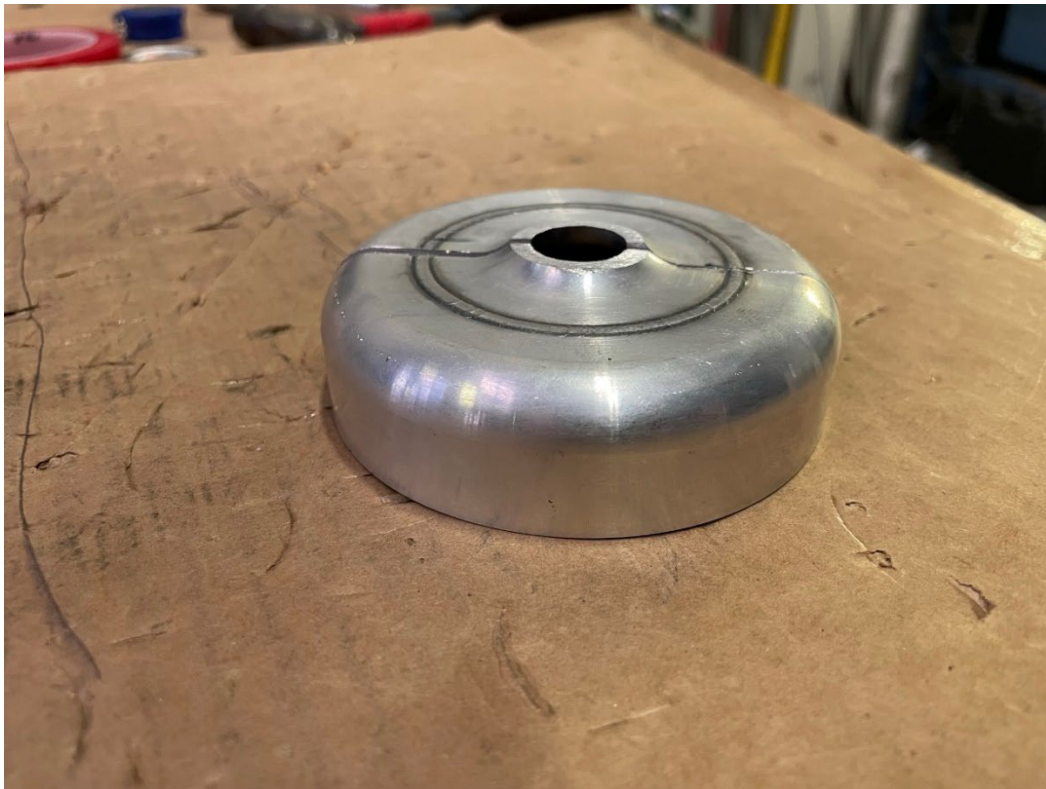
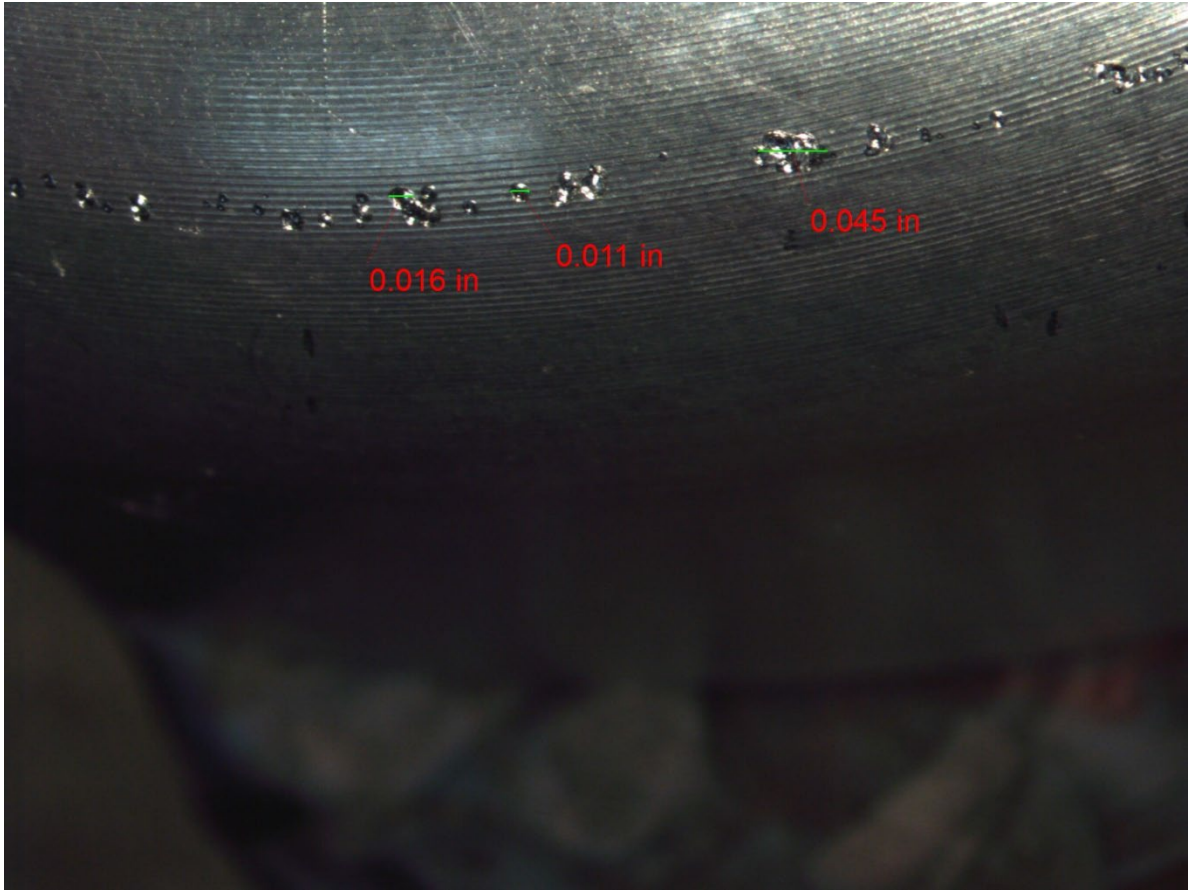
Beam strikes on the hydrogen vessel sample due to overpenetration of the vacuum vessel weld.

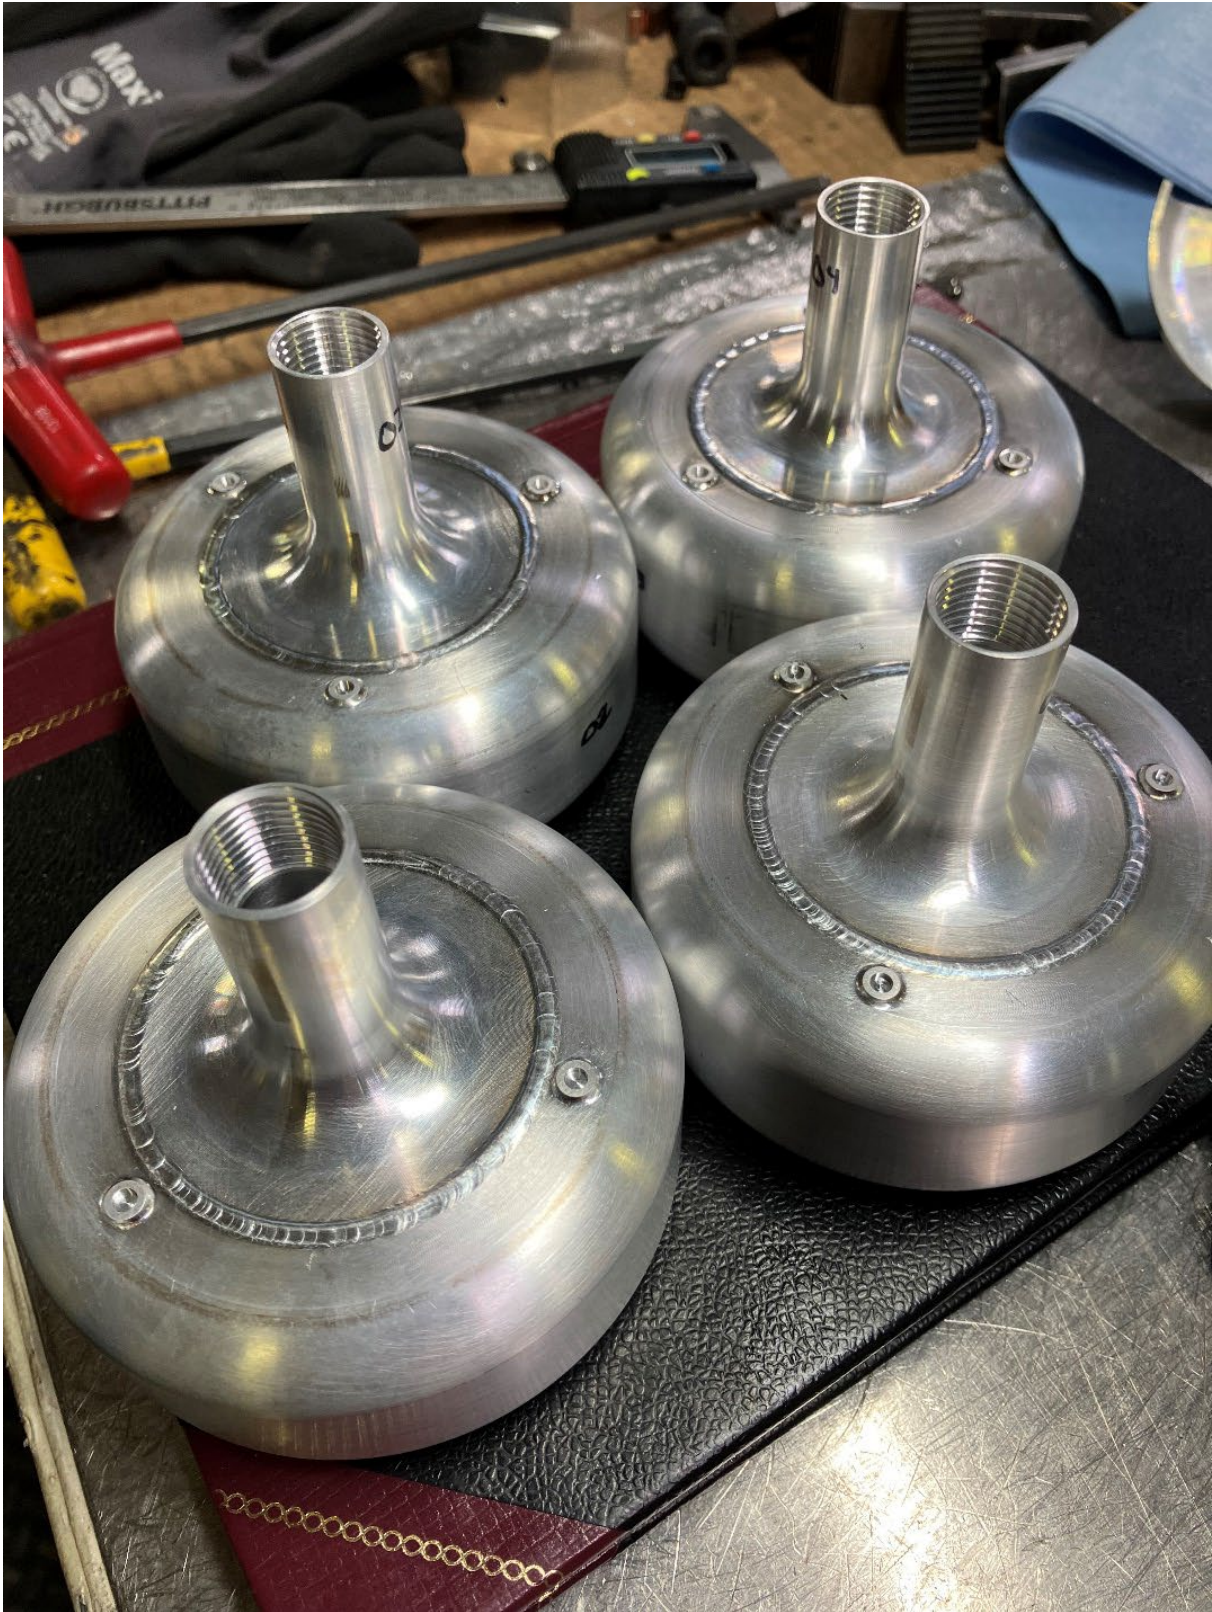
Four completed hydrogen vessels.

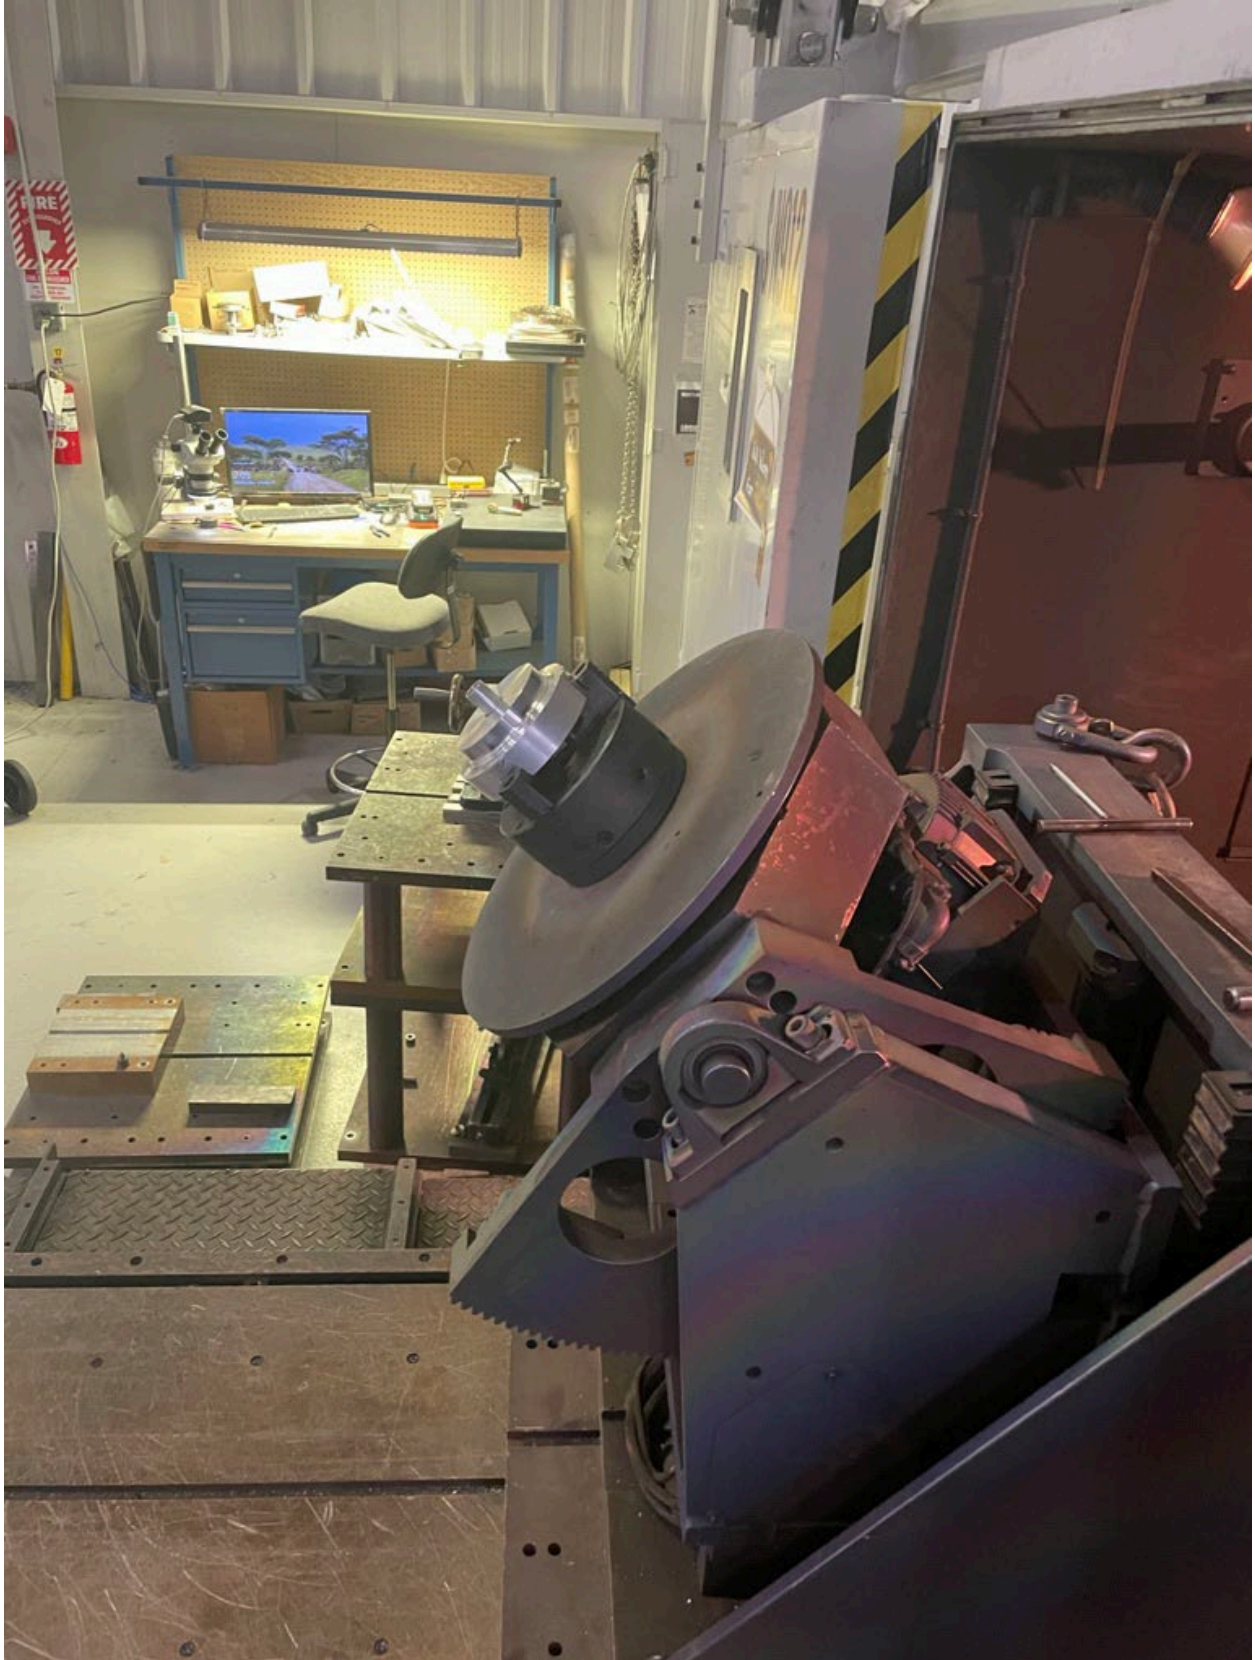
Loading vacuum vessel weld sample into EB weld machine.

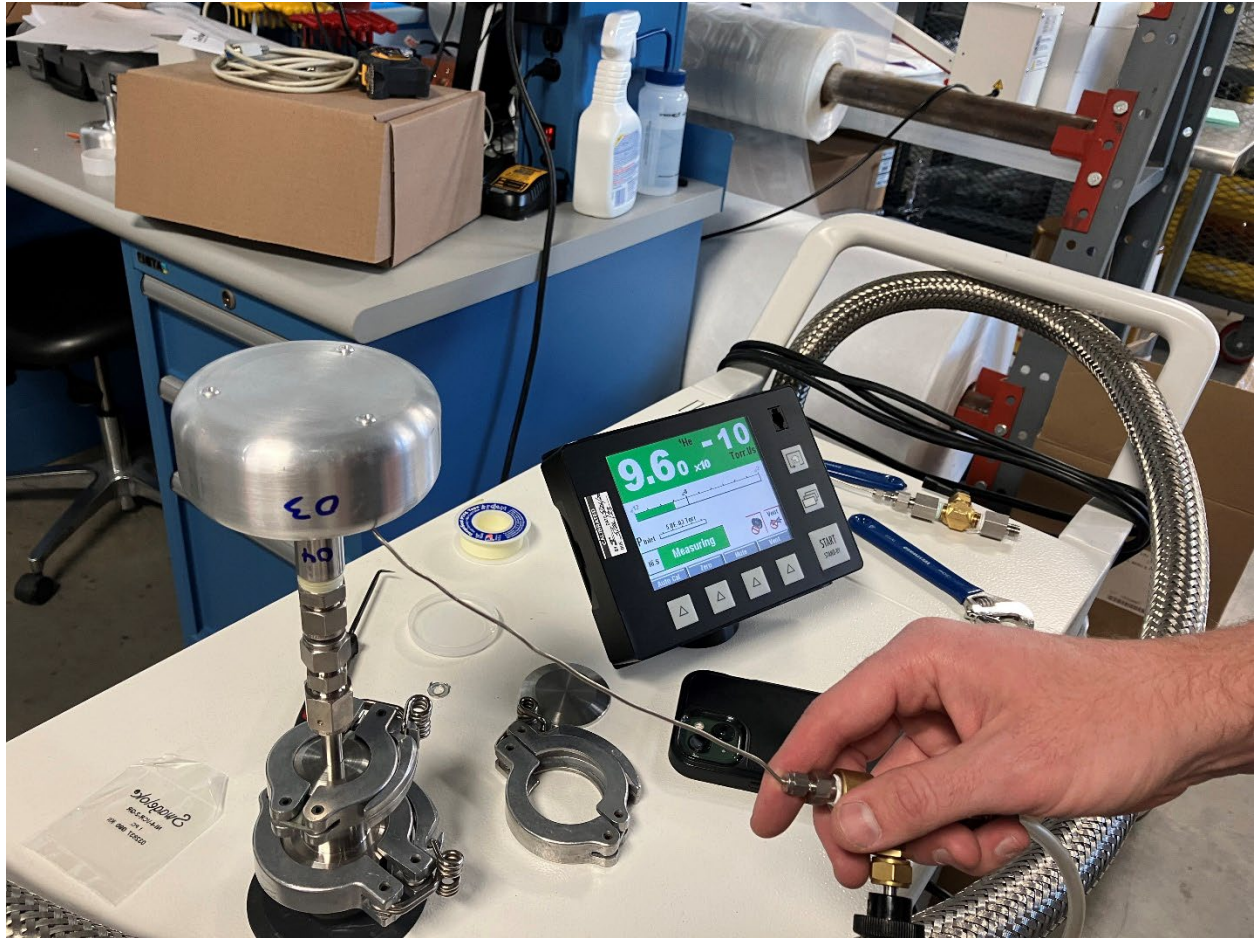
During hydrogen vessel welding and inspection, a scheme for protecting the installed hydrogen vessel from over penetration during the vacuum vessel weld was created. Protecting from overpenetration of the vacuum vessel weld was difficult due to the small gap, only 3 mm. Shims were designed to be placed in the gap and protect the inner vessel from over penetration and then removed after welding. Shims and a shim form were designed (S07030200-M8U-8800-A10002, S07030200-M8U-8800-A10003, and S07030200-M8U-8800-A10005) and fabricated by TN Tool under the Basic Ordering Agreement (BOA).

Beam Blocker shims and forming tool

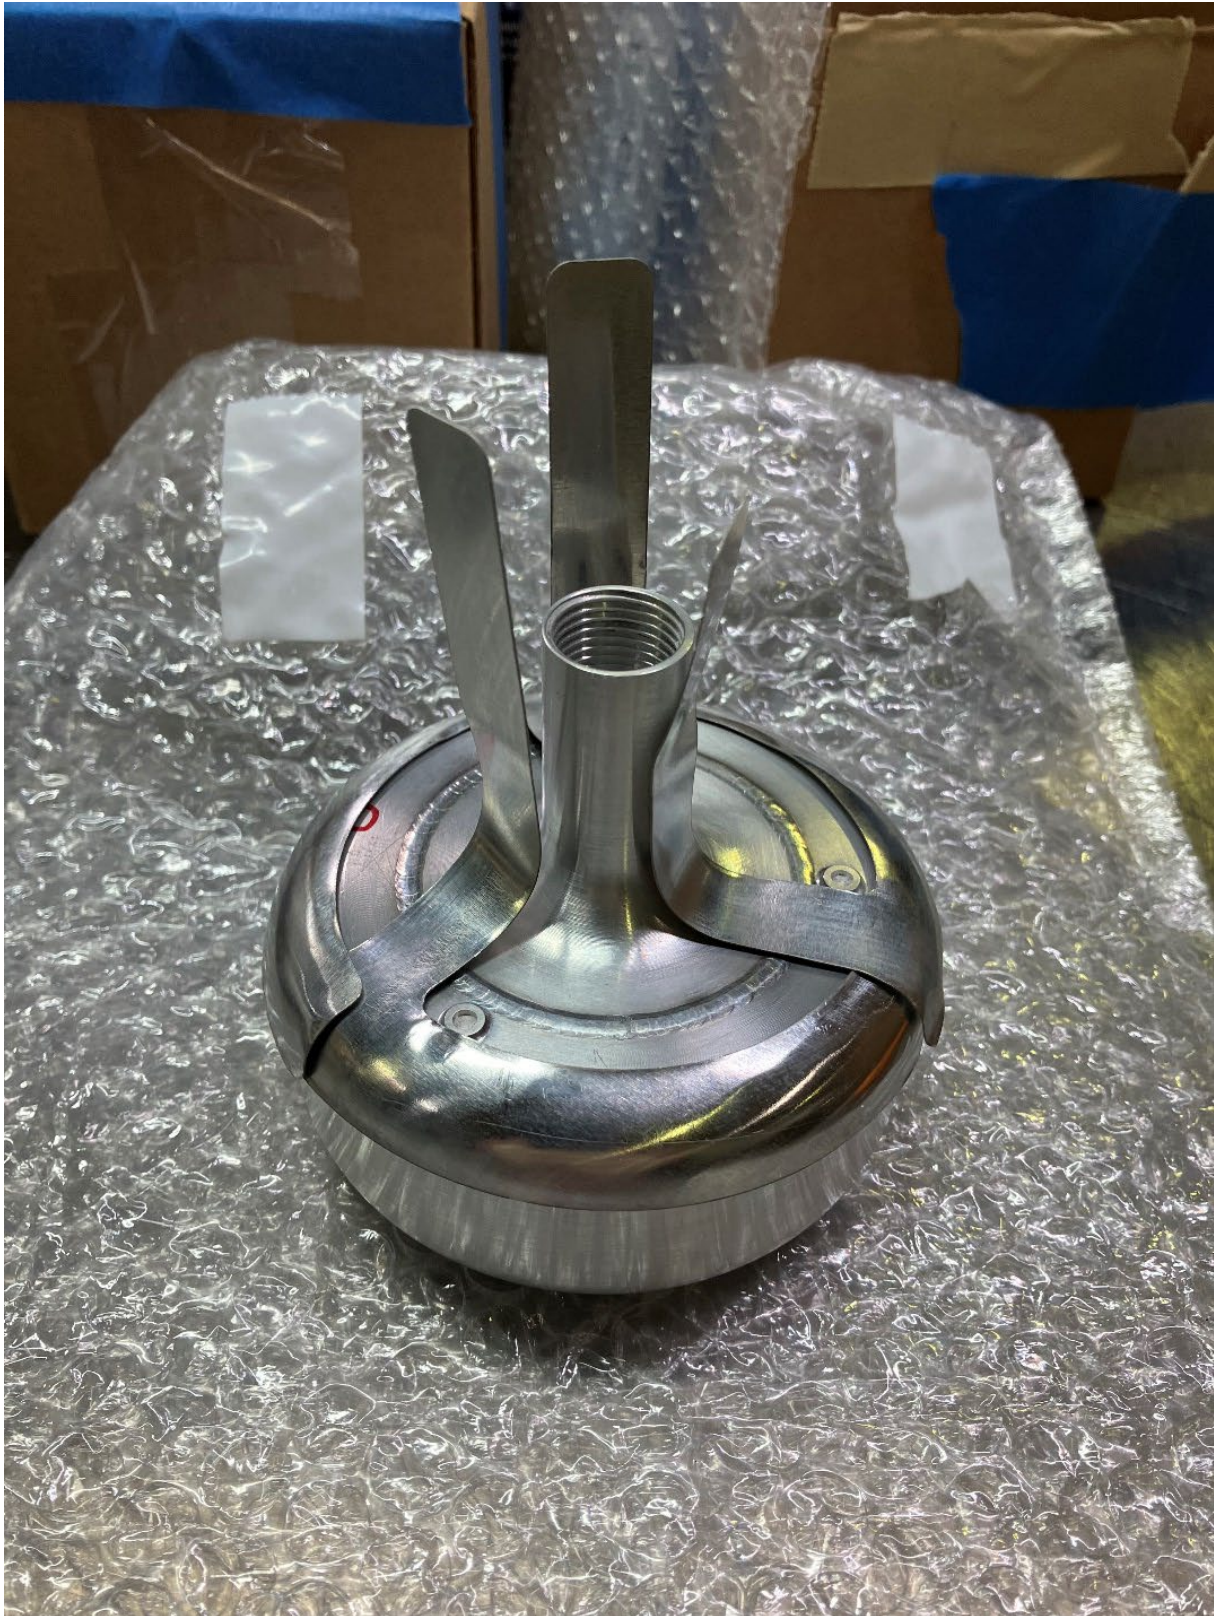
Hydrogen vessel with beam blocker shims installed.
