# Second Target Station Project: Cylinder Moderator Prototype Manufacturing Report

**S07030200-TRT10000-R00**

**CYLINDER MODERATOR PROTOTYPE MANUFACTURING REPORT**

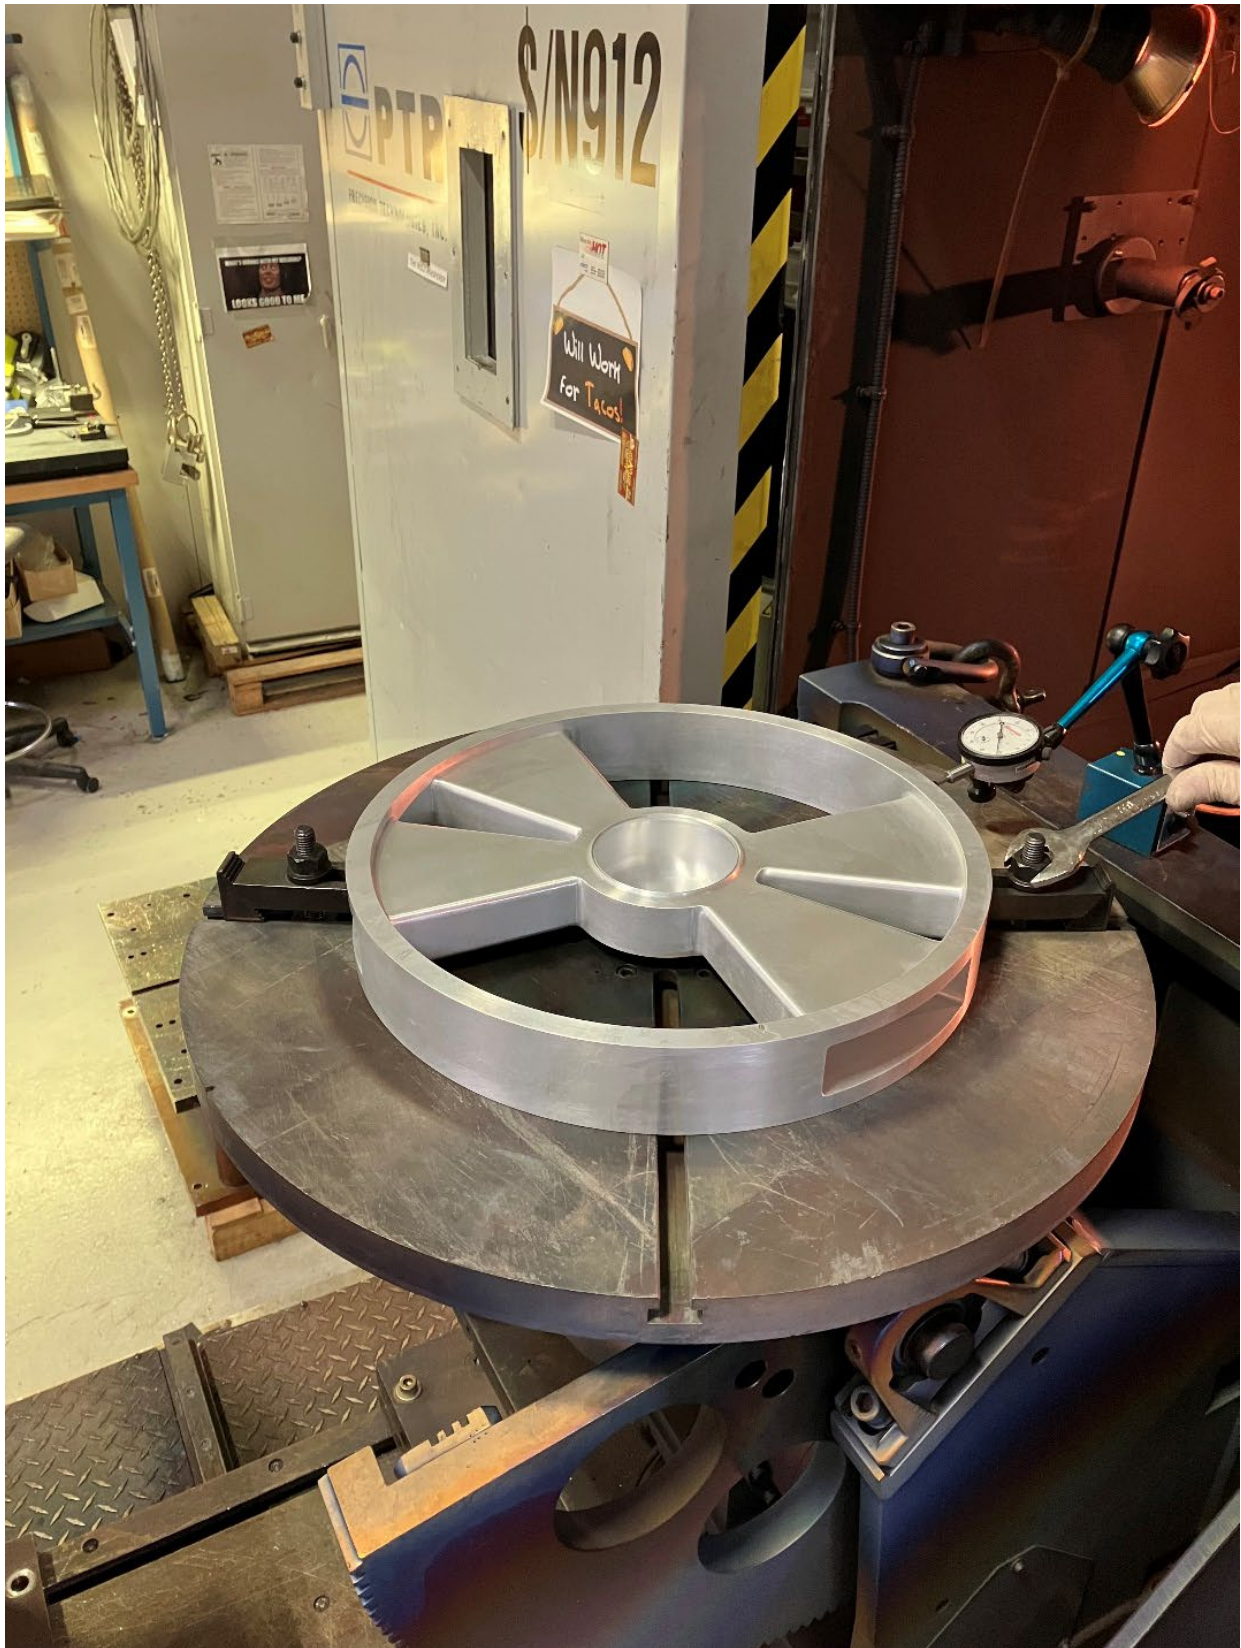
Vacuum vessel body being indicated in on rotary table.

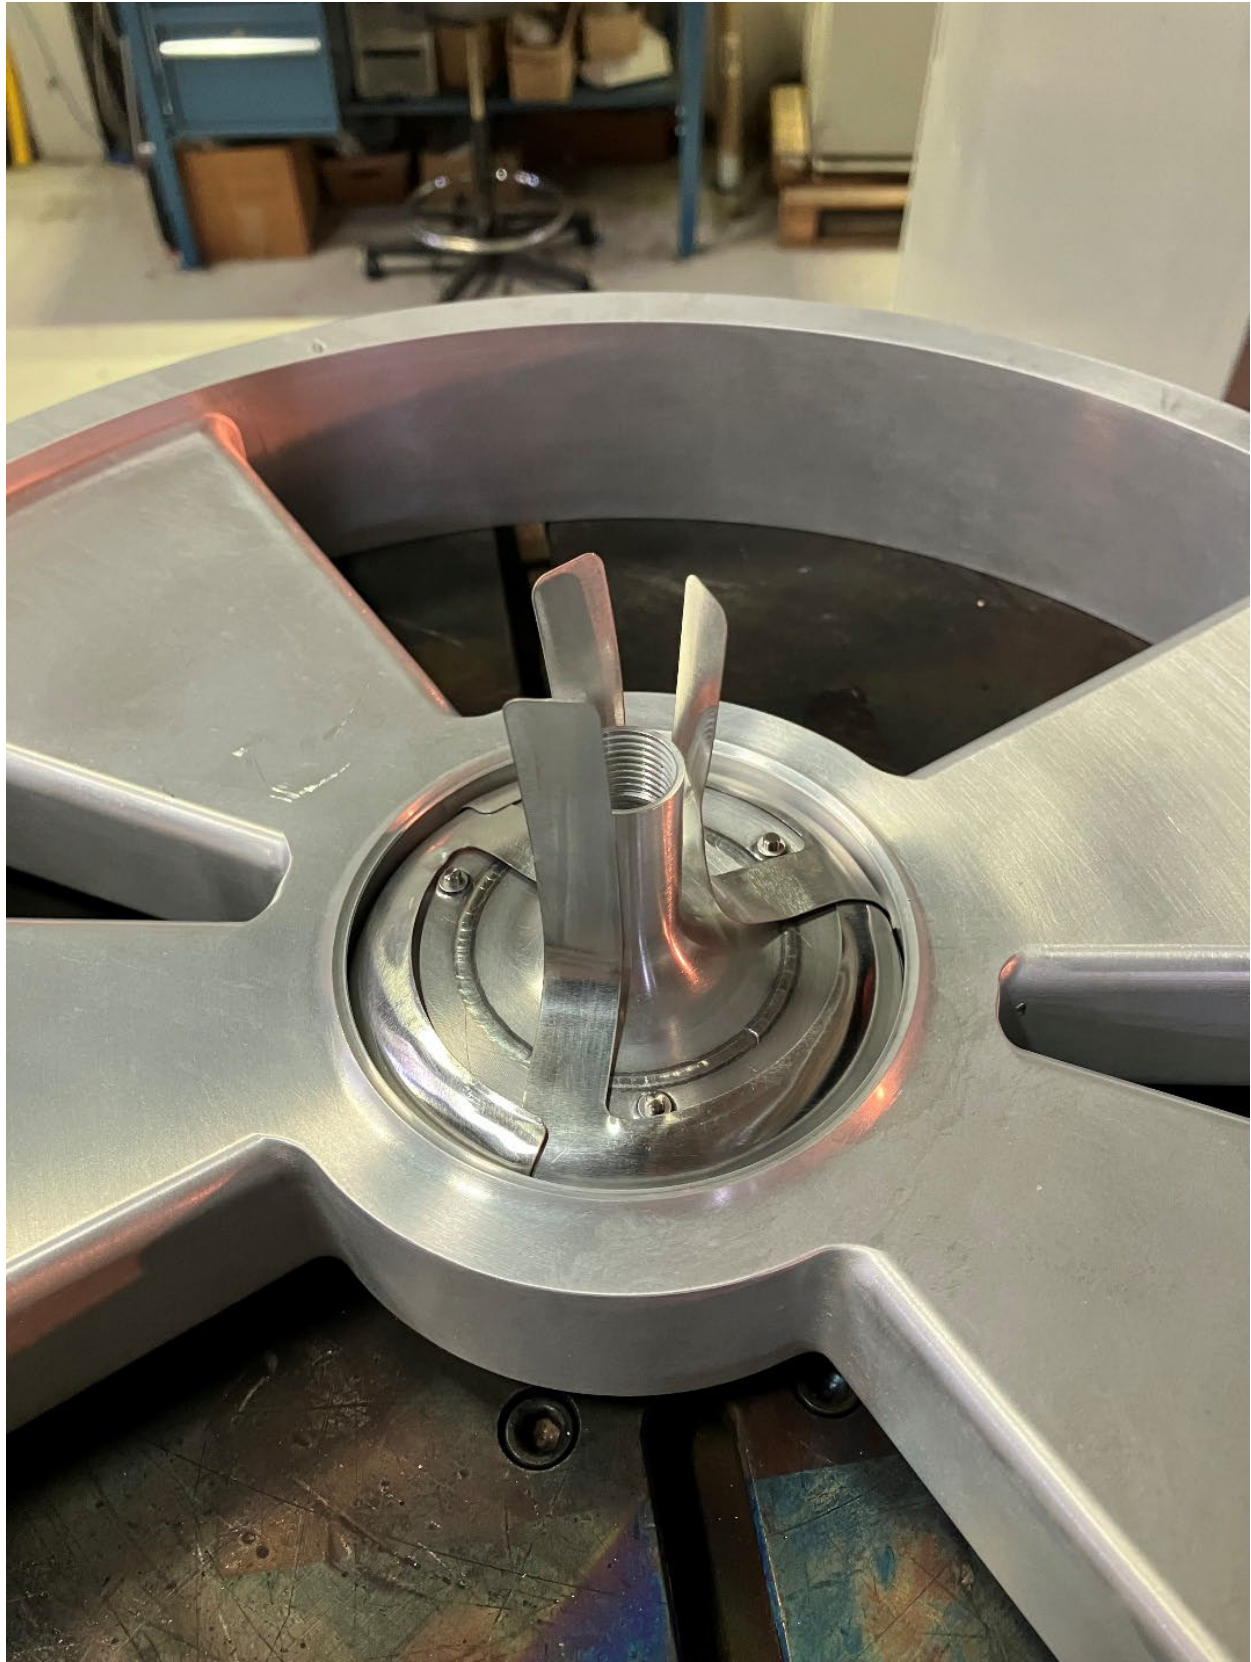
Hydrogen vessel with beam blocker shims installed into vacuum vessel body.

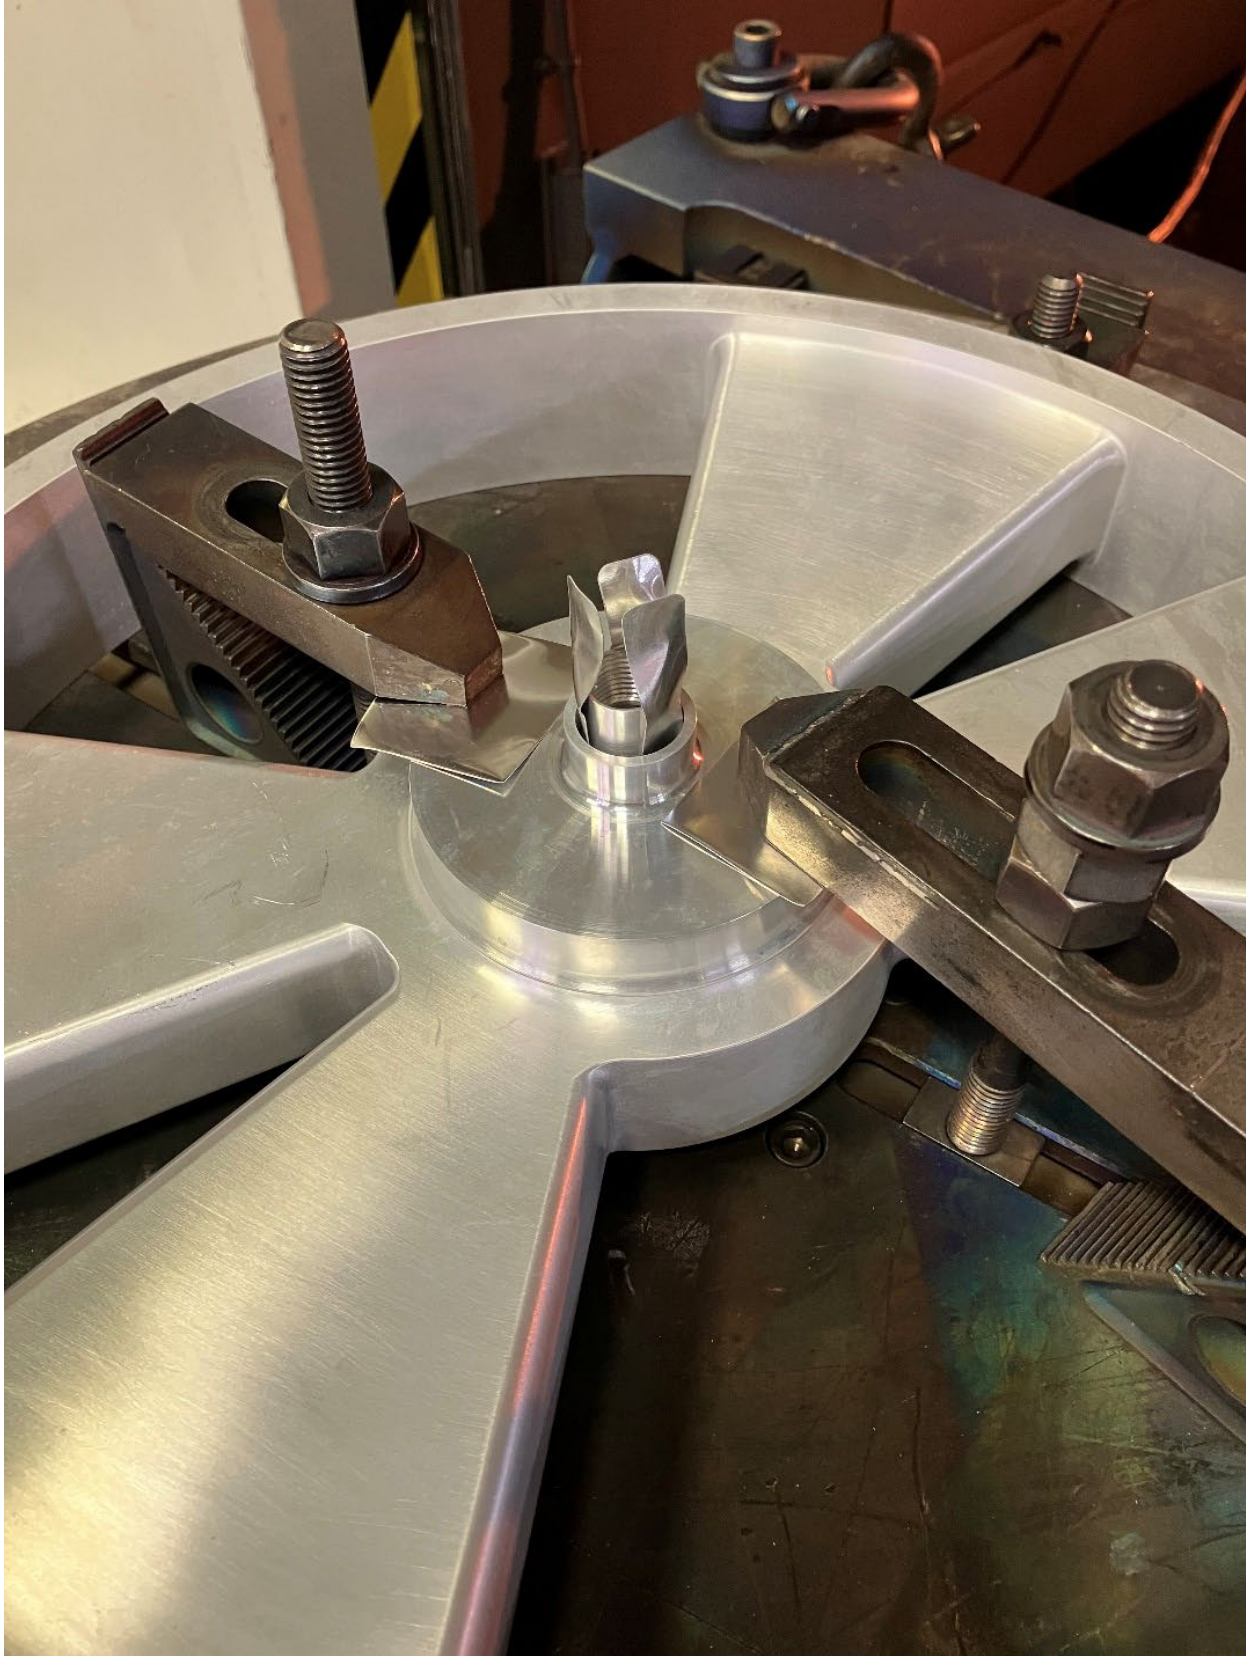
EB welding was performed using an existing CNC rotary table with a tilt axis. The vacuum vessel lid was clamped to the body during tack welding to ensure proper fit up for the full penetration pass. The clamps were removed after tacking was complete to allow for continuous welding of the full circumference. The full penetration weld was followed by a cosmetic pass which resulted in a smooth, even weld crown.

Vacuum vessel lid installed and clamped down for tacking.

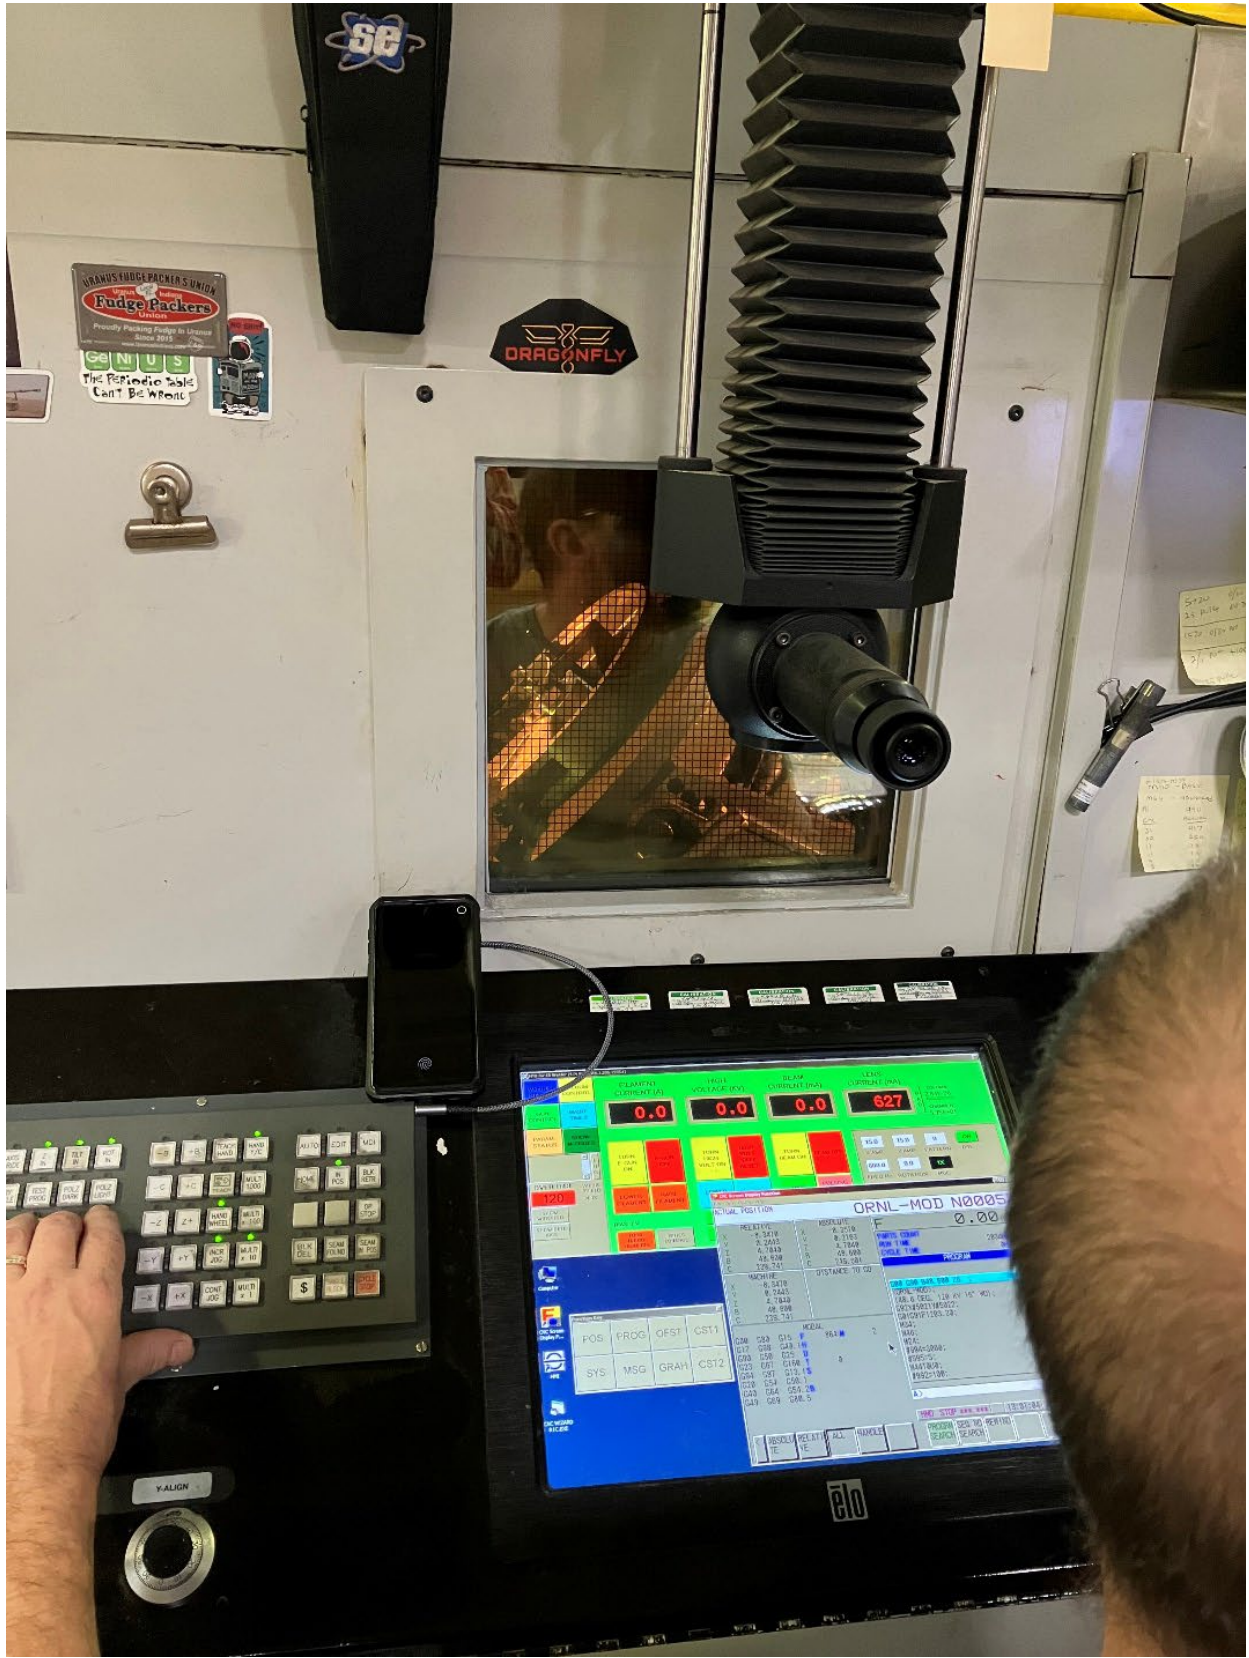
Vacuum vessel welding in the EB weld chamber.

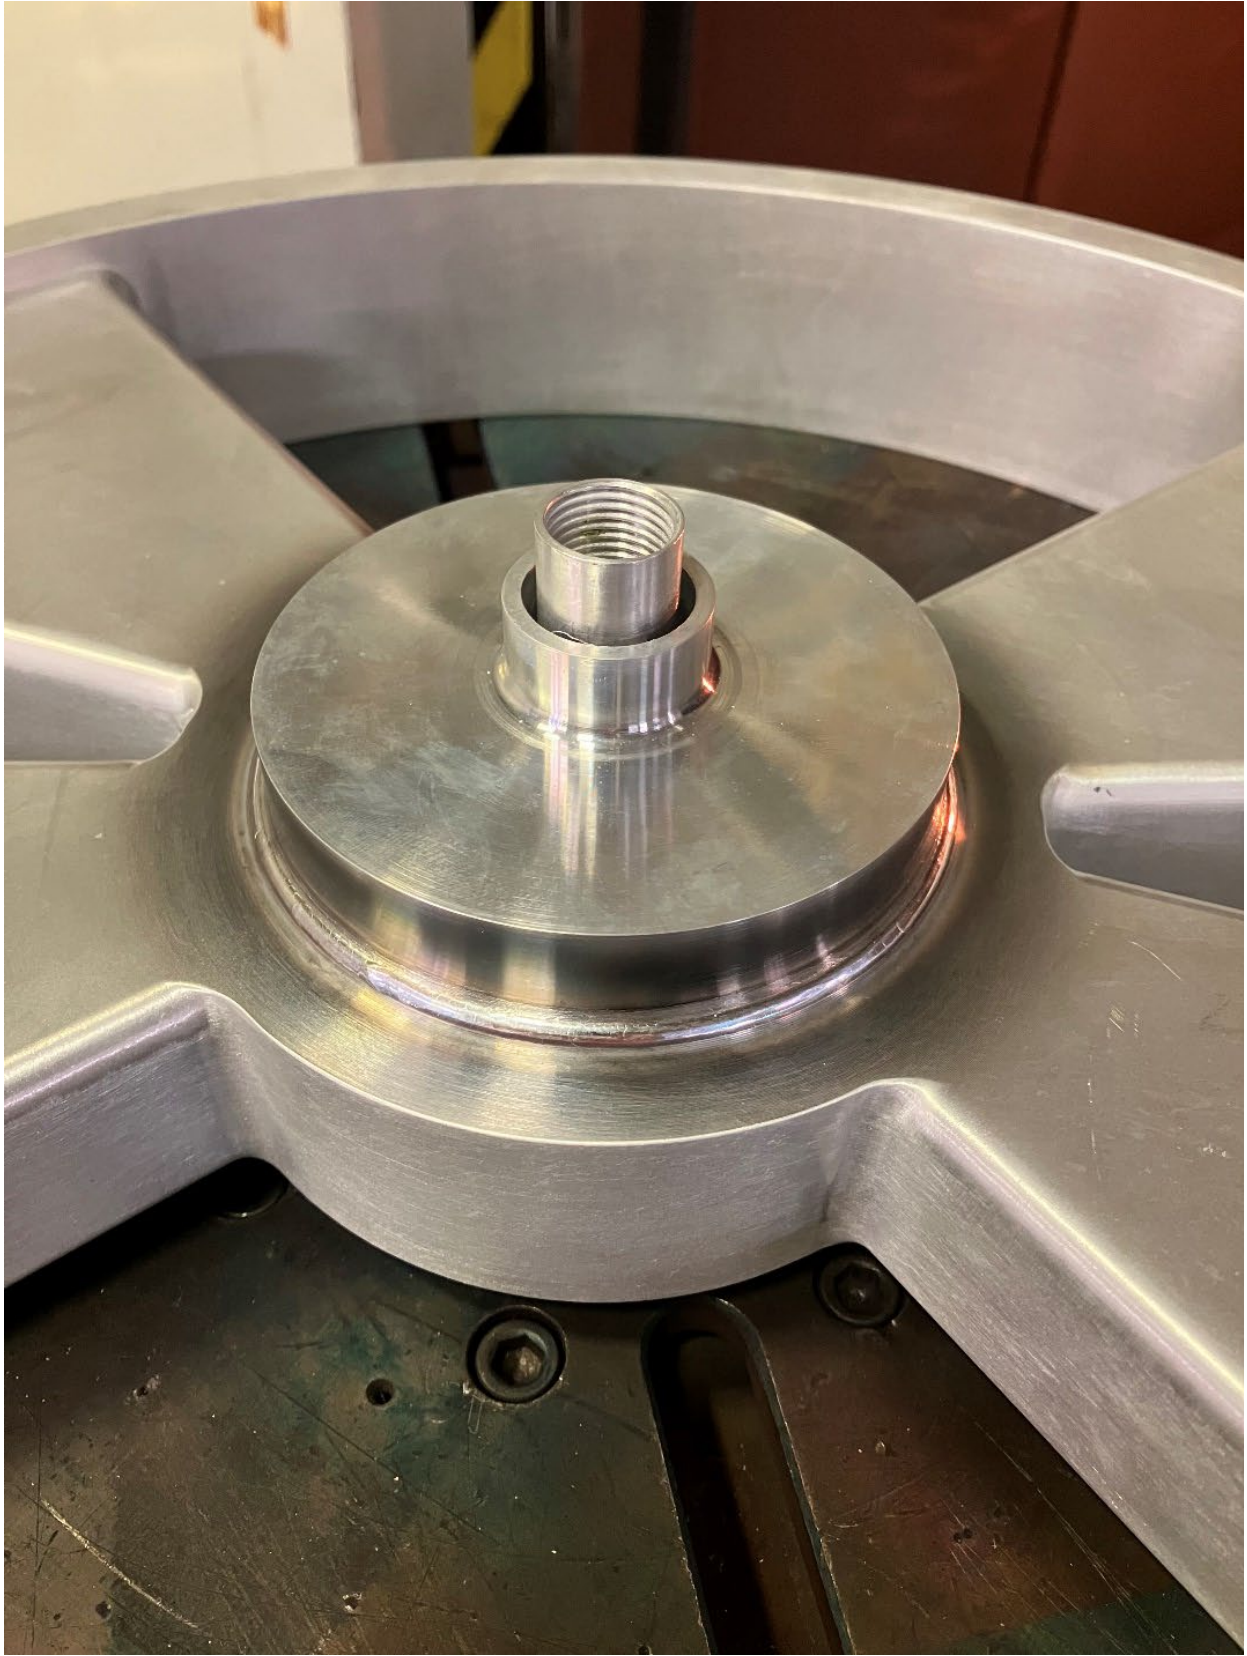
After welding, we attempted to carefully remove the weld shims; however, all 3 shims broke, trapping them between the hydrogen and vacuum vessels. Upon review of the photographs, it was discovered that the shims were incorrectly rotated, making removal more difficult than it needed to be. It was unclear whether the shims would be removable if the orientation was optimal, but we decided that for the second vessel we should perform welding without the shims.

Vacuum vessel weld completed and shims unsuccessfully removed (broken off at lip).

The second vessel was assembled with some difficulty and then successfully welded. Because this vessel does not contain trapped shims, it was chosen for final machining to complete the prototype. In the future, the alignment bosses should be adjusted so that the slotted side of the interface is on the part that will be lowered into place while the round side of the interface should be on the stationary part for minimizing assembly difficulty. The shims proved to be an unsuccessful solution for weld overpenetration. While there may be opportunity for making the shims successful, future moderator designs should feature a larger weld backer to remove the need for a shim.

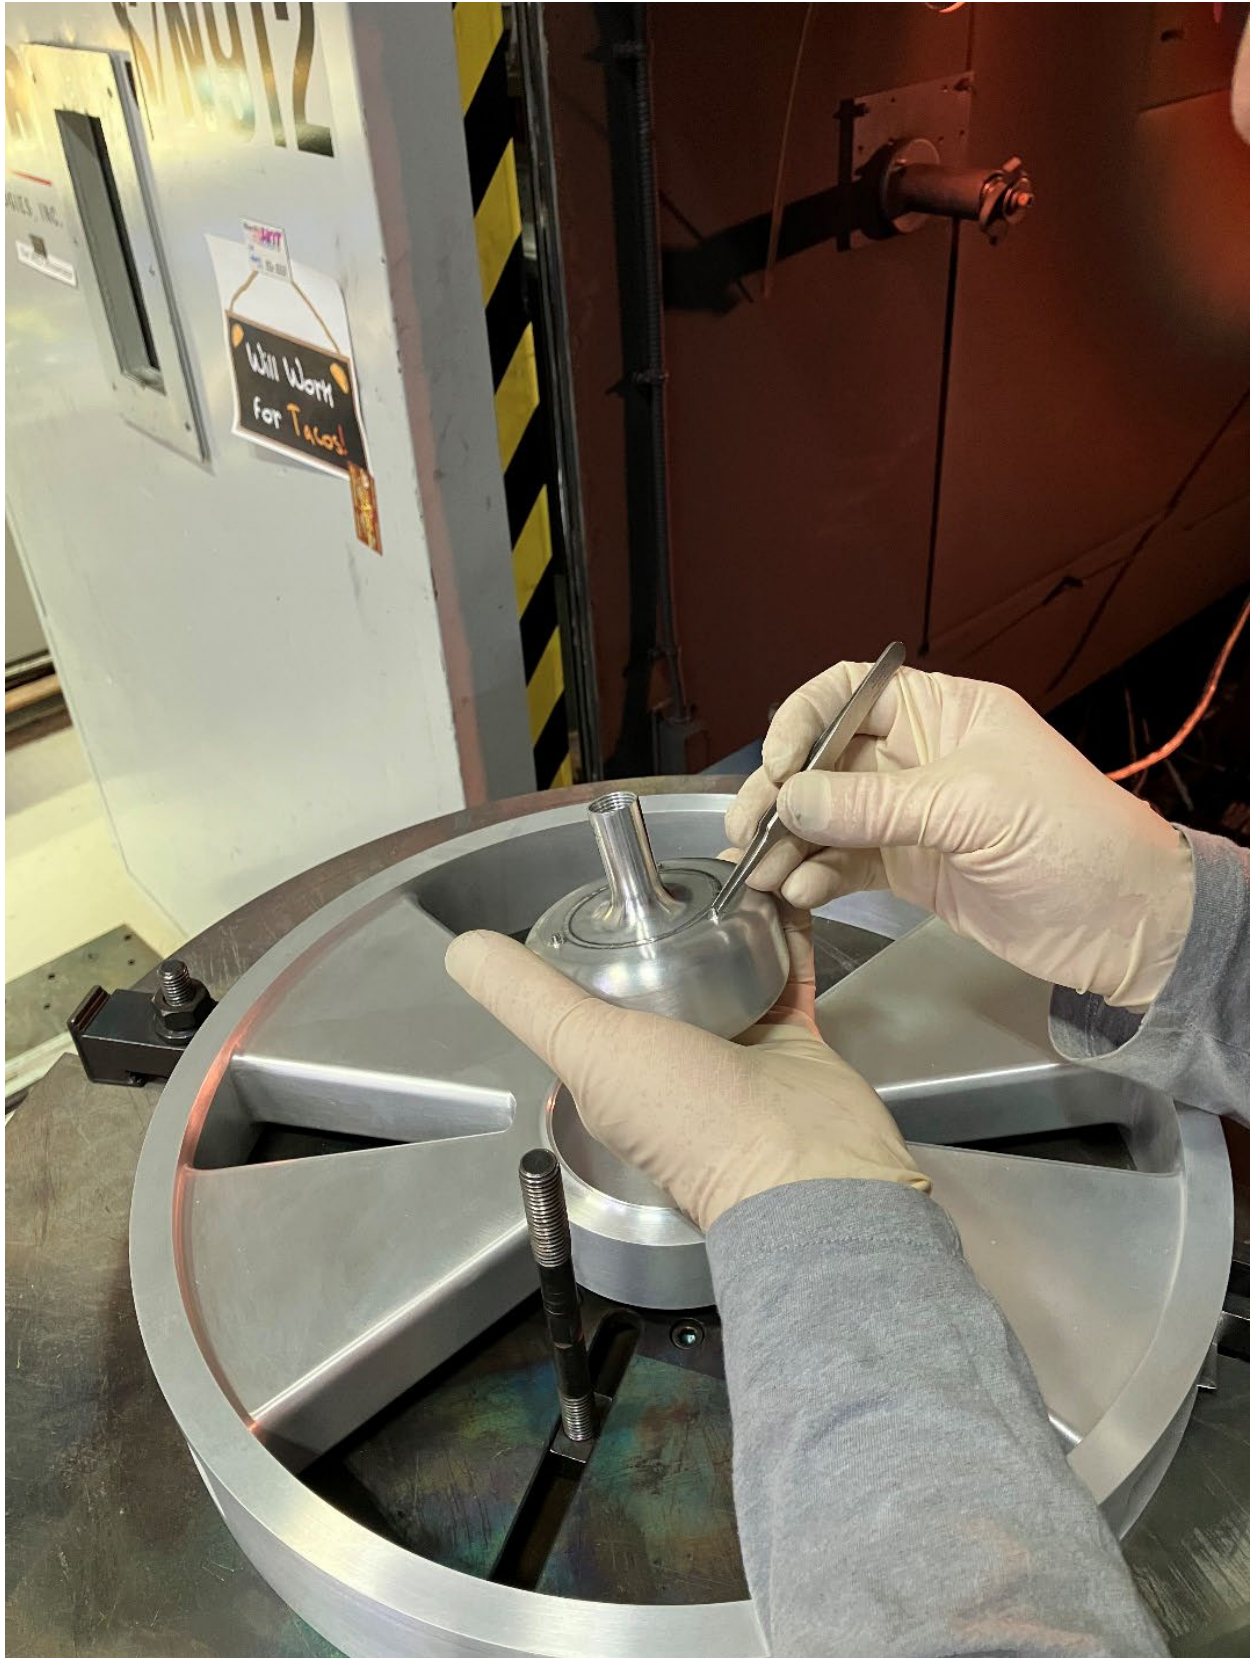
These shims were formed and installed prior to assembly of the first hydrogen vessel within the vacuum vessel. Assembly of the hydrogen vessel within the vacuum body was quite finicky. It was very difficult to get the titanium pins to engage correctly and to be certain of proper engagement, and multiple attempts were necessary. The vacuum vessel lid was also similarly finicky to install with difficult engagement of the pins. The beam blocker shims made the pin installation slightly more difficult by adding one more element to monitor during assembly, but the pin installation is challenging regardless.

Tedious installation of titanium spacers onto hydrogen vessel.

- The hydrogen and vacuum vessel alignment bosses should be adjusted so that the slotted side of the interface is on the part that will be lowered into place while the round side of the interface should be on the stationary part for minimizing assembly difficulty

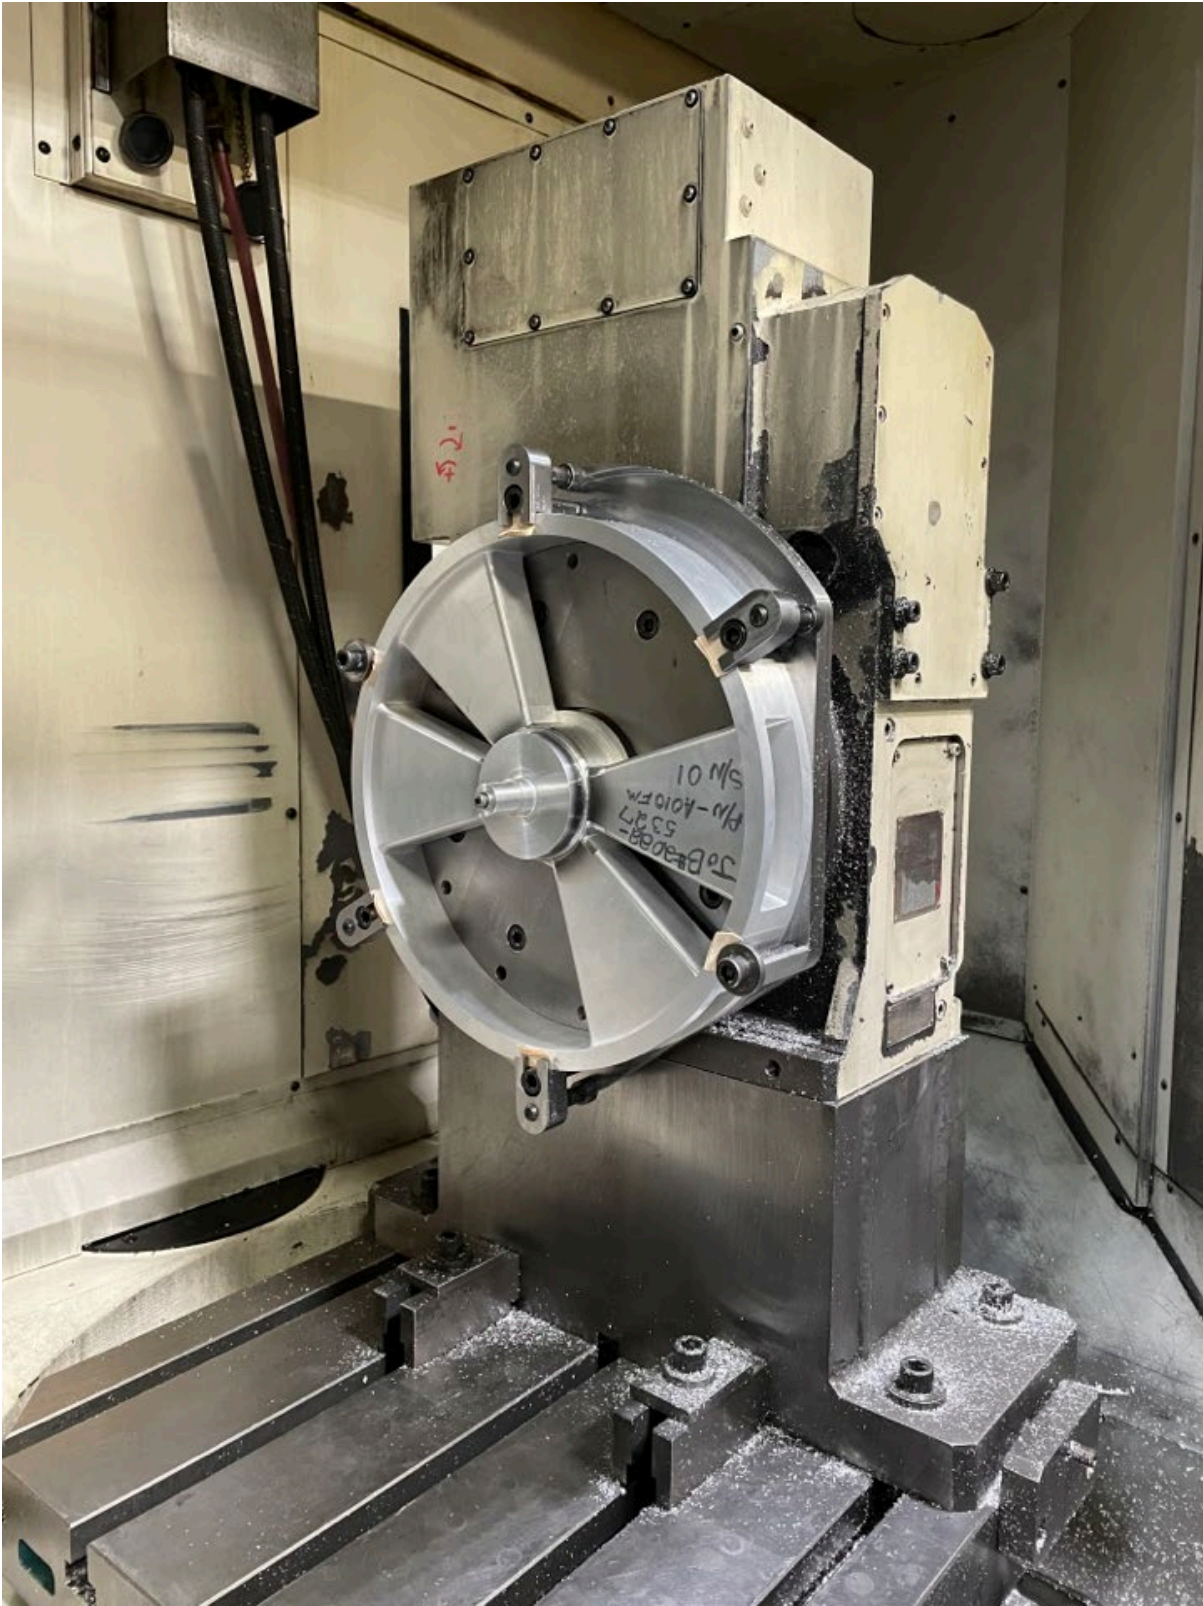
Vacuum vessel undergoing post weld machining at Metalex.

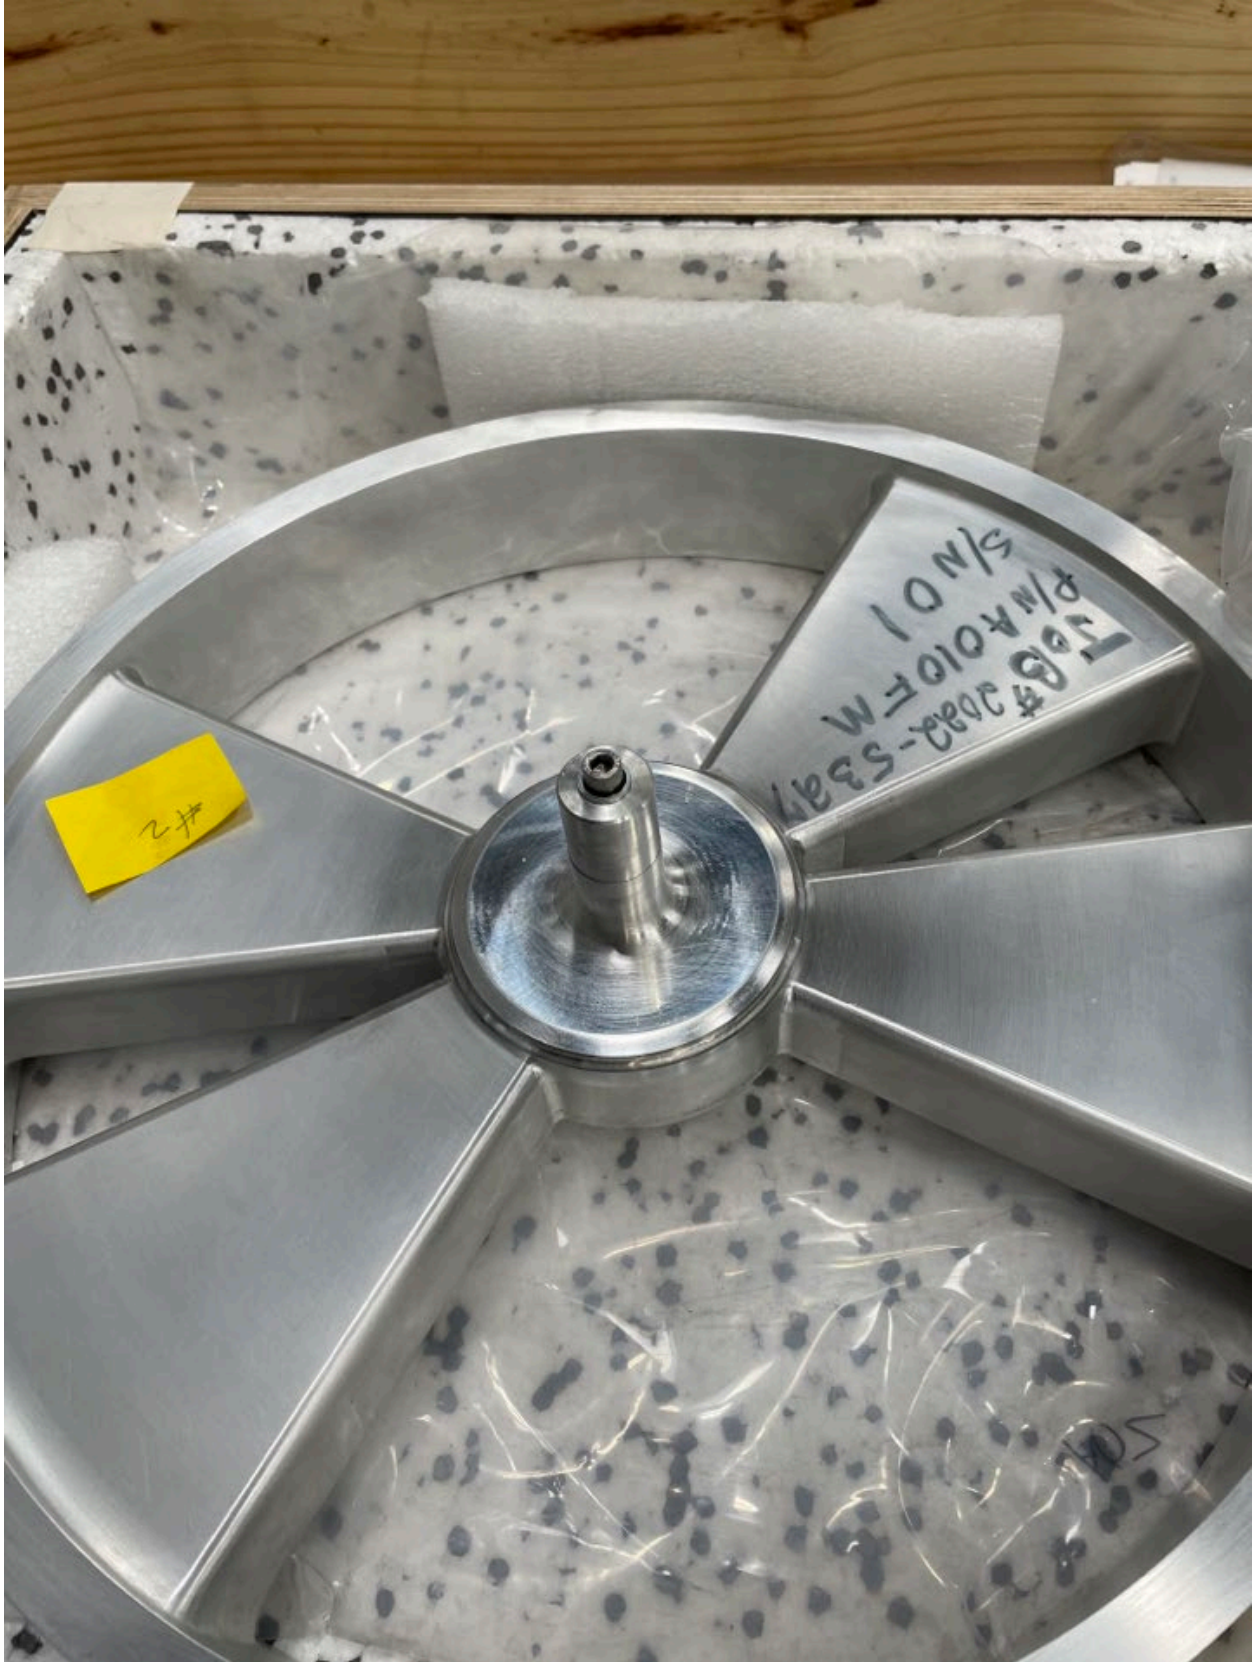
Vacuum vessel after post weld machining completed at Metalex.

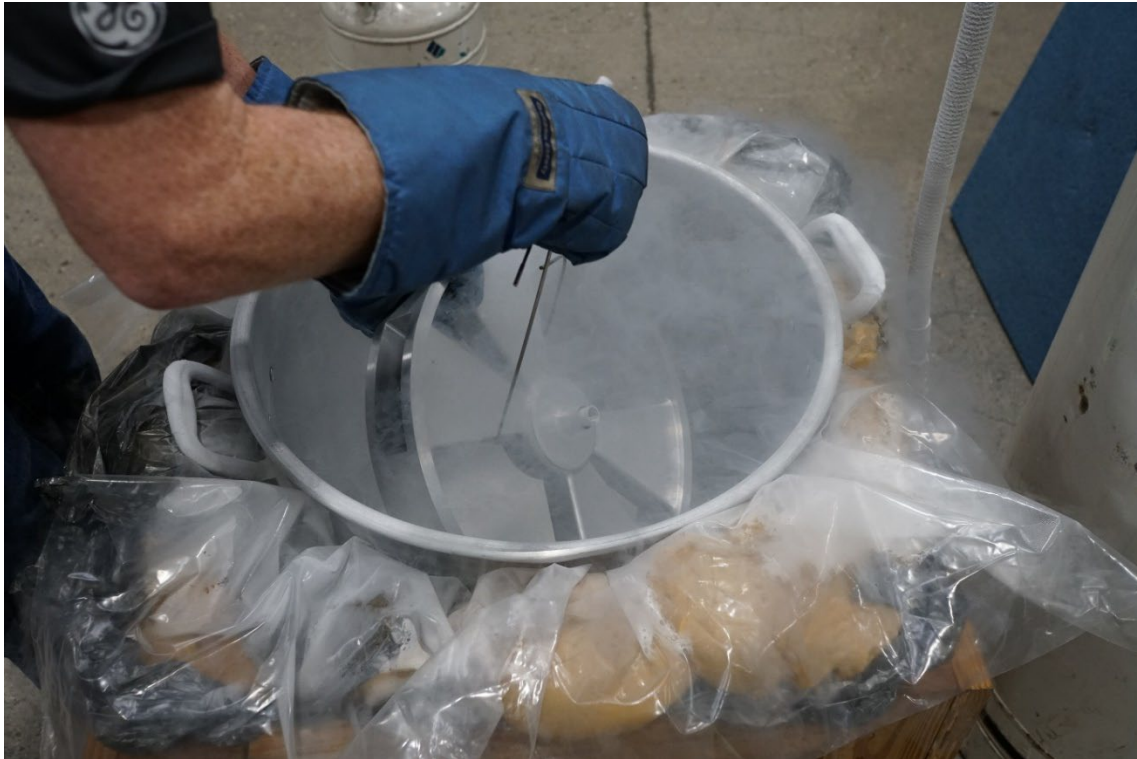
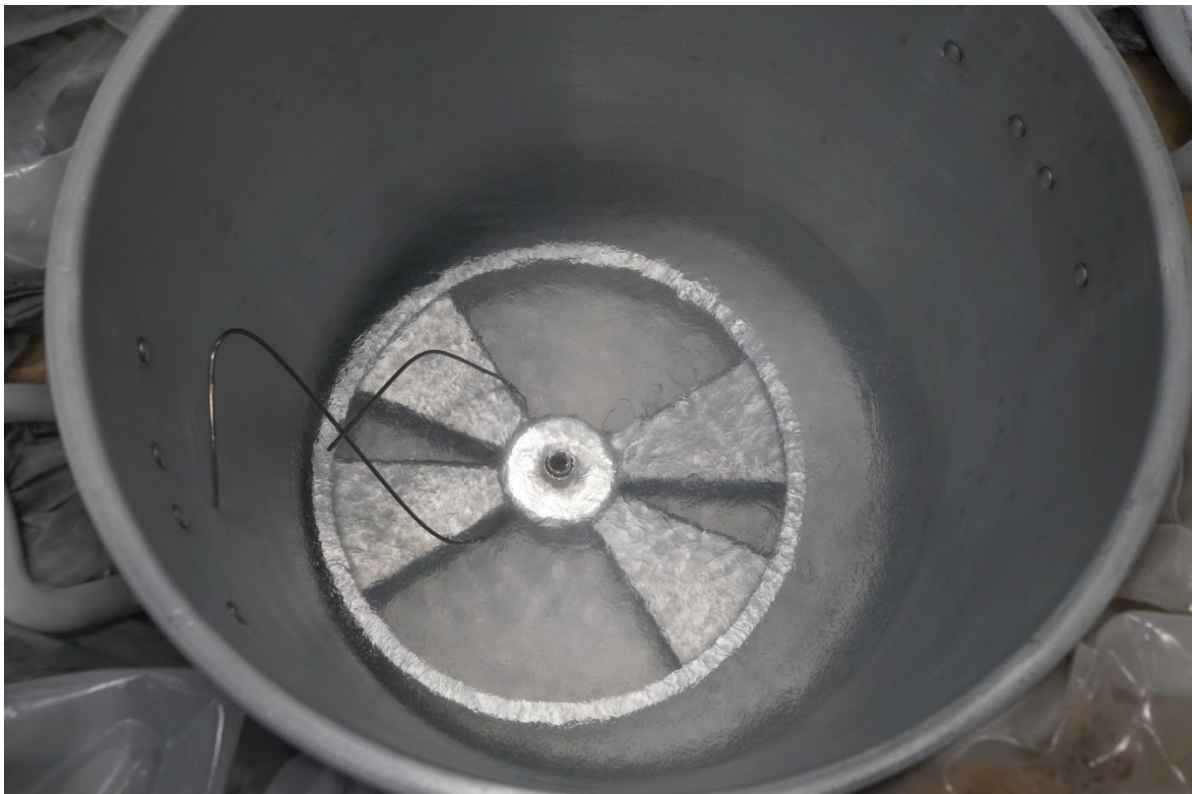
Cold shocking in LN2 at Metalex.

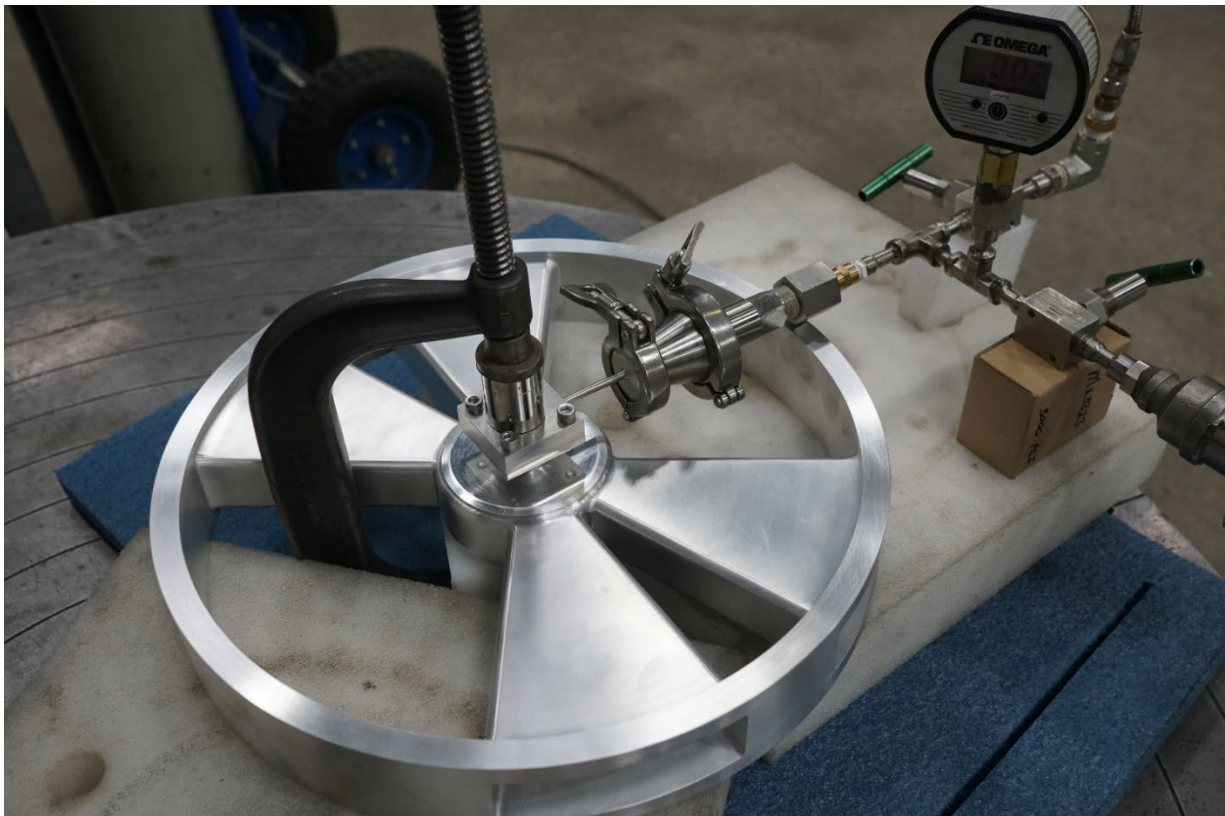
Vacuum vessel pressure testing set up.

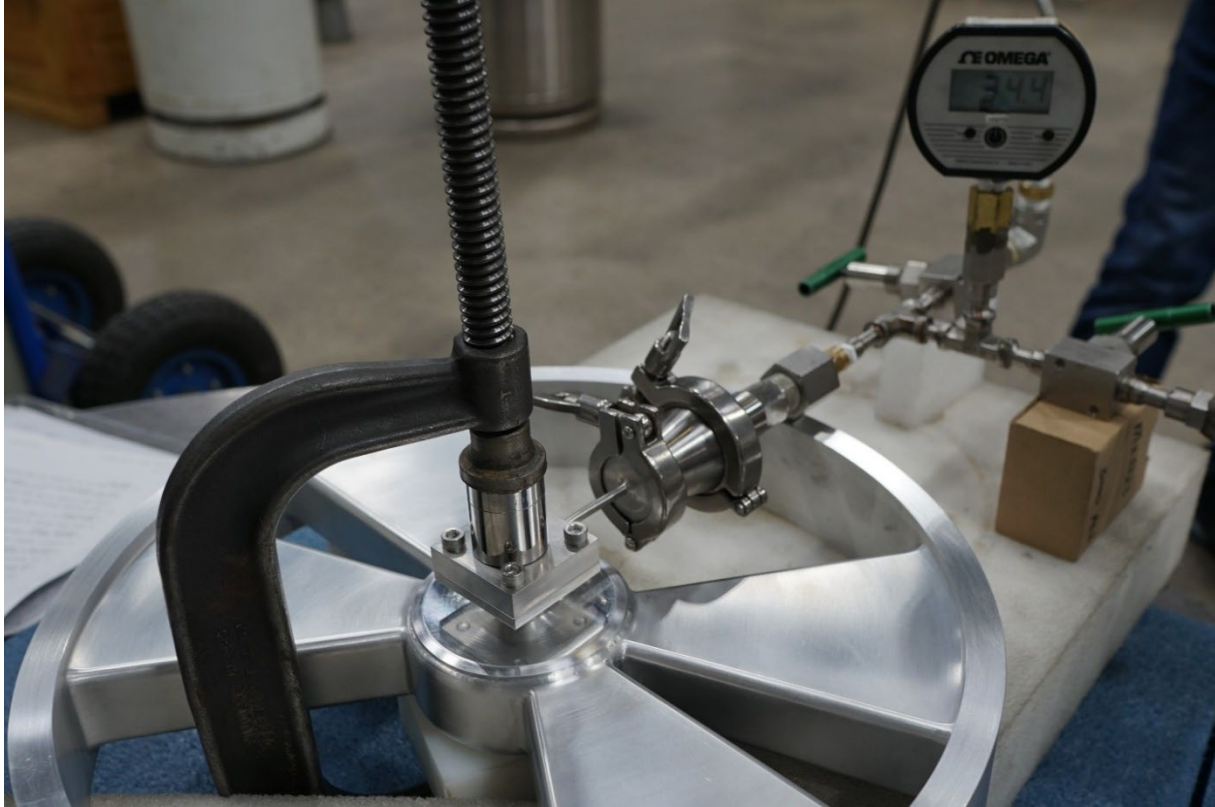
Vacuum vessel pressure test at test pressure.

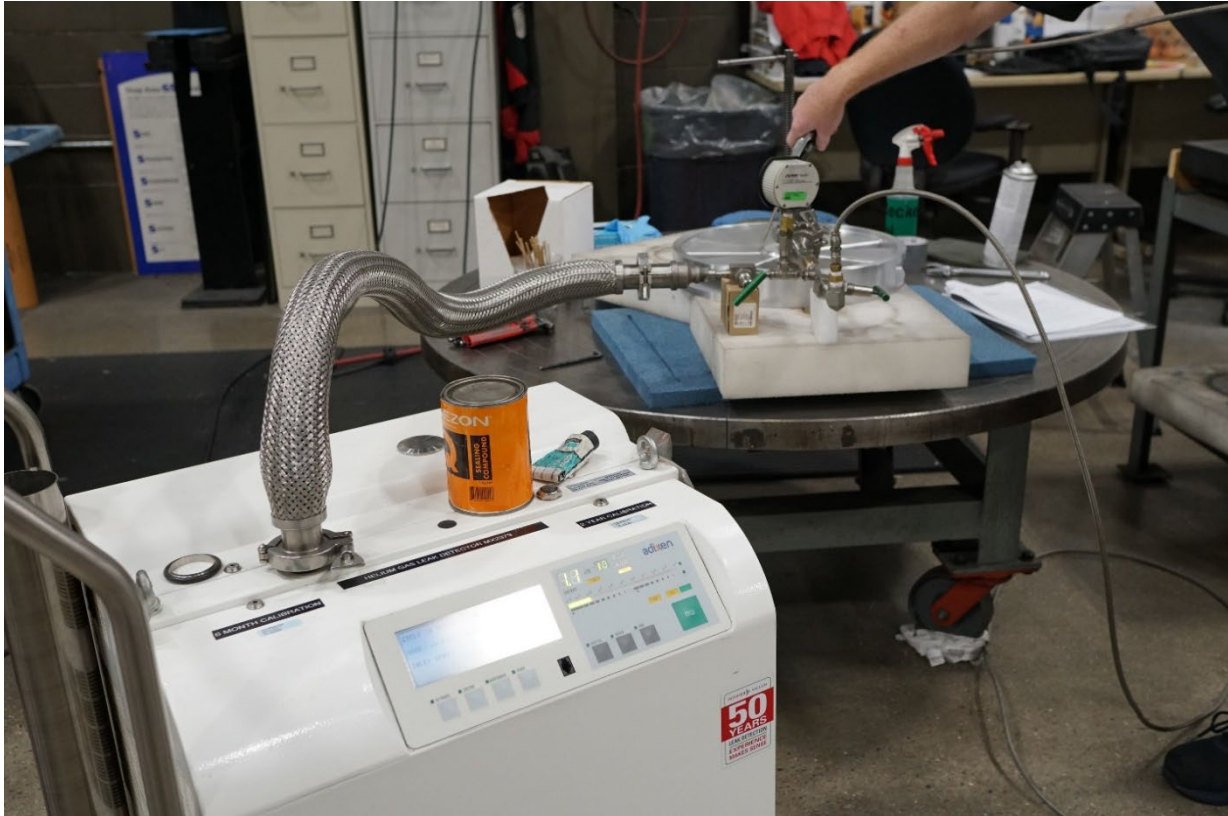
Vacuum vessel leak checking at Metalex.
