# Present status of JSNS mercury target

Katsuhiro Haga, Hiroyuki Kogawa, Takashi Wakui,  
**Takahsi Naoe**, Eiichi Wakai, Hiroshi Takada

J-PARC Center, JAEA

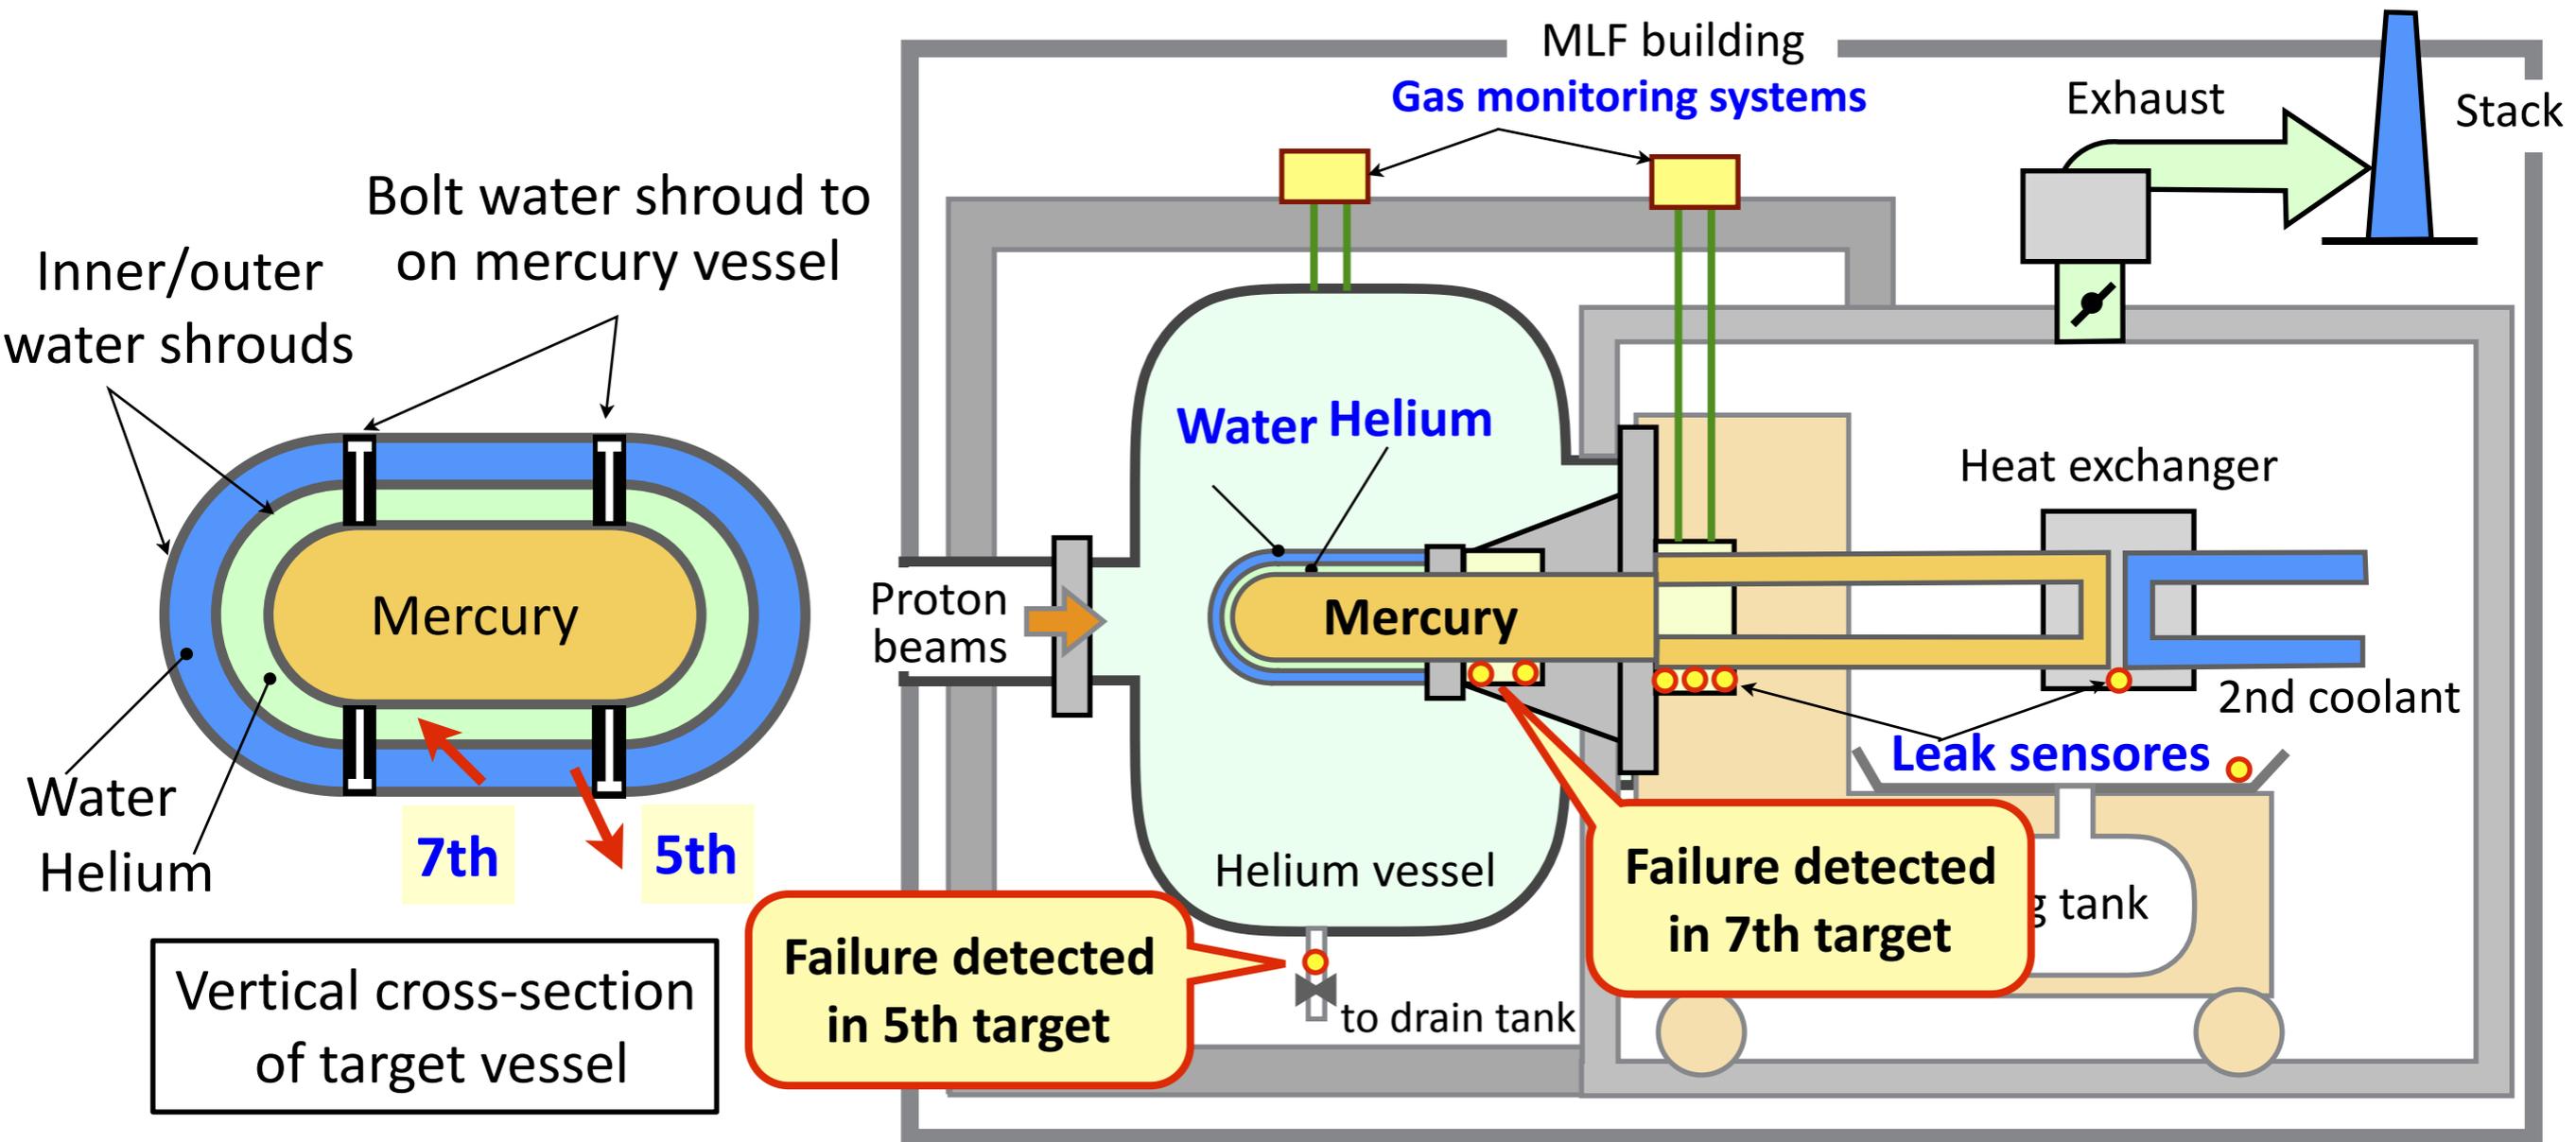
- 5th and 7th targets were failed due to water leak at water shroud
- Leak sensor at the drain tank of helium vessel was detected leak for 5th target  
Water leaked to outside of target vessel
- Leak sensor inside target vessel was detected leak for 7th target  
Water leaked to inside of target vessel

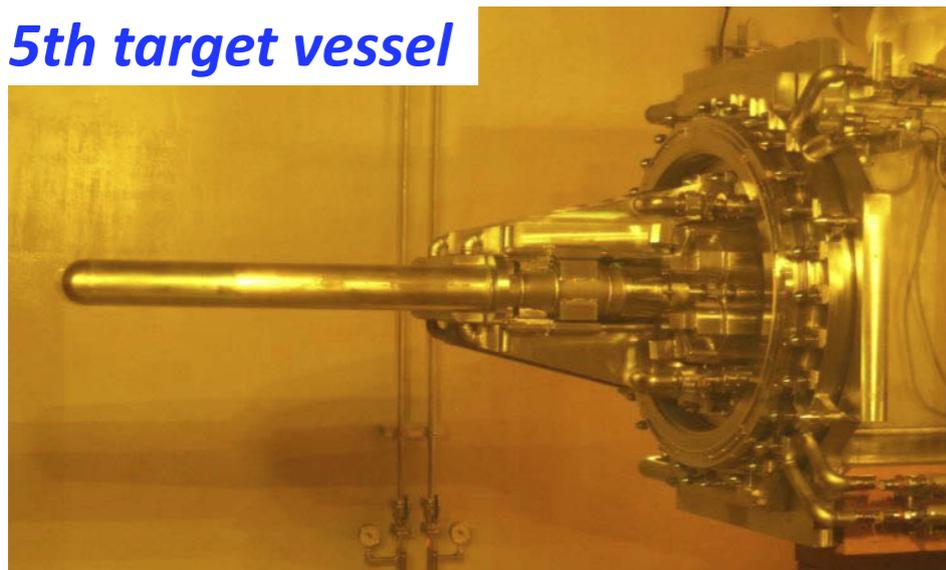
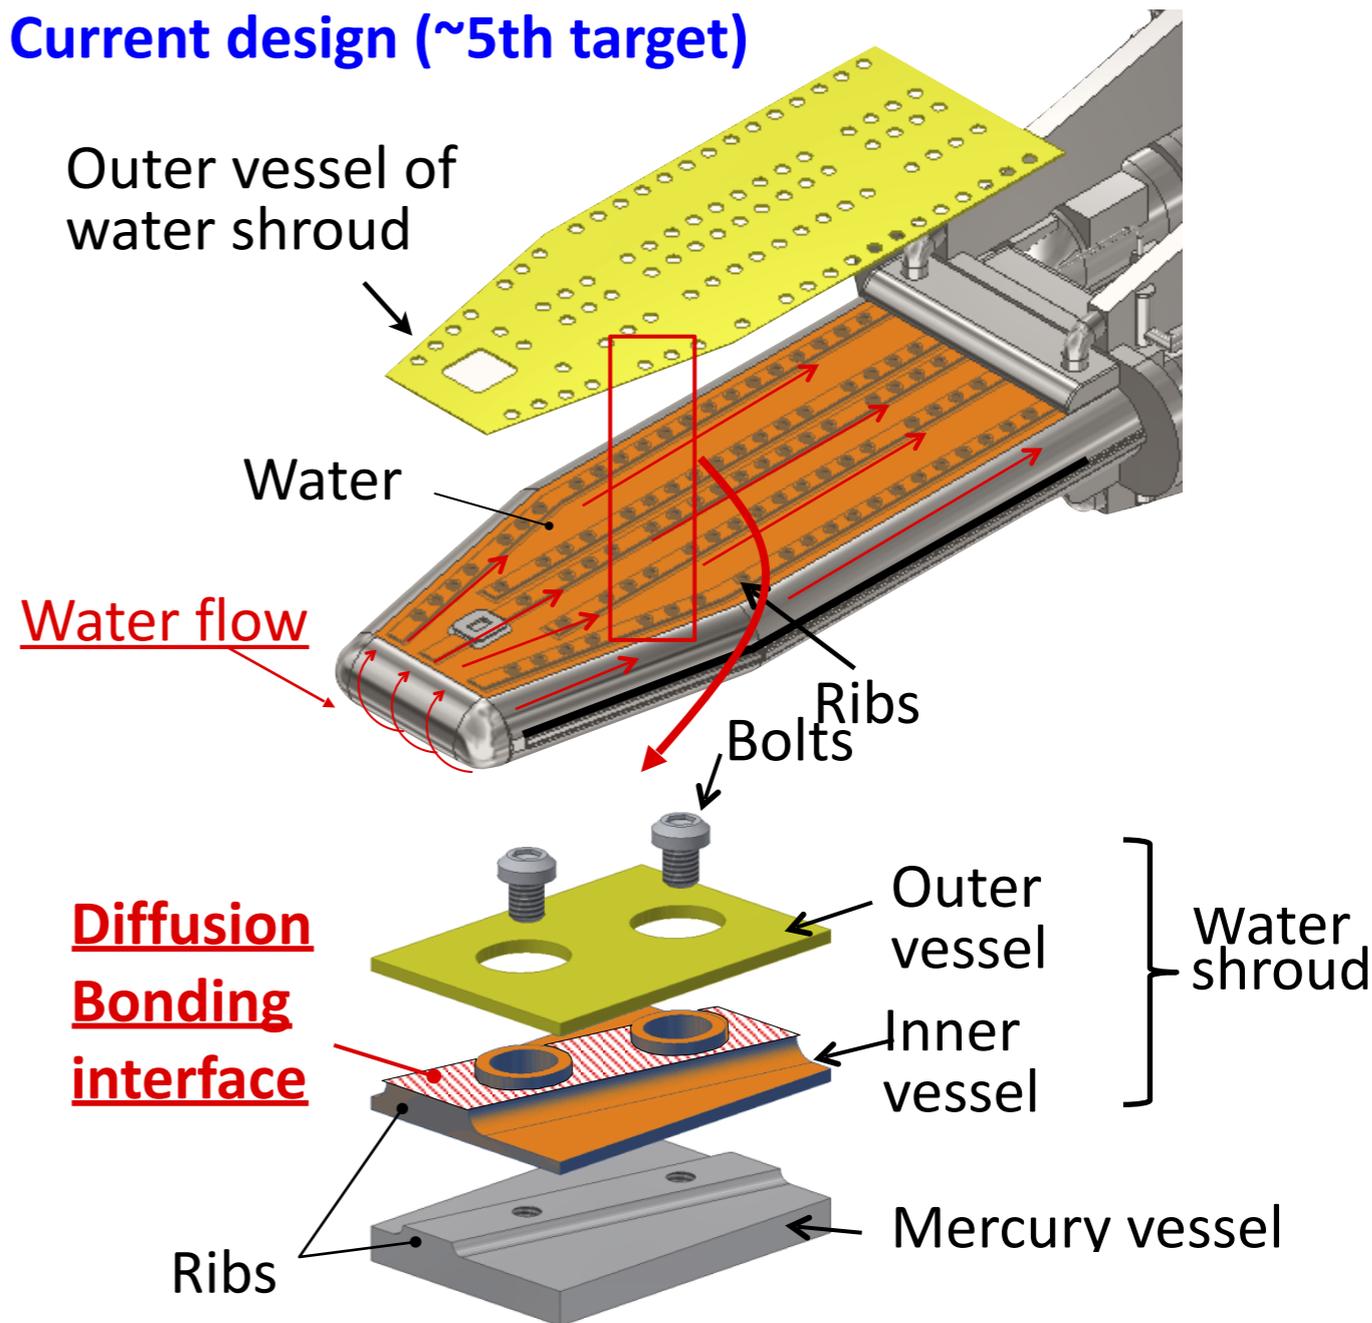
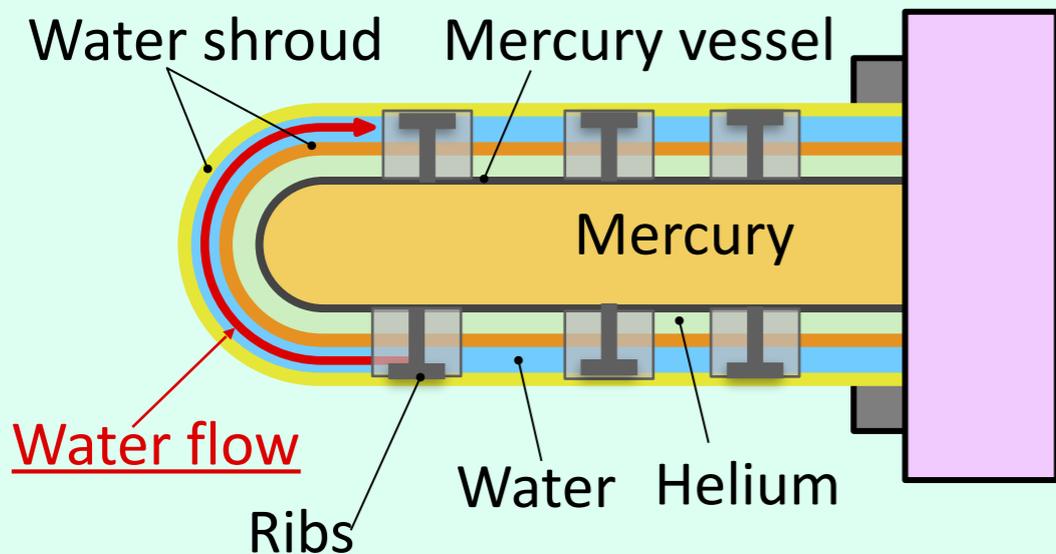
Current design (~5th target)

- Target vessel has triple walled structure (Inner/Outer water shroud, Mercury vessel)
- Outer and inner water shroud (diffusion bonded) was bolted to mercury vessel
- Bolt head and outer/inner shroud interface was welded by GTAW

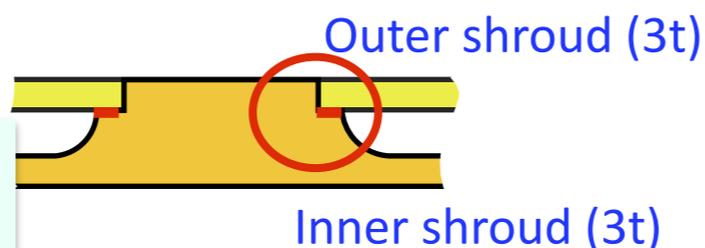
Diffusion bonding

**Ultrasonic inspection was passed**

**Diffusion bonded interface was detached by thermal deformation**

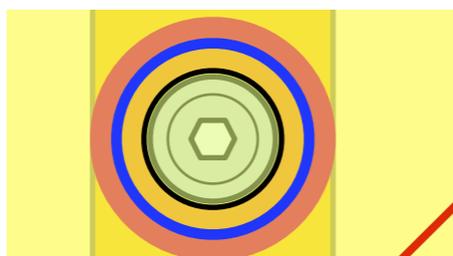
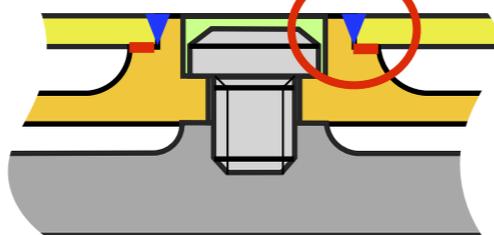
Seal welding w/o groove to ensure airtightness in water shroud

**Leak tightness test was passed**

**Seal welding of thin penetration depth (<1.5 mm) was failed by repeated thermal stress**

- Crack propagated through the seal welded part between inner and outer shroud
- Total number of thermal cycles due to beam trip for 5th target is ca. 2500
- Structural design, that allowed the seal welding without groove, was attributed to the water leak

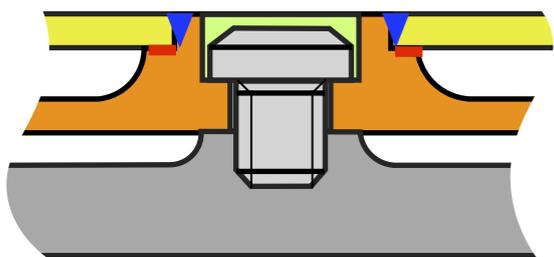
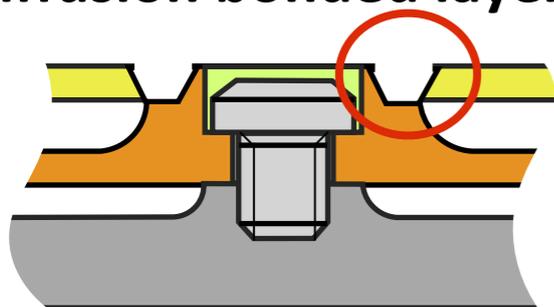
- Spare target (7th target) which is the same design with 5th target was repaired to eliminate seal welding without groove
- 167 portion of around bolts were repaired and beam operation with repaired 7th target was started from Oct. 2015
- **7th target was failed two weeks after restarting operation at 500 kW**

## Remove seal welding and diffusion bonded layer

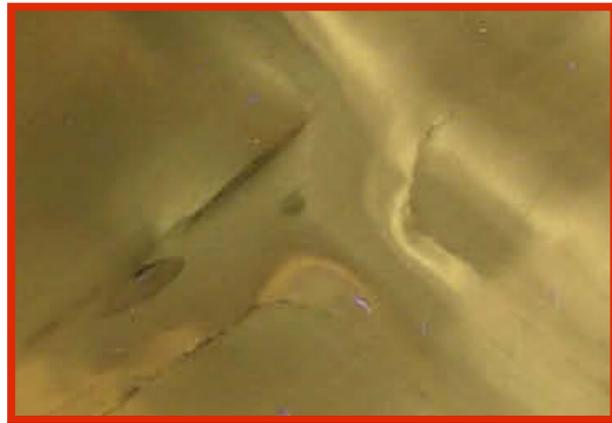
Triple point of welding

***No-visible change was found from outside inspection***

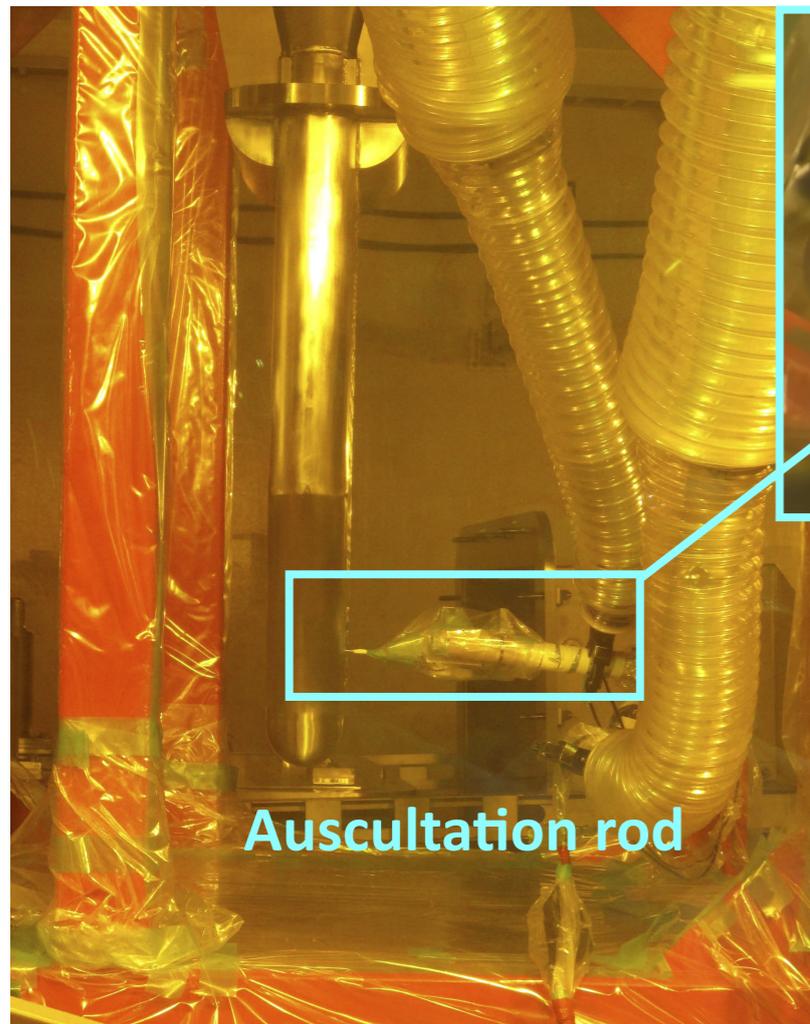
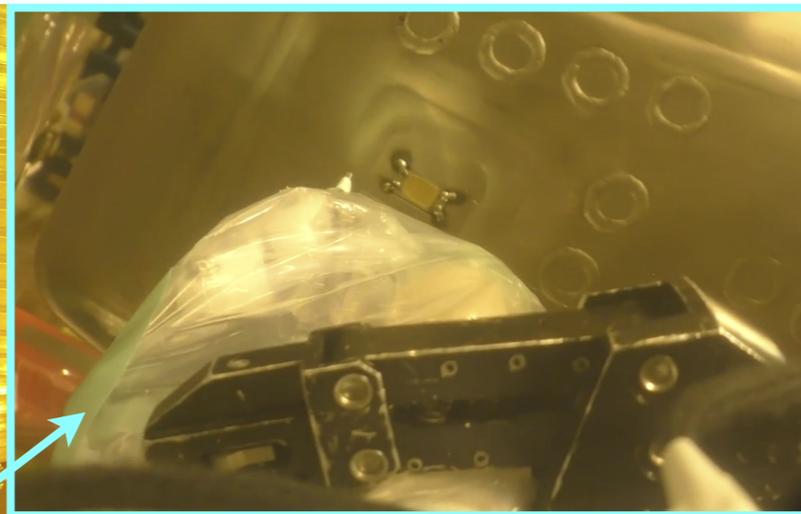
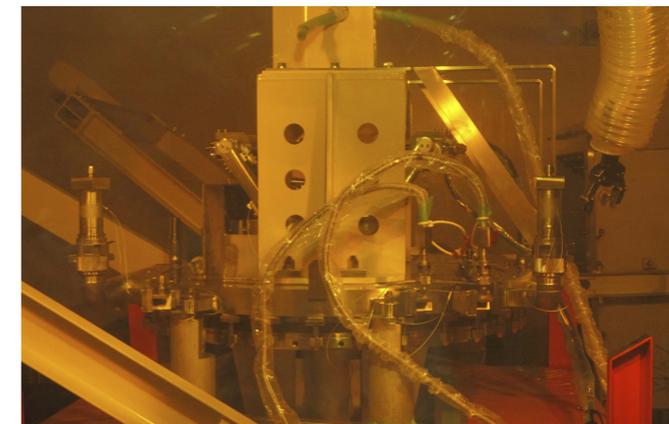
Auscultation rod

- Prepared microphones to detect the sound of gas ejecting from inner water shroud
- However, passage of gas between helium layer and water layer was closed when we tried to measure sound

***We retried sound measurement in this October, but still unclear the leak location***

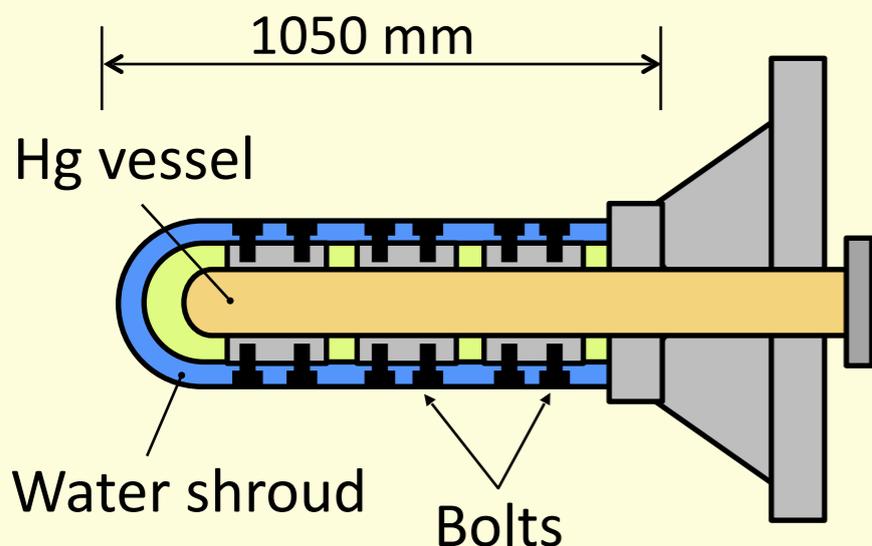
*Many welds incl. diffusion bonding with constraints between vessels*

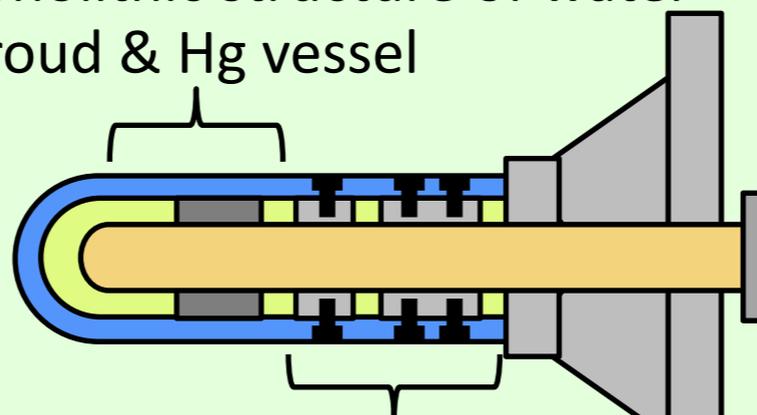
*Much fewer welds with constraints*

- Reducing welding parts as few as possible (reduced to 70%)
- Adopting fabrication processes which makes inspections of welding lines easier

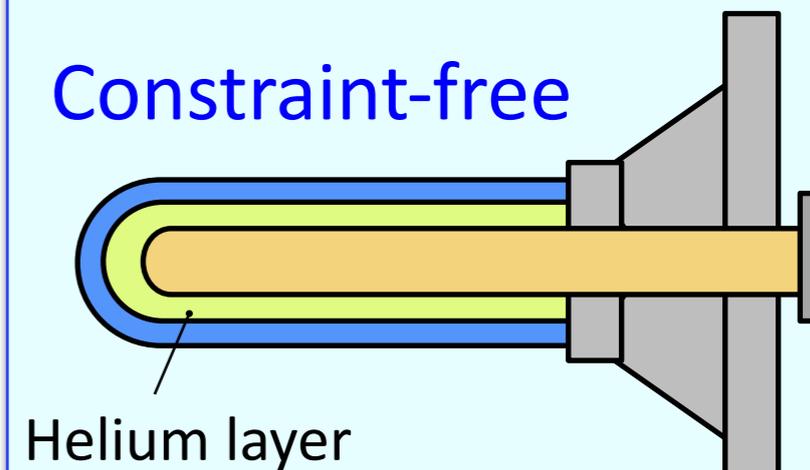
*Few welds with no constraints*

- Minimizing the constraints between water shroud and mercury vessel to reduce thermal stress

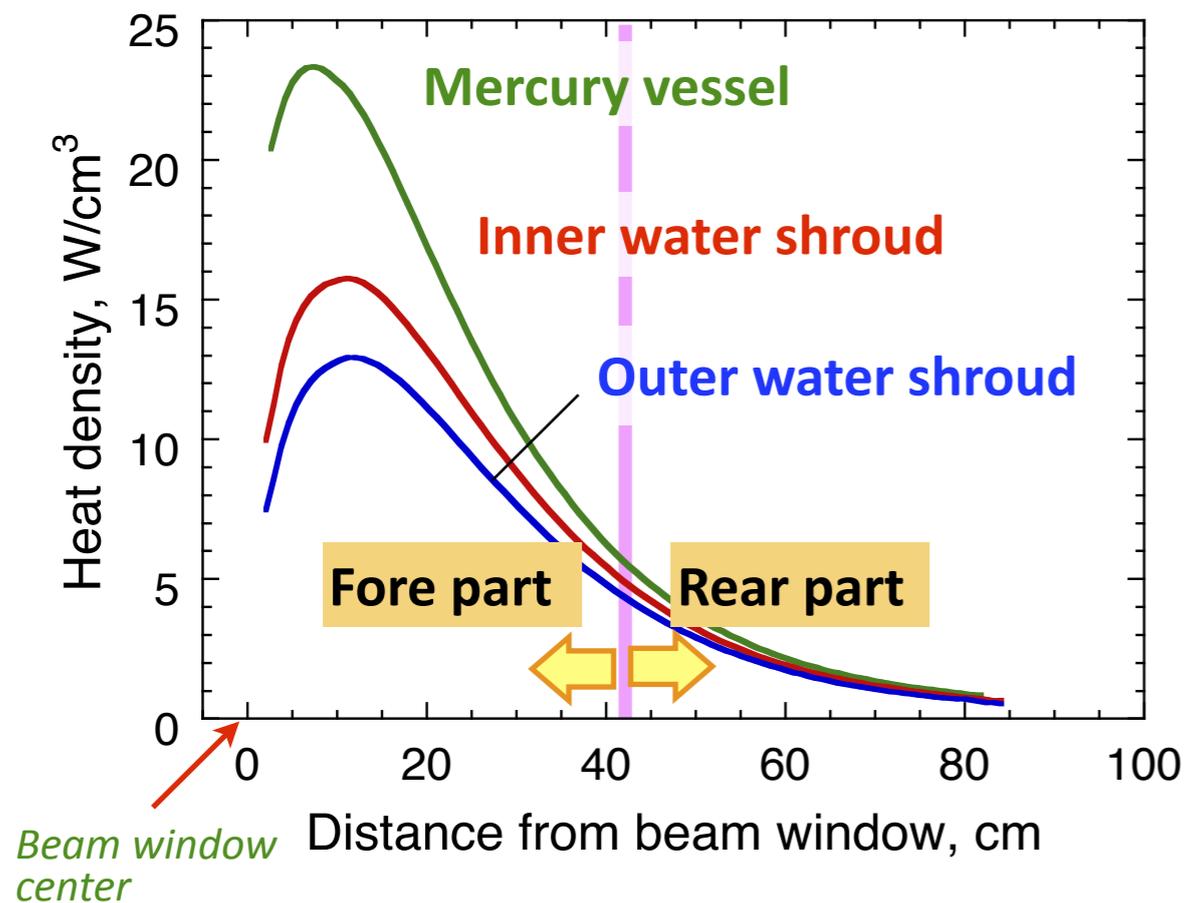
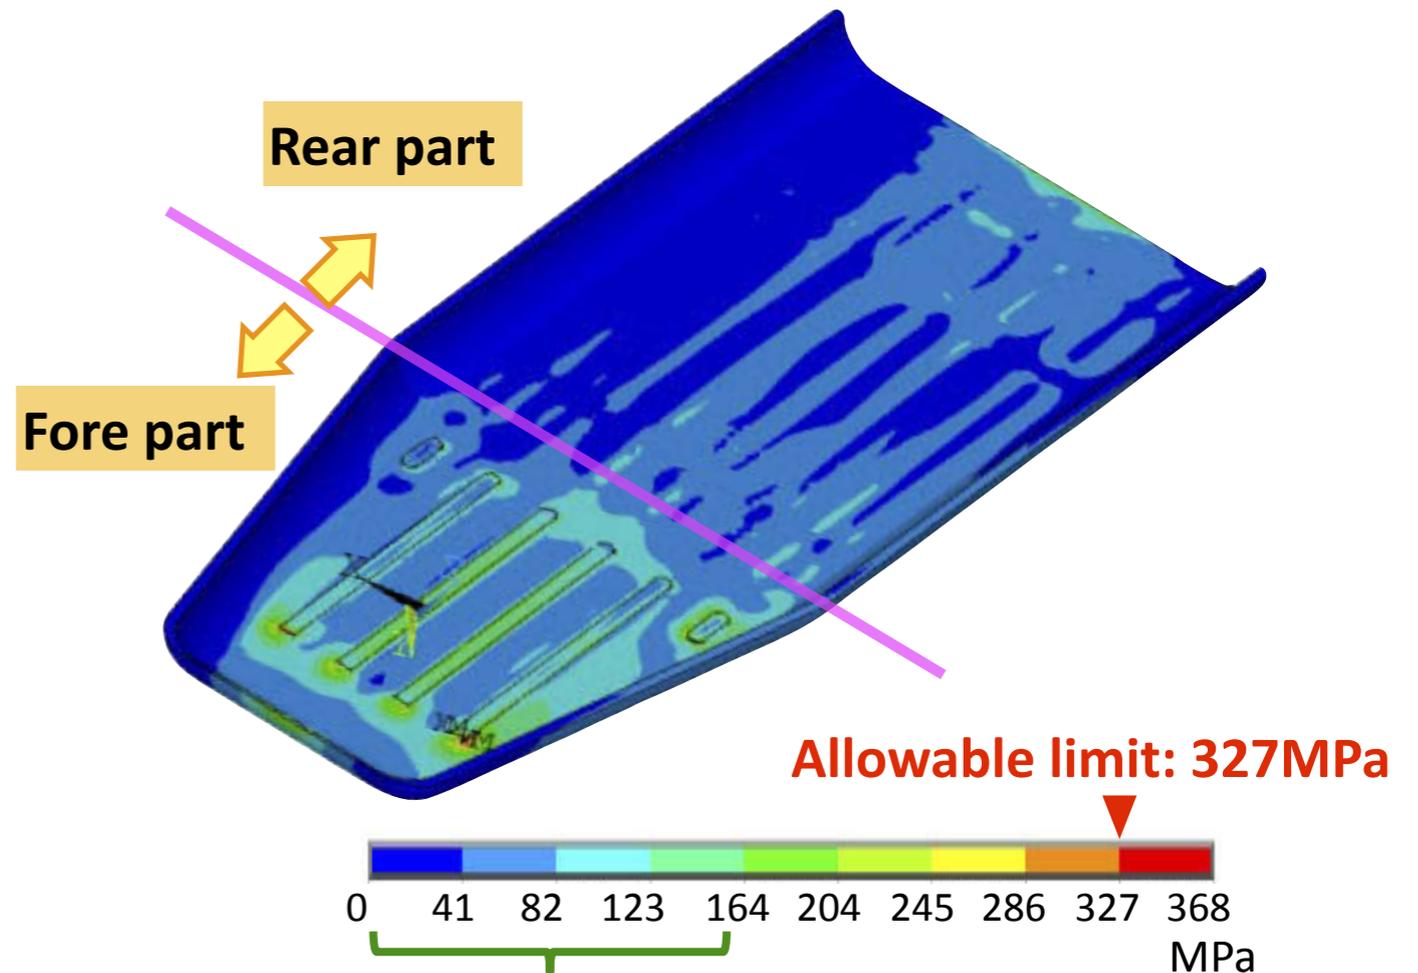
- Heat density in rear part is less than 1/4 of fore part
- Thermal stress is less than half of allowable stress

**Bolt structure in rear part is enough to withstand thermal stress at 1 MW**

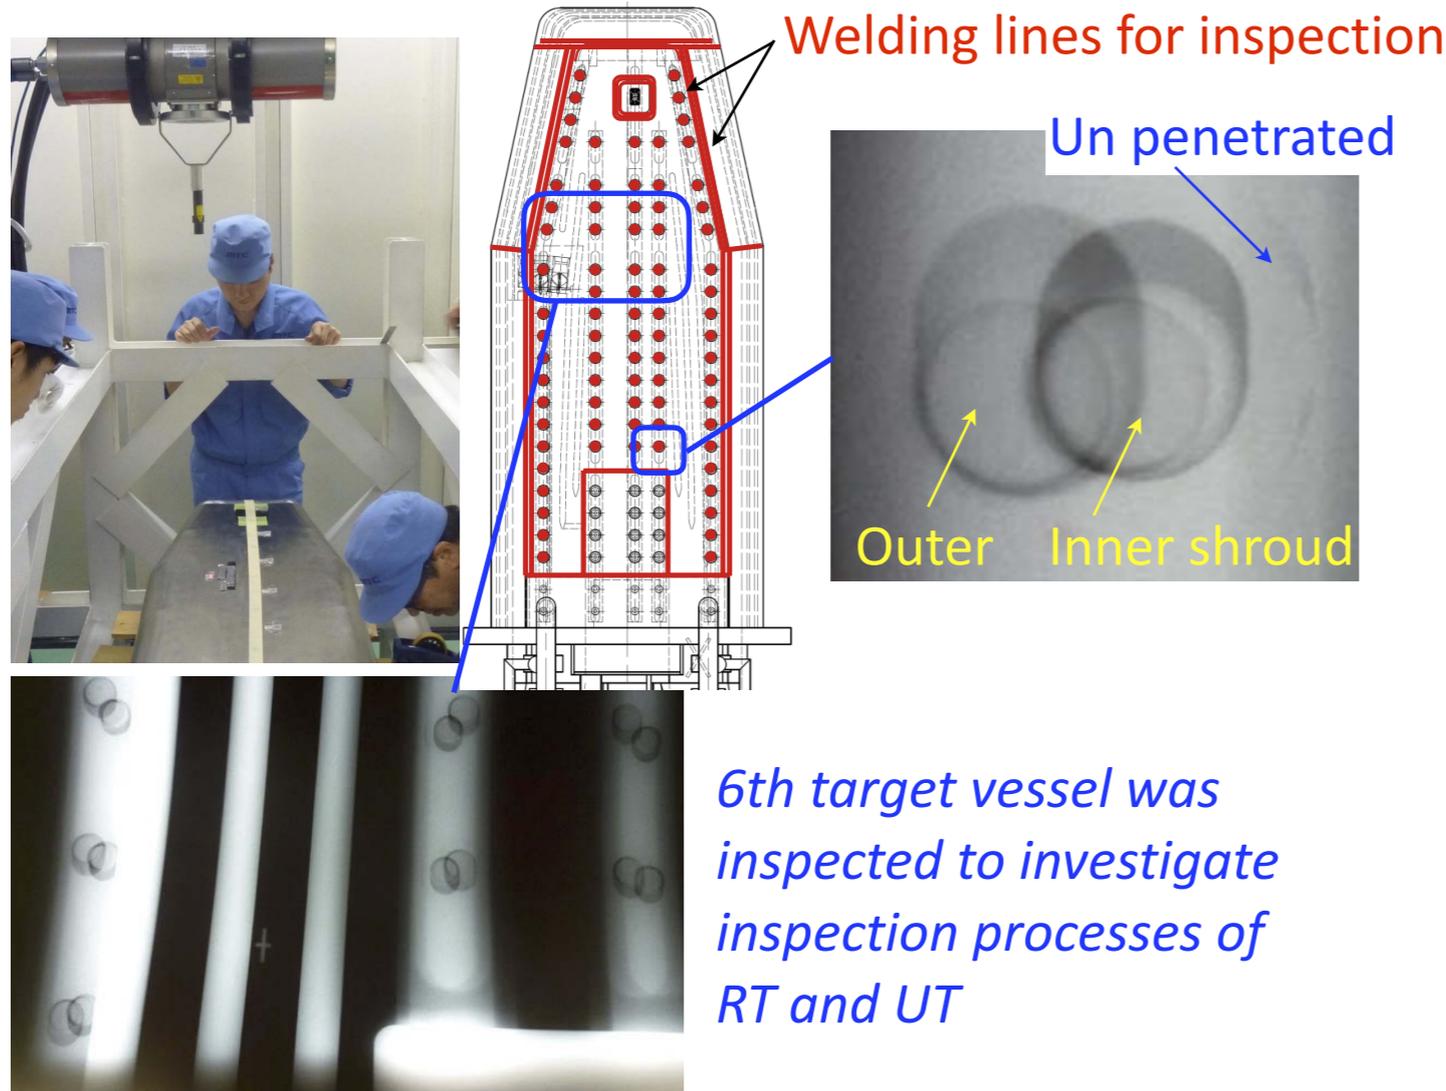
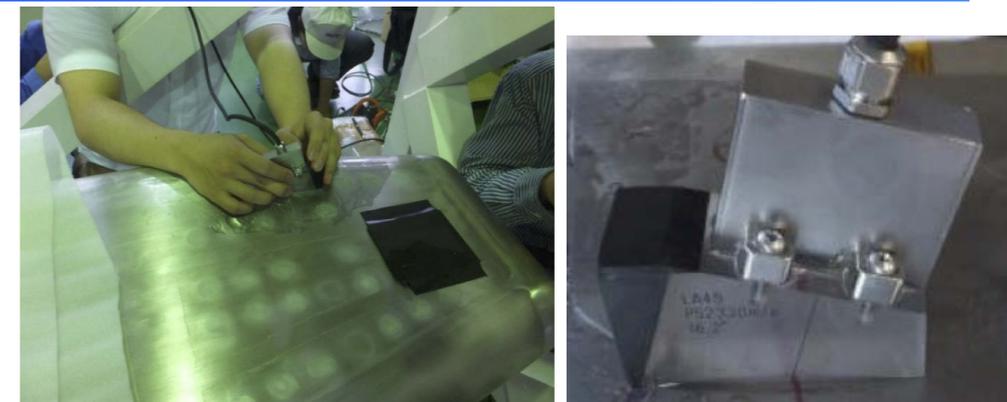
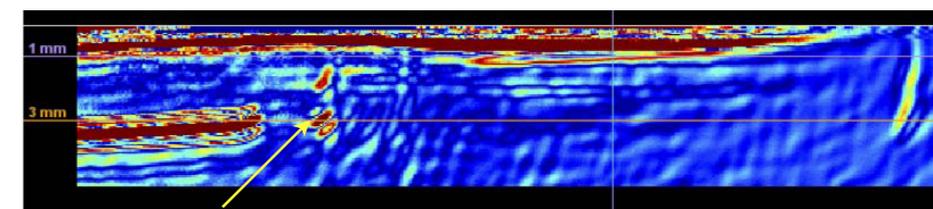
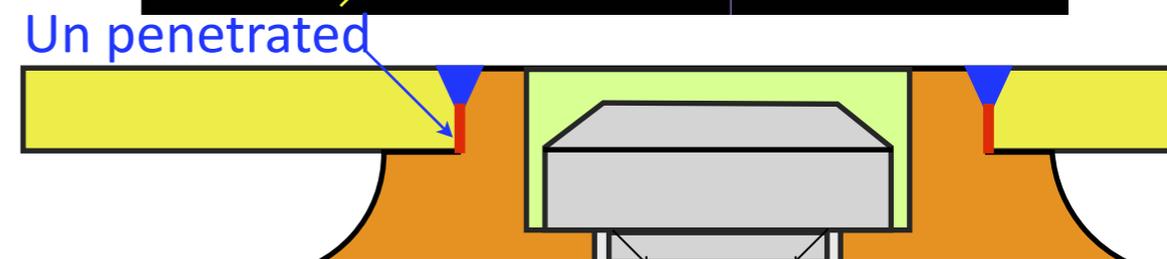
Inspection of mock-up specimen by phased array & Full Matrix Capture (FMC) / Total Focusing Method (TFM)

- Based on the experiences of target failure, we revised the inspection procedure  
*RT : Front part of mercury vessel only (~7th) → All part including water shroud (8th~)*
- UT inspection will be added :  
*Nondestructive inspection method: phased array & FMC/TFM method (GEKKO, Insight)*

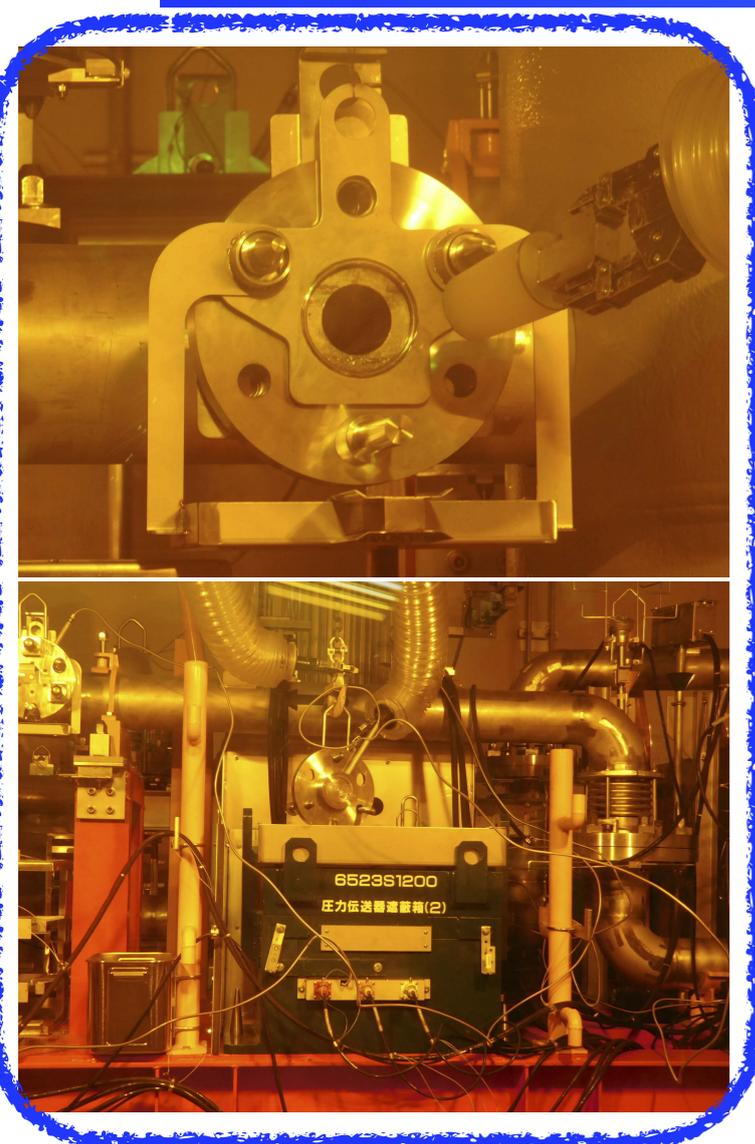
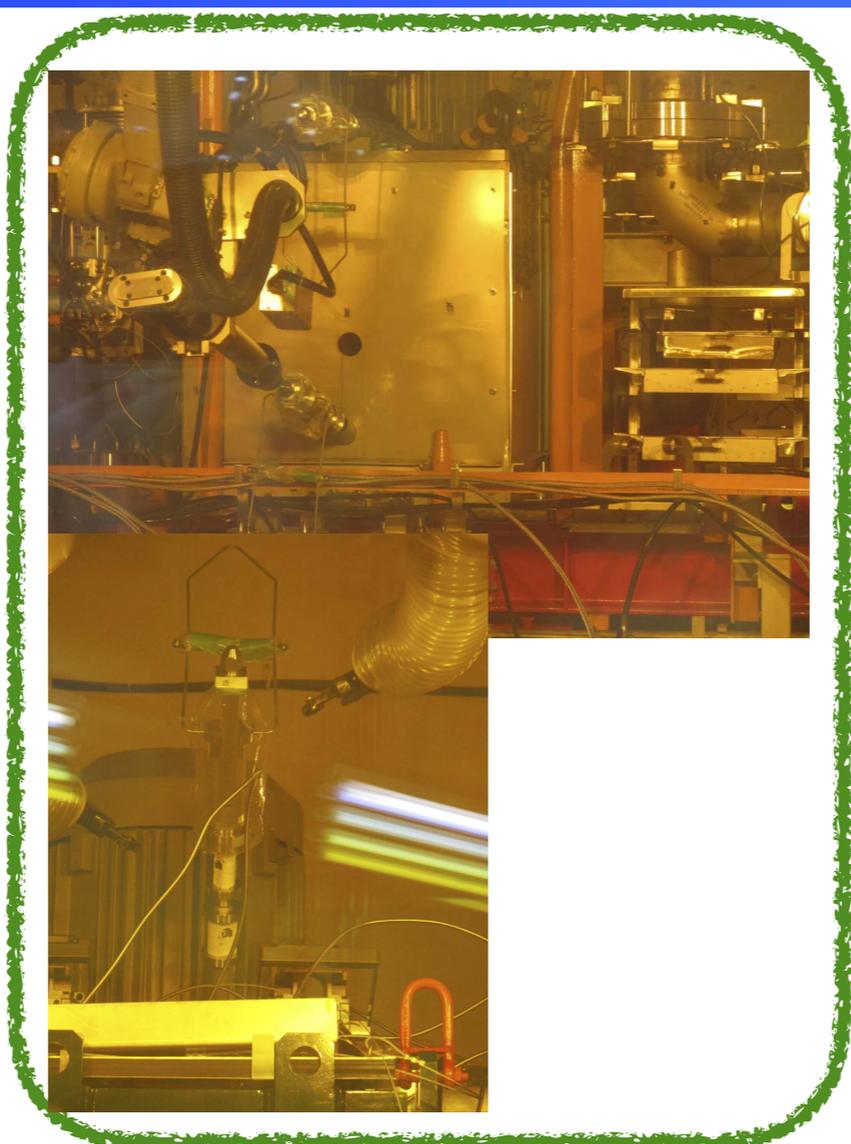
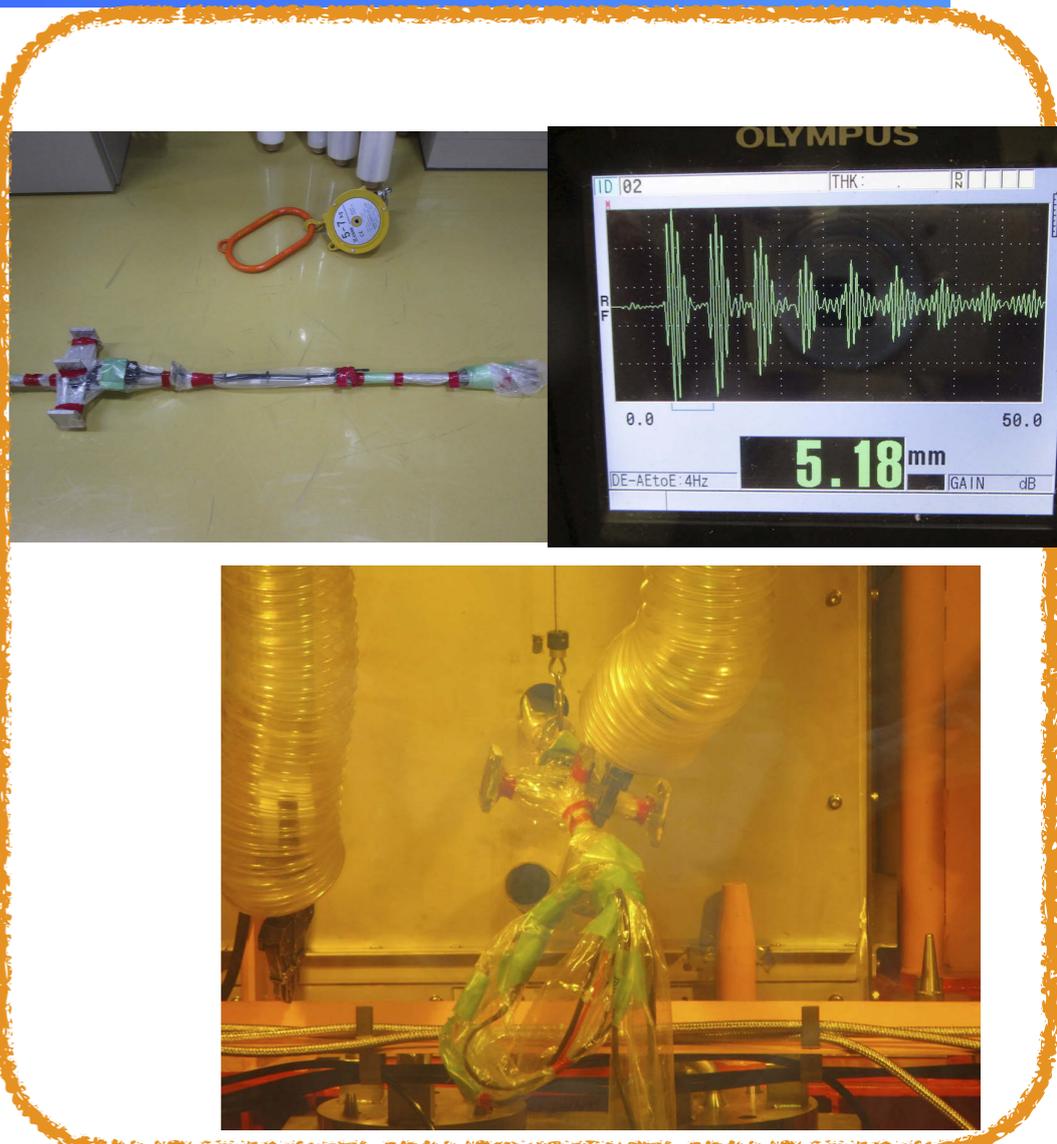
- Pressure sensors, which were damaged by neutron irradiation and showed strange value, were replaced new type sensors (Rosemount sensor)
- Grease the bearing and motor for mercury pump by remote handling  
 Design life of motor for mercury pump is 10 years (8y /10y now)
- Erosion of mercury channel for mercury pump in which thickness is 5 mm was measured using ultrasonic thickness gage by remote handling  
 No-obvious erosions were detected after about 8 years operation

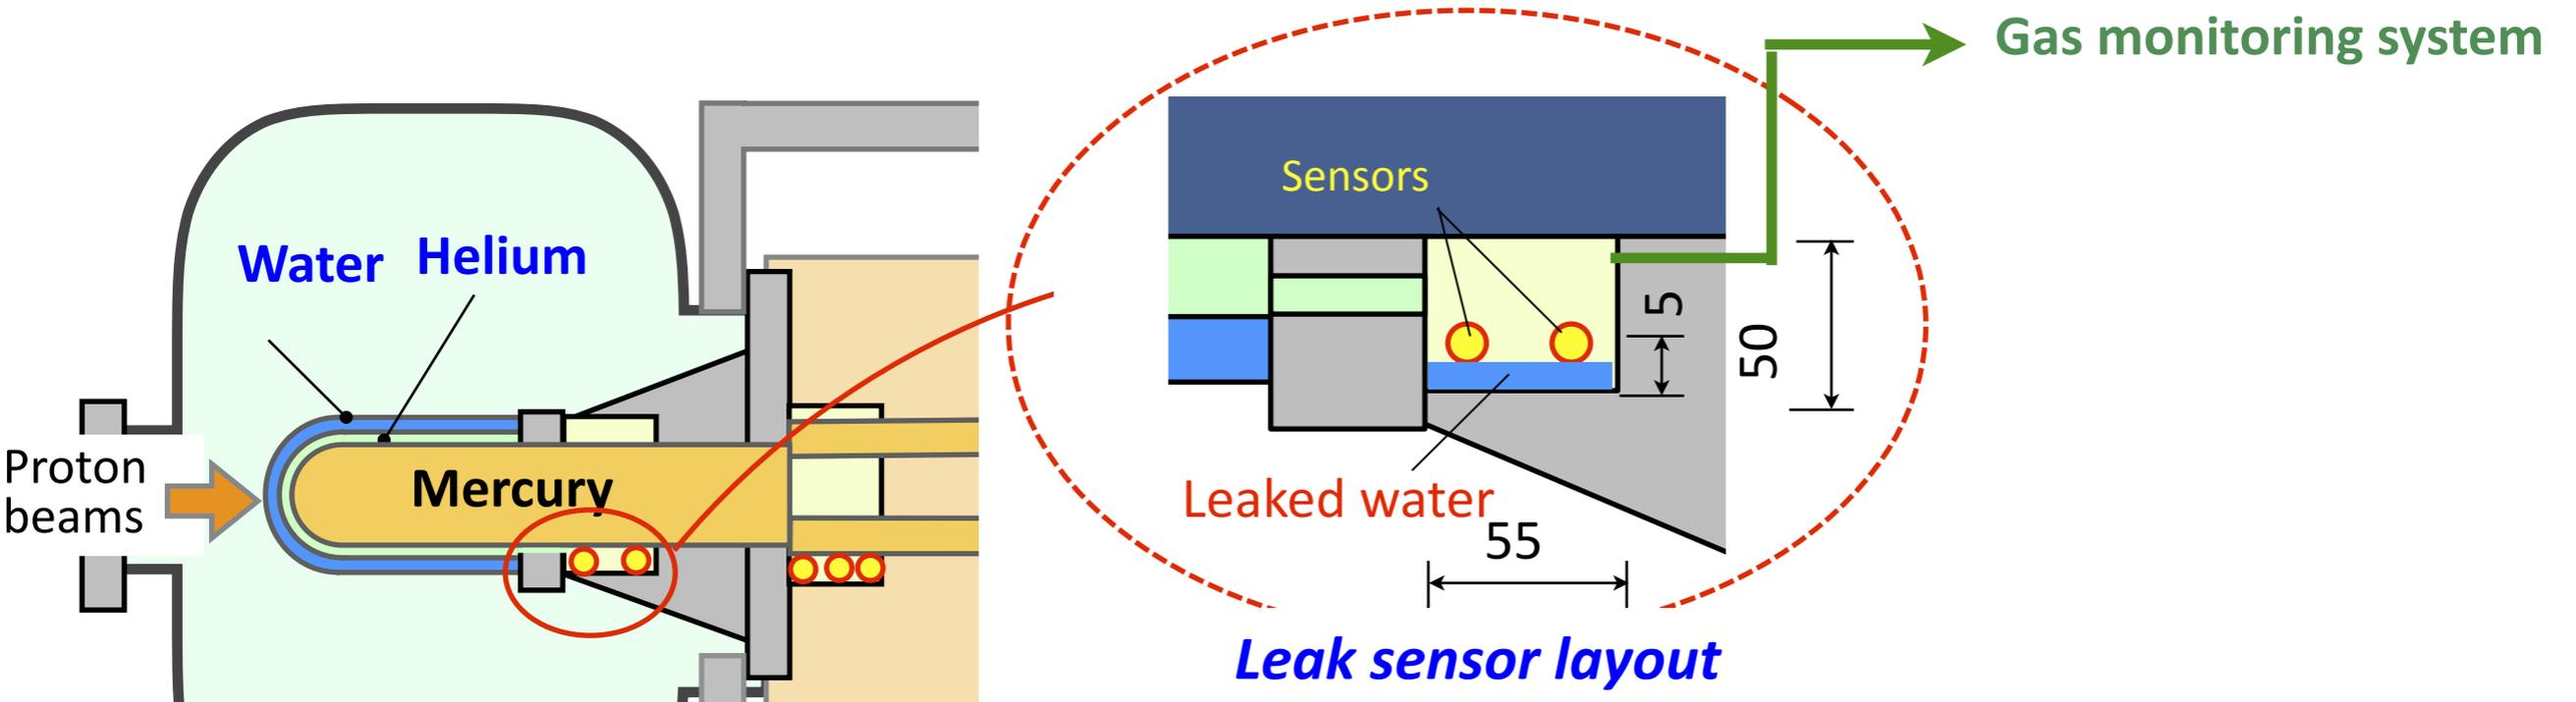
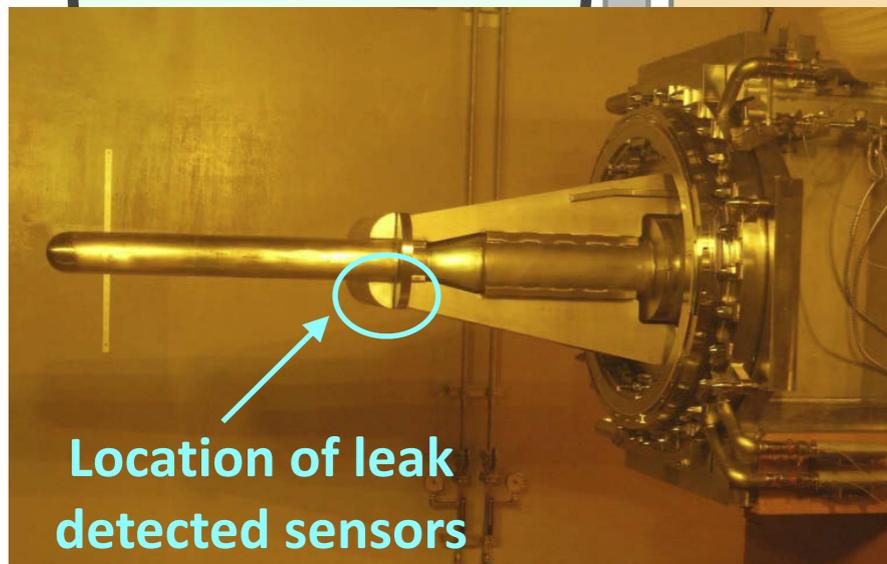
- No-mercury related radio active gas was detected by gas monitoring system
- Electric resistance of sensor showed 5~6 k $\Omega$  (same as water)
- Pressure of helium layer correlated closely with pressure change in water layer

- 7th target was failed by water leak two weeks after starting 500 kW operation
- Two leak sensors detected leak in operation Nov 20th, 2015
- **Leak location was inner water shroud, but not yet found pinpoint location**
