Cavitation damage in double-walled mercury target vessel

**J-PARC Center,
Japan Atomic Energy Agency**

Cutting and inspection of 5th target

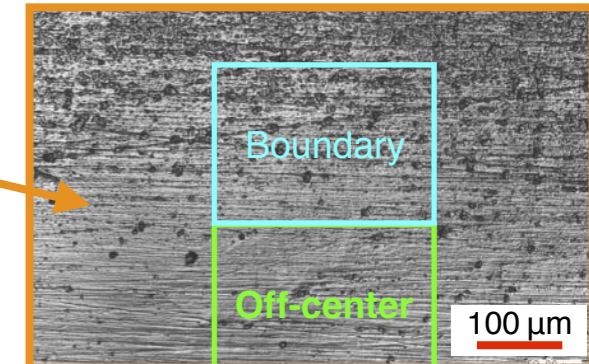
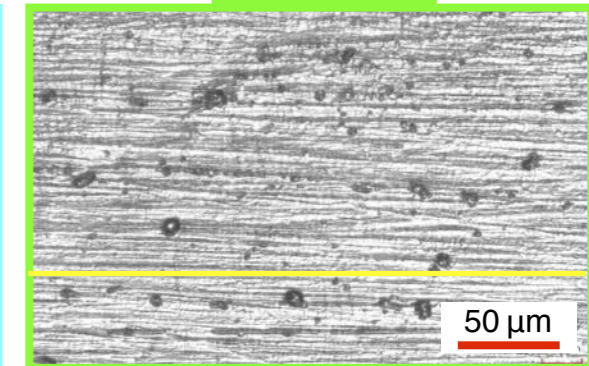
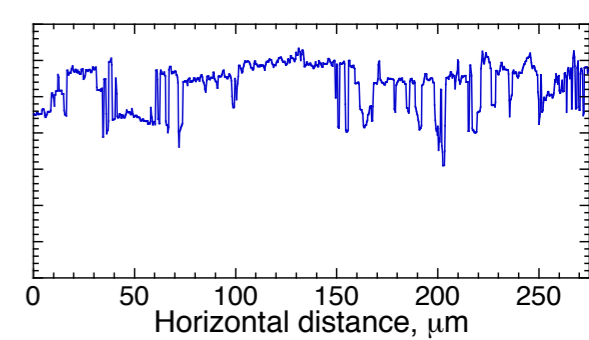
Replica enclosed in glass cell and
measured depth profile by LSM

- Damage band seems to be formed by accumulated pits
- Maximum depth at around center is not changed much compared with off-center
- Relatively deep pits are scattered with rough surface
- Maximum damage depth at center is $25 \pm 5 \mu\text{m}$ (deeper than predicted value 10-15 μm)

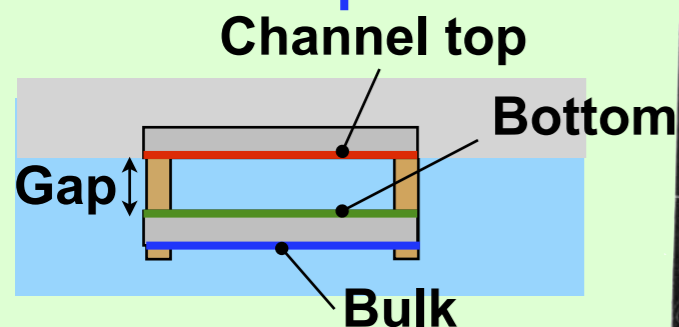
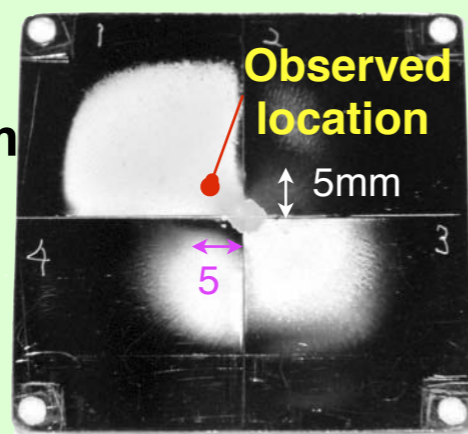
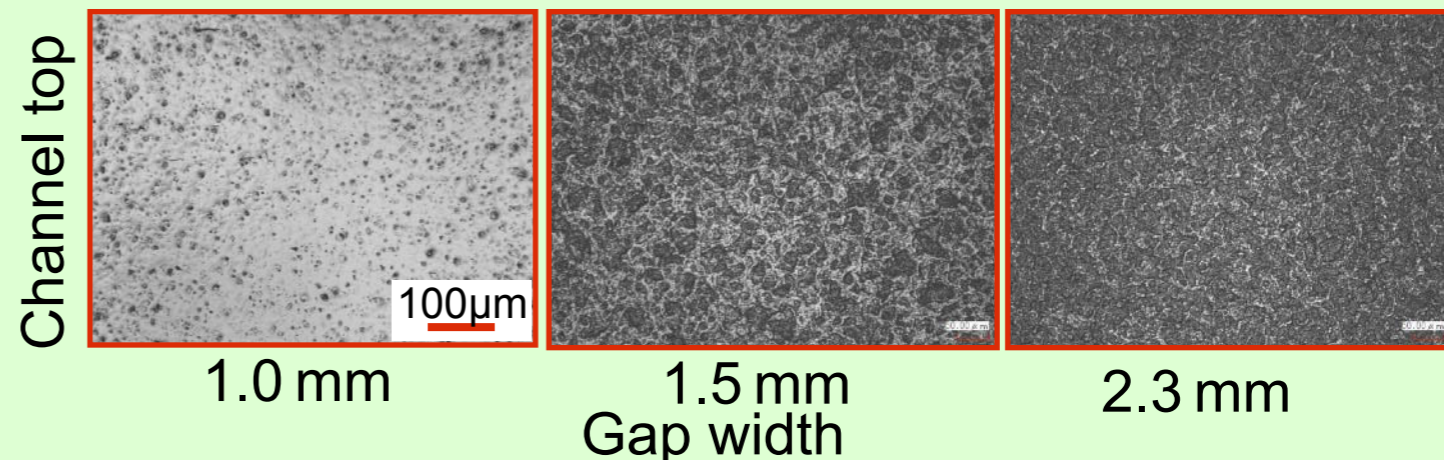
Specimen surface after 10^6 impact test

• Damage seemed to be increased with increasing in gap width in off-beam experiment

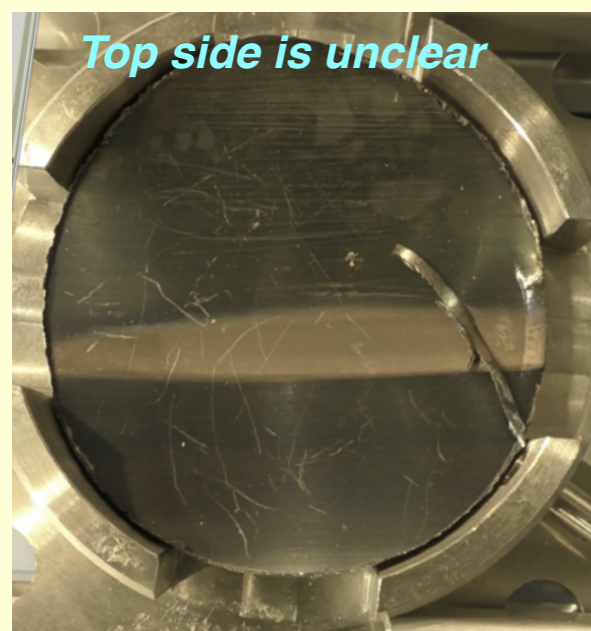
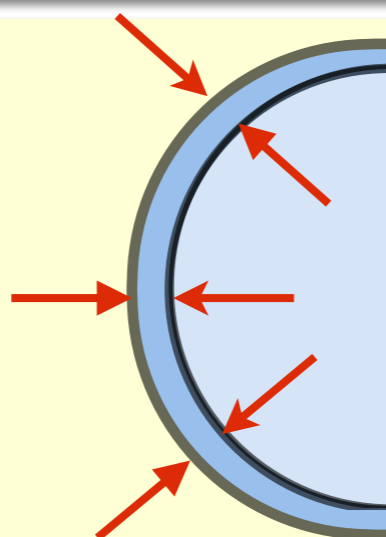
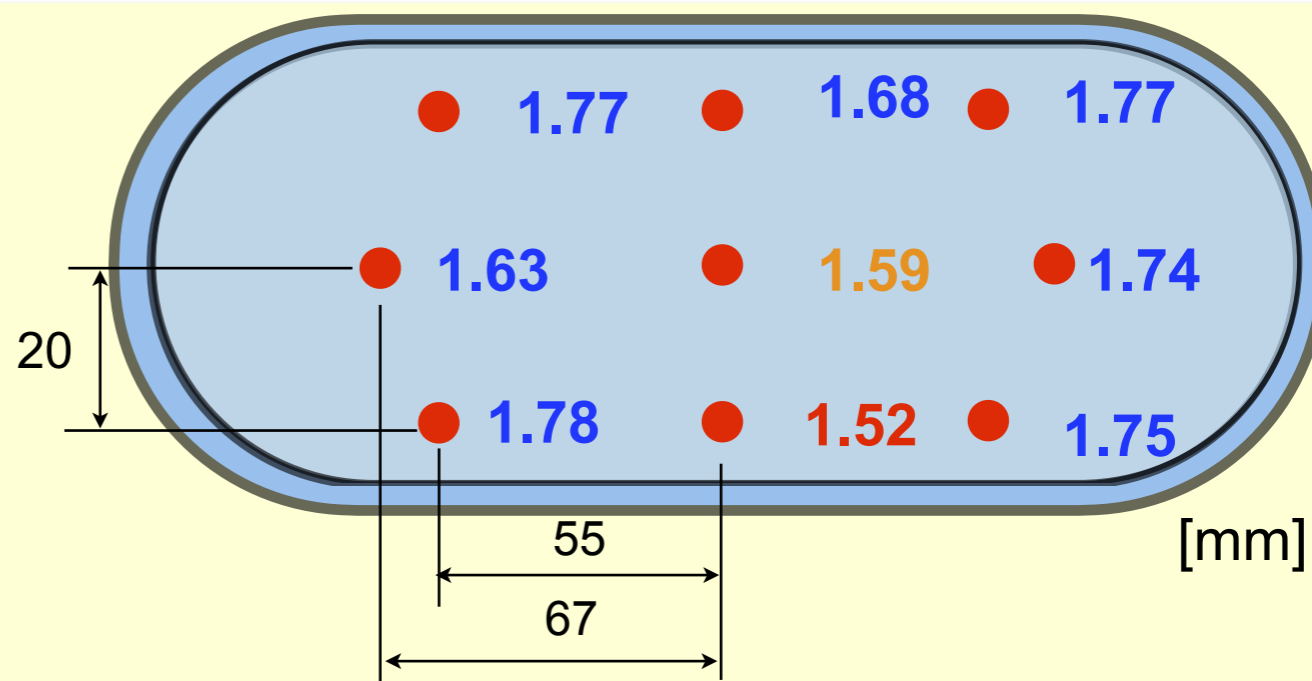
Measured gap between outer and inner wall (in fabrication inspection)

• Gap at center part is slightly narrower than other part not so much
Opposite trend with off beam experiment

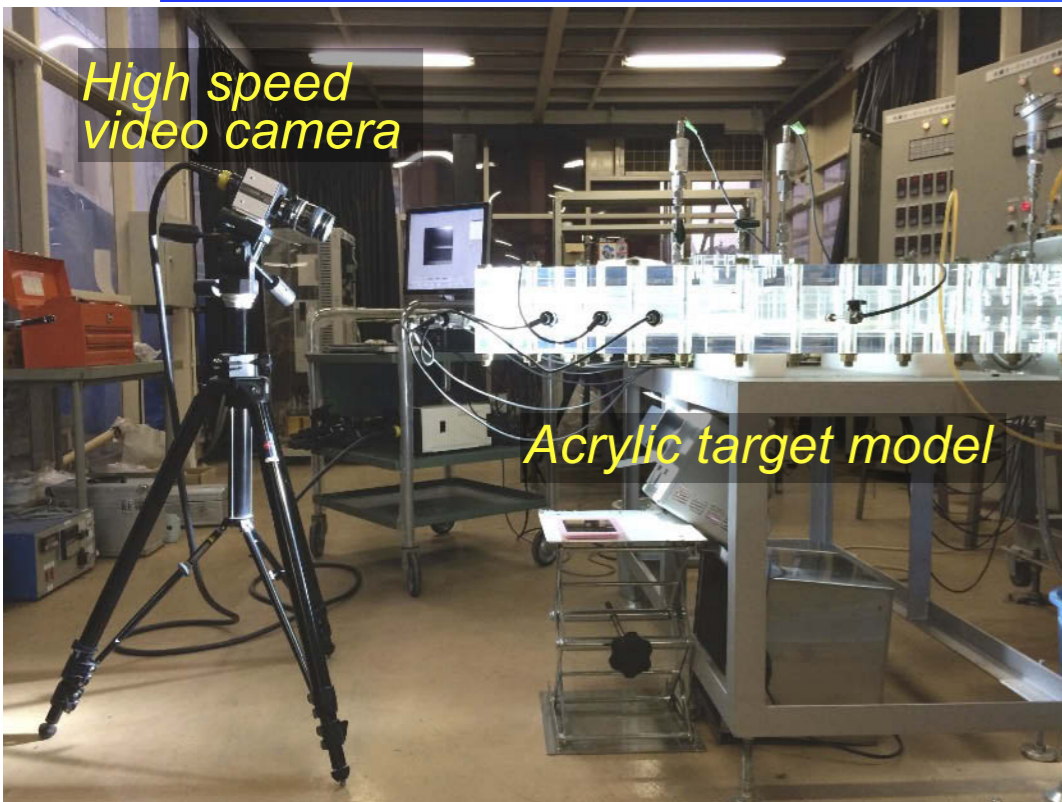
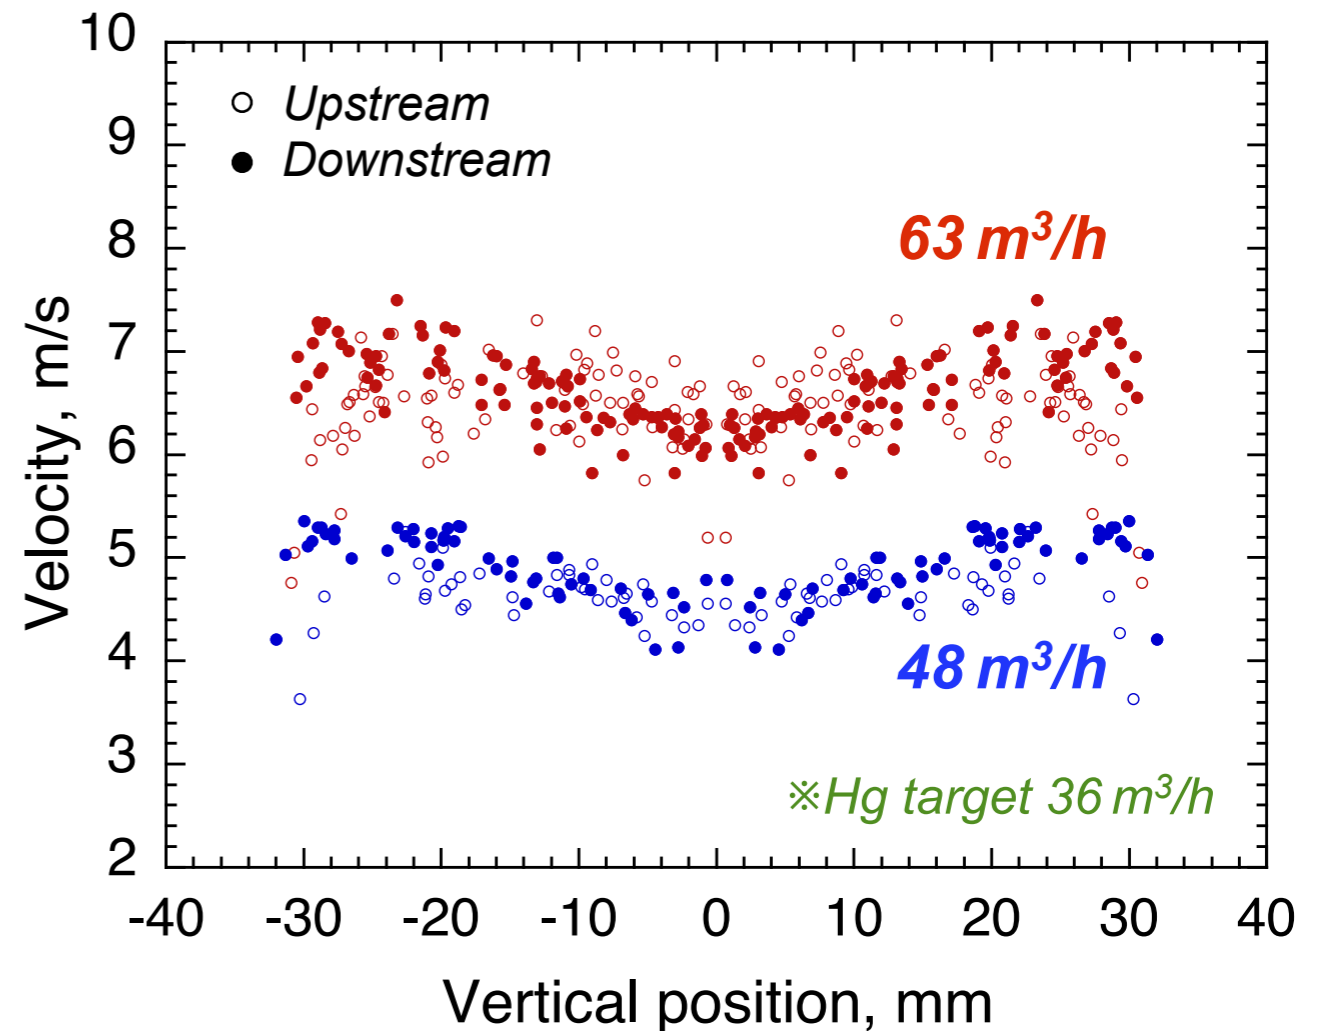
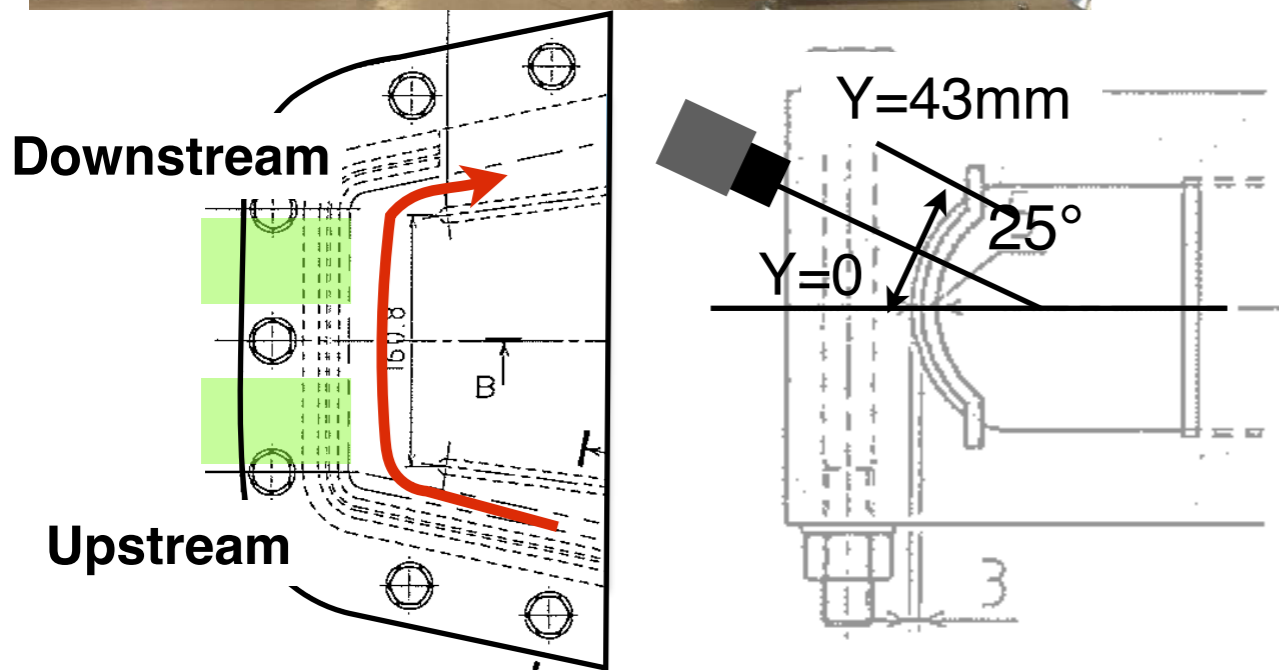
Water experiment with acrylic full-size model

- Flow velocity distribution in narrow channel was experimentally investigated using full-size acrylic model with water loop
- Flow velocity at center part is slightly slower than top&bottom side

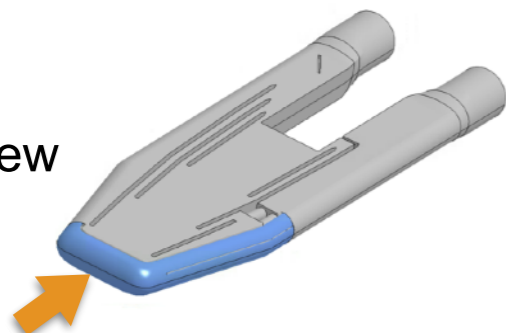
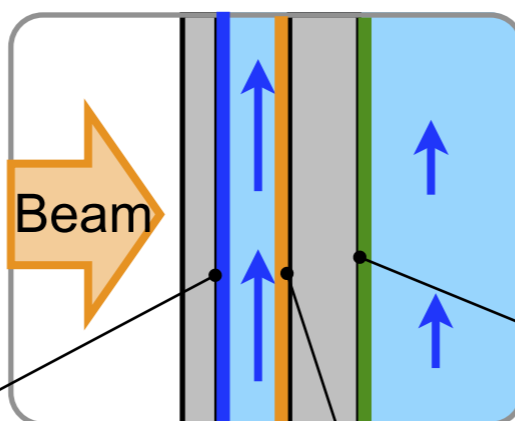
Distribution of accumulated value of negative pressure period: T_{Naccum}

- Accumulated negative pressure period up to 2 ms seems to be correlated with the damage distribution on cut out disk
- Short time of negative pressure period is effective to form damage in narrow channel

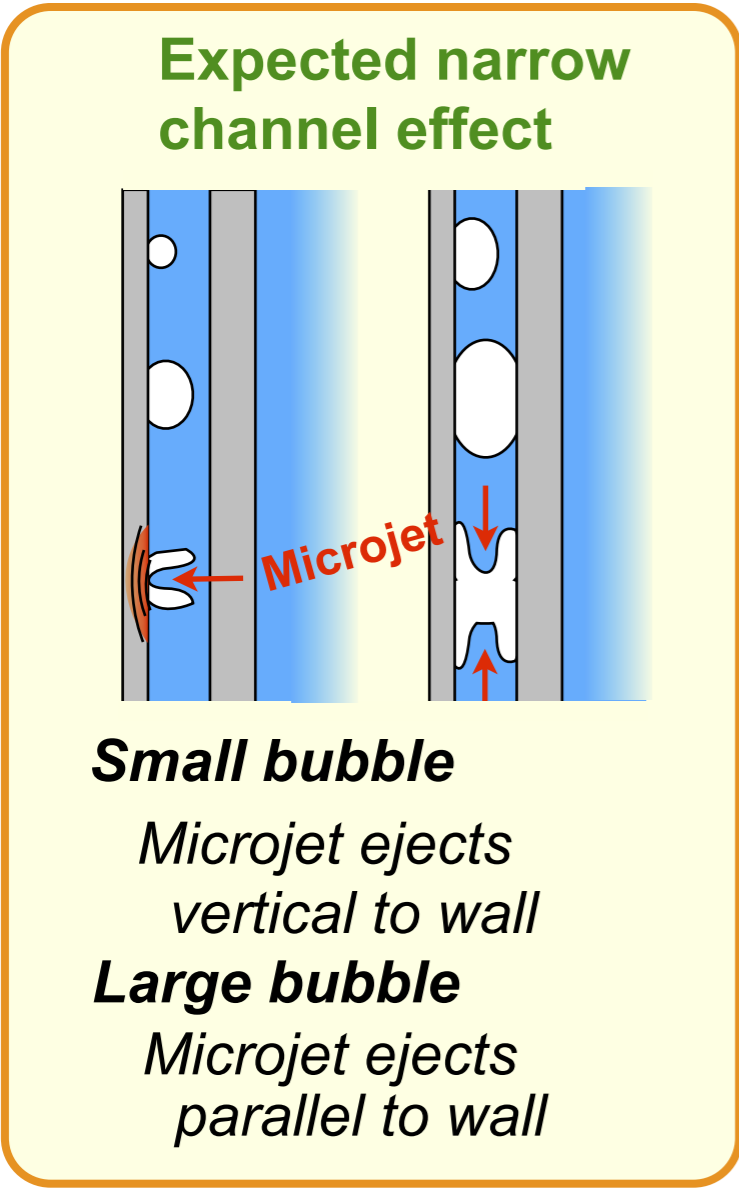
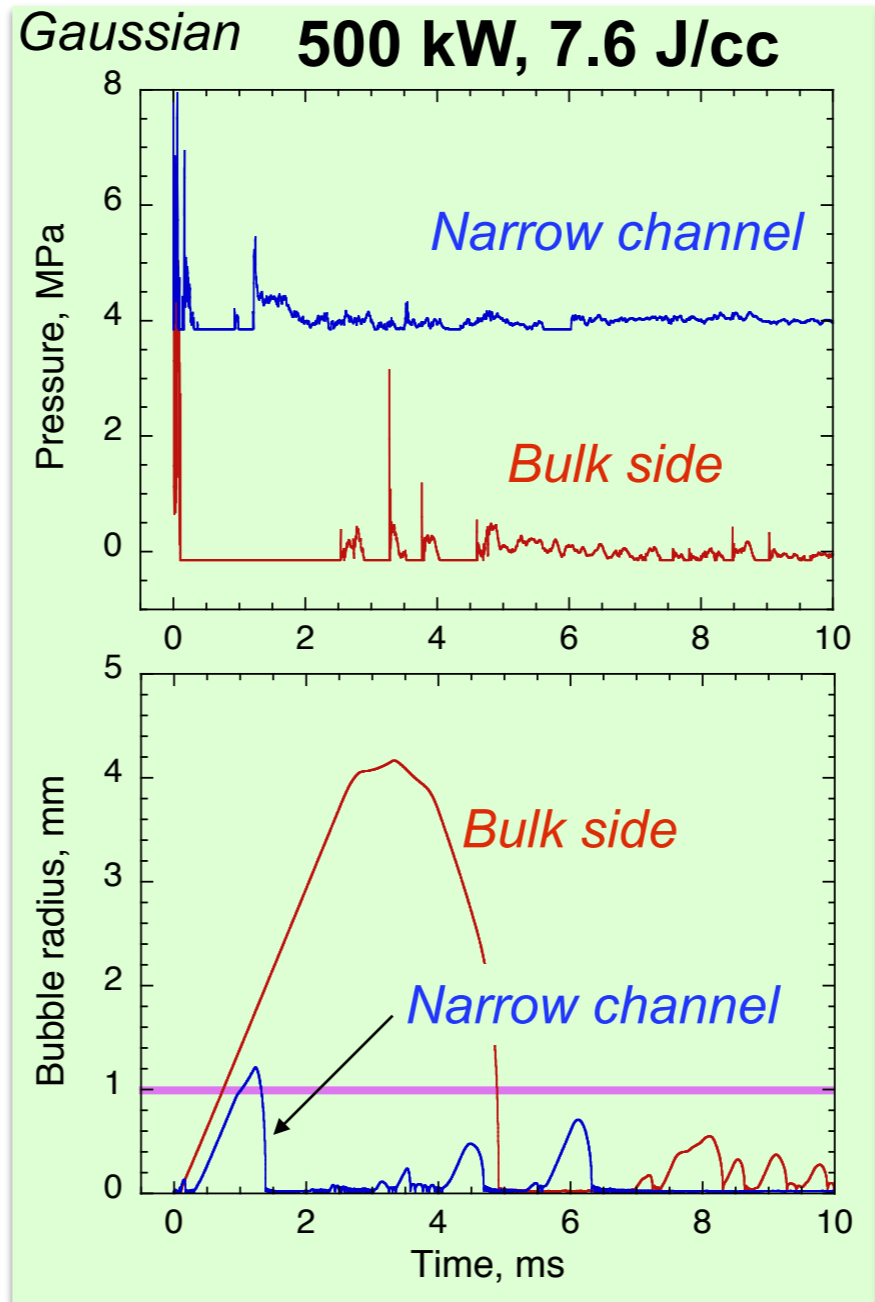
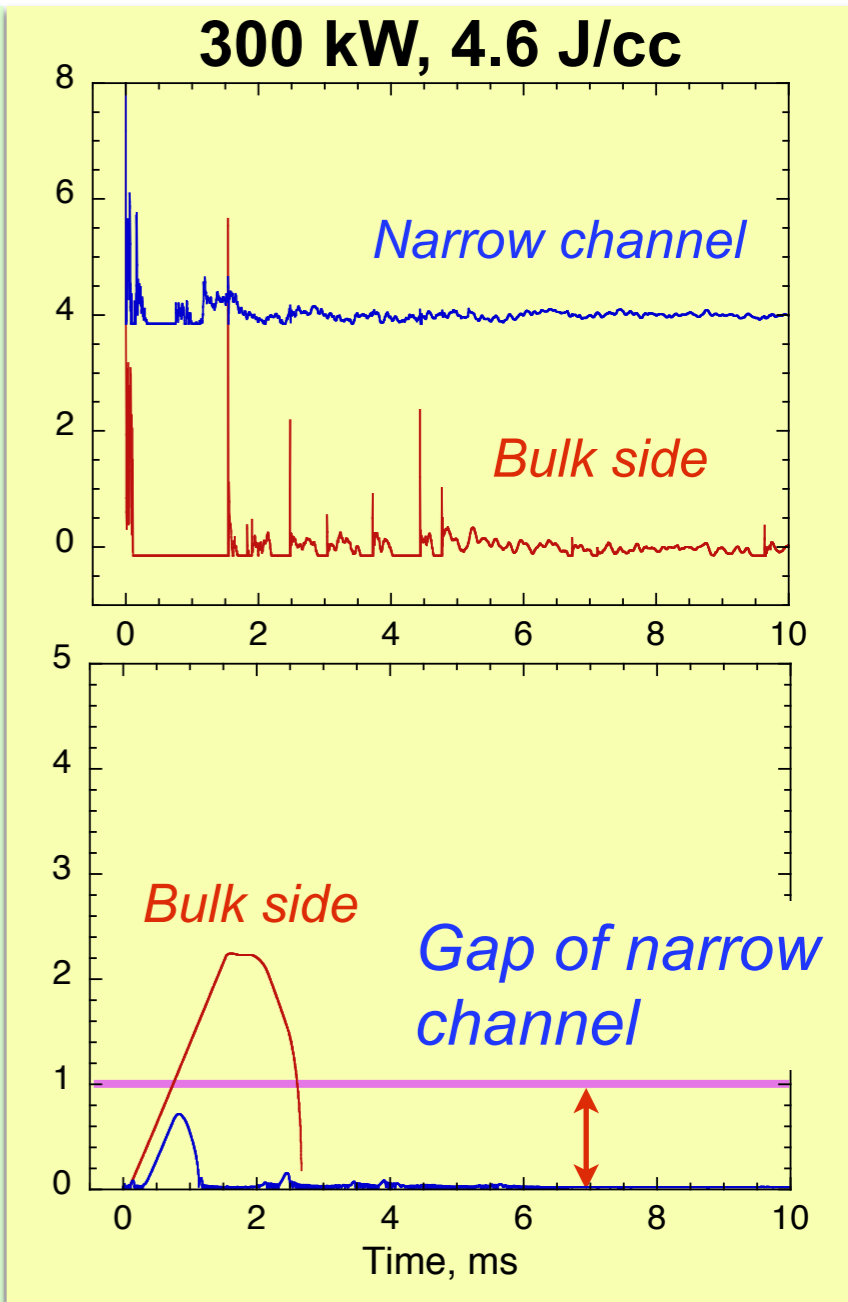
Pressure and bubble responses at center

- Bubble growing and collapsing occurs before 2 ms in 300 kW
- In the case of 300kW (take bubble effect into account), it has the possibility to occur violent cavitation bubble collapse

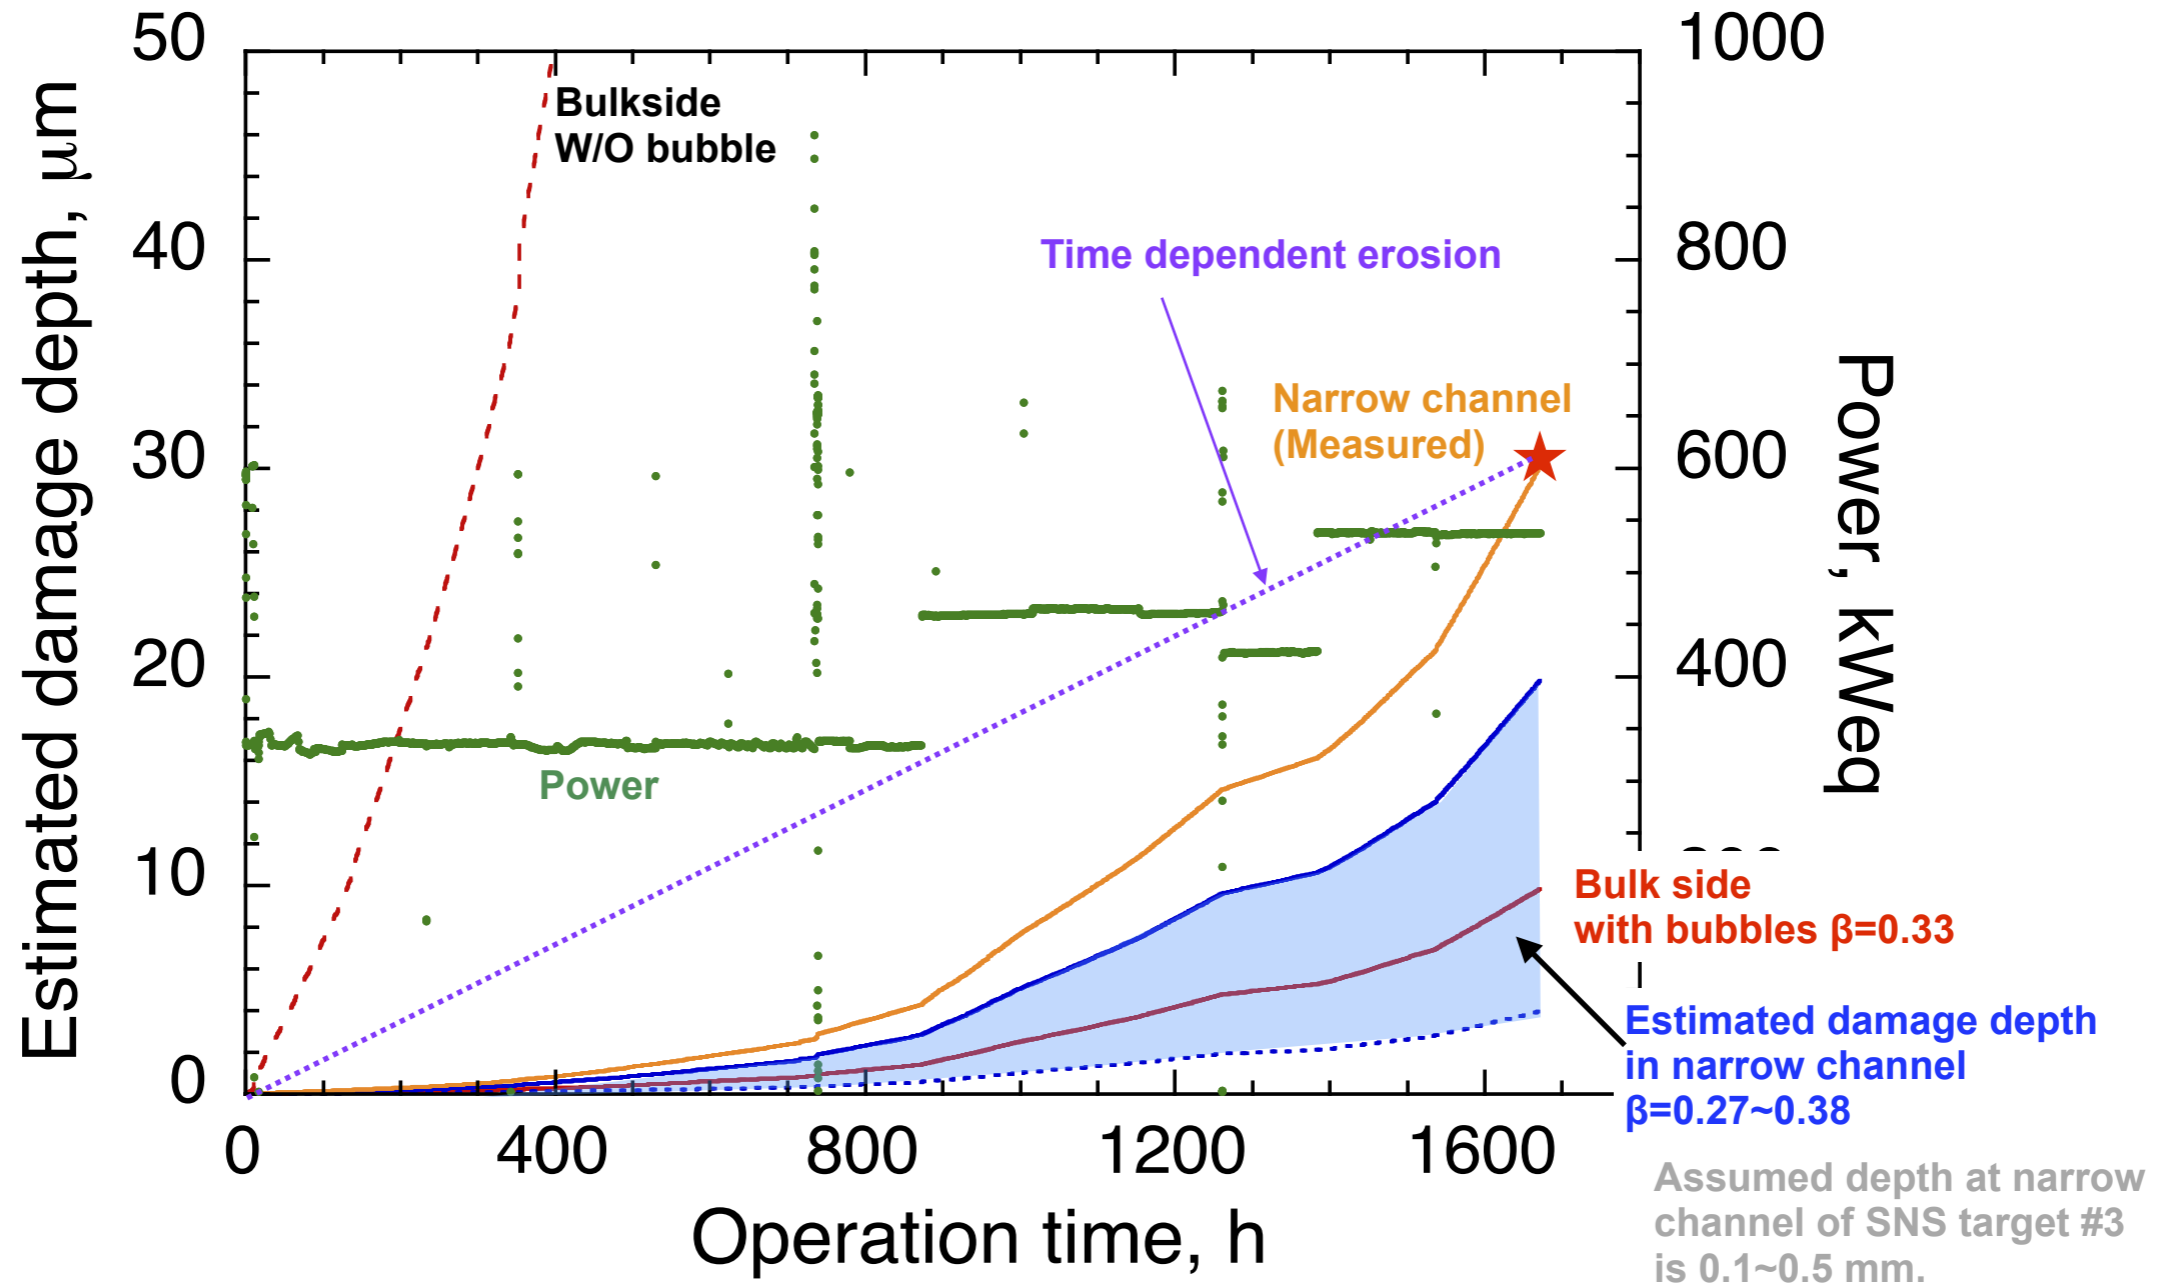
Estimated depth change

- Measured depth of pit at narrow channel is about 25 μm
- If this damage was time dependent erosion, < 0.1 mm at 5000 hours
- If power dependent damage , depth of 5000 hr at 550 kWeq \rightarrow about 0.7 mm
- Is the double wall effect smaller than bubbling?

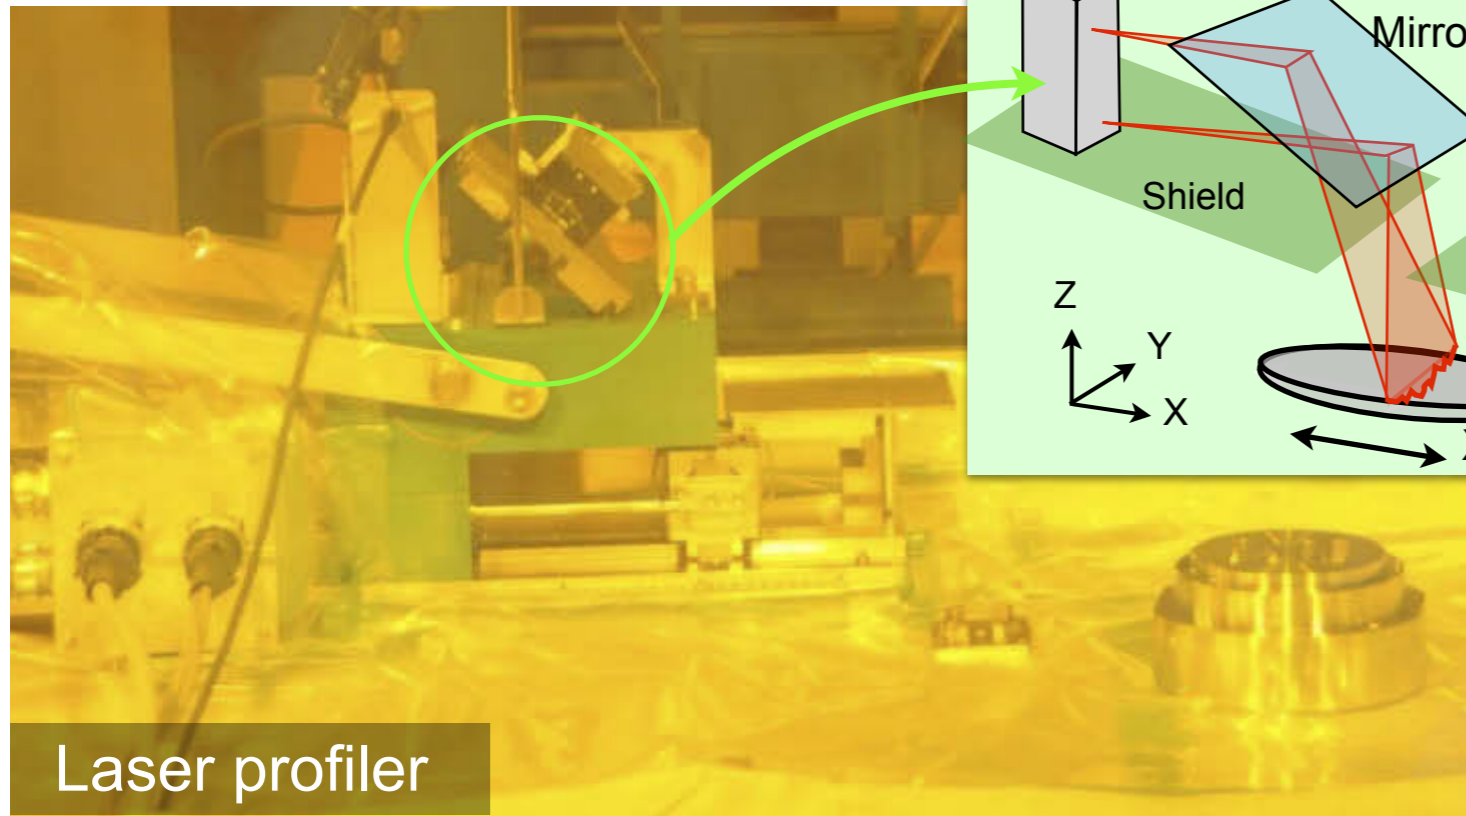
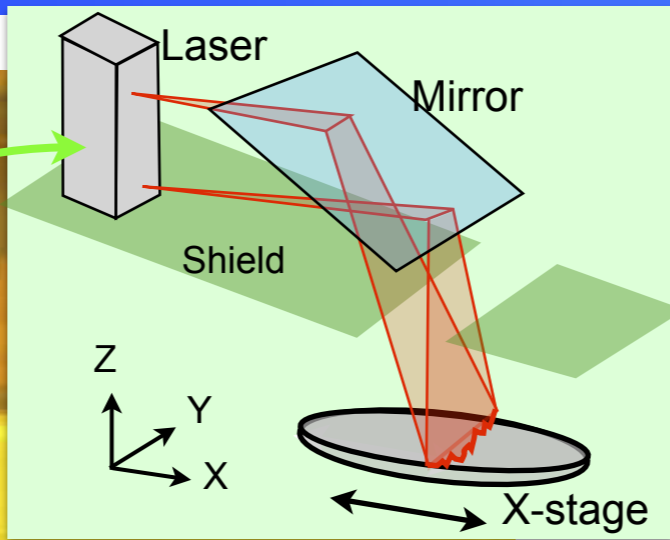
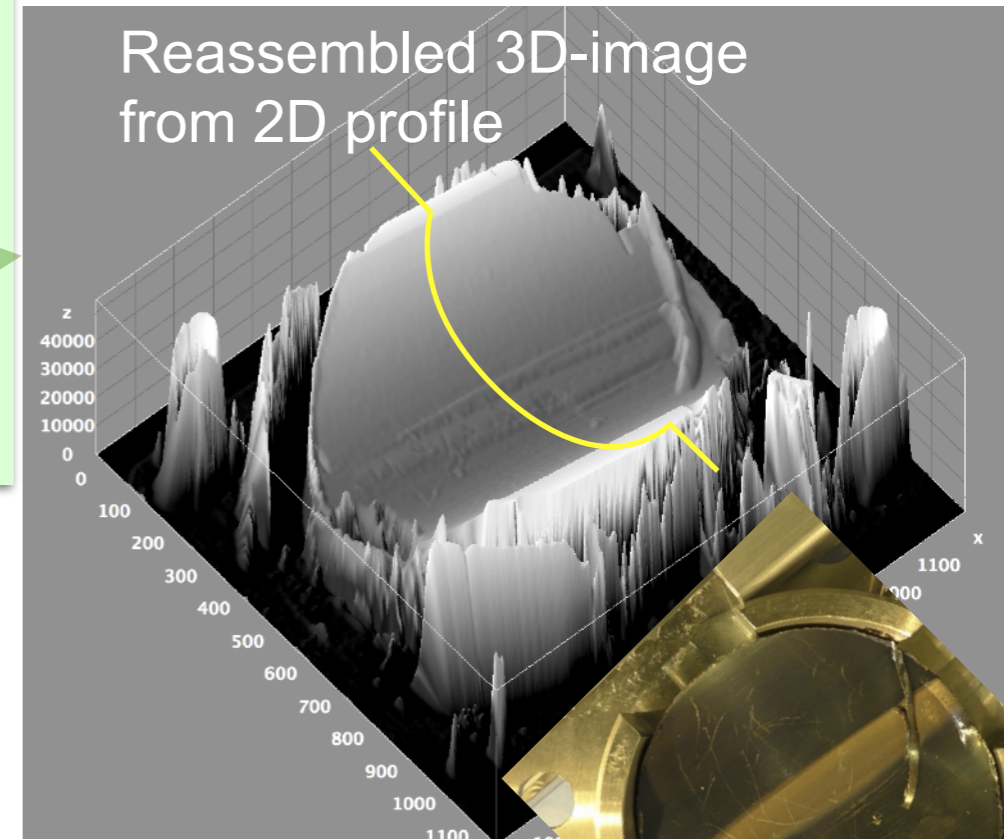
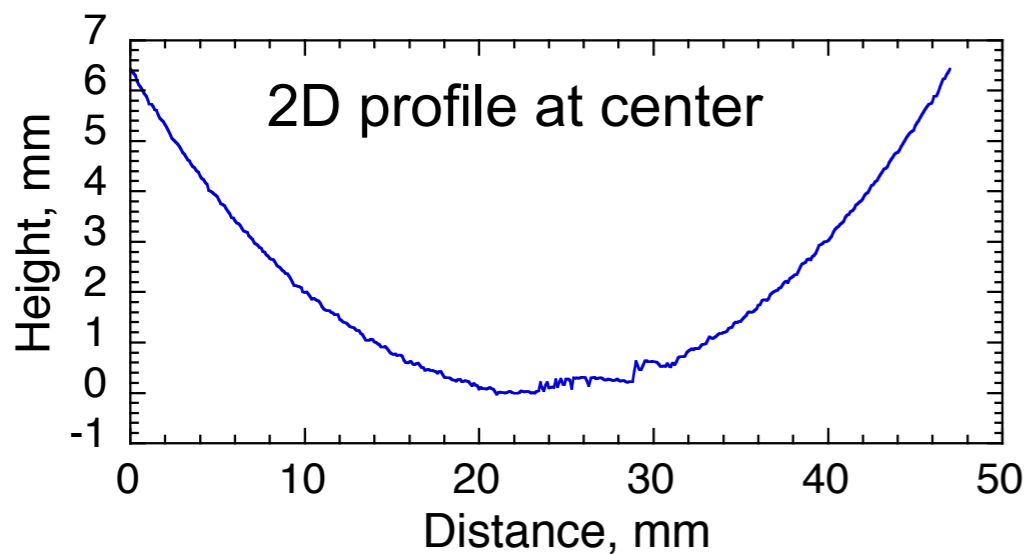
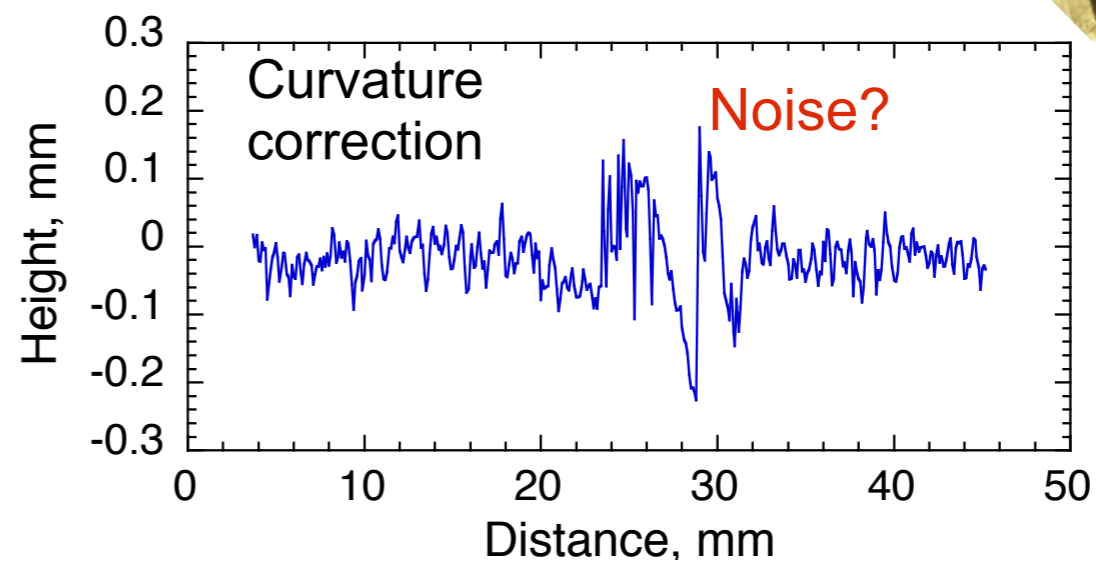
Depth measurement by laser profiler

- Damage depth profile was measured using laser profile of 0.1 mm in resolution
- Resolution of this machine is insufficient for damage on specimen

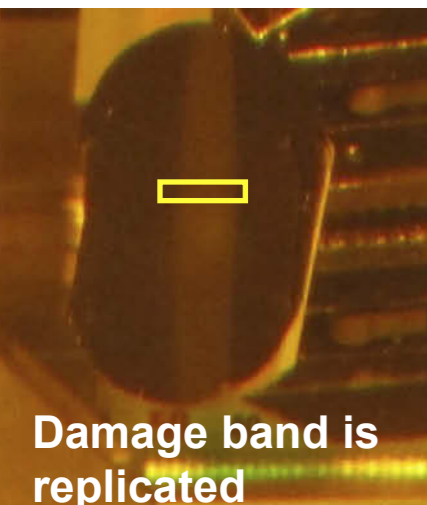
Jointed image

- Silicone rubber replica (Struers Repliset-F1, 0.1 μm in resolution) was used to quantitatively measure the damage depth using laser microscope
- Clear surface erosion was not detected
- Surface roughness (swell) is about $\pm 10 \mu\text{m}$
