Hardness of a carburized surface layer on AISI 316L stainless steel from high-use Spallation Neutron Source target vessels after irradiation

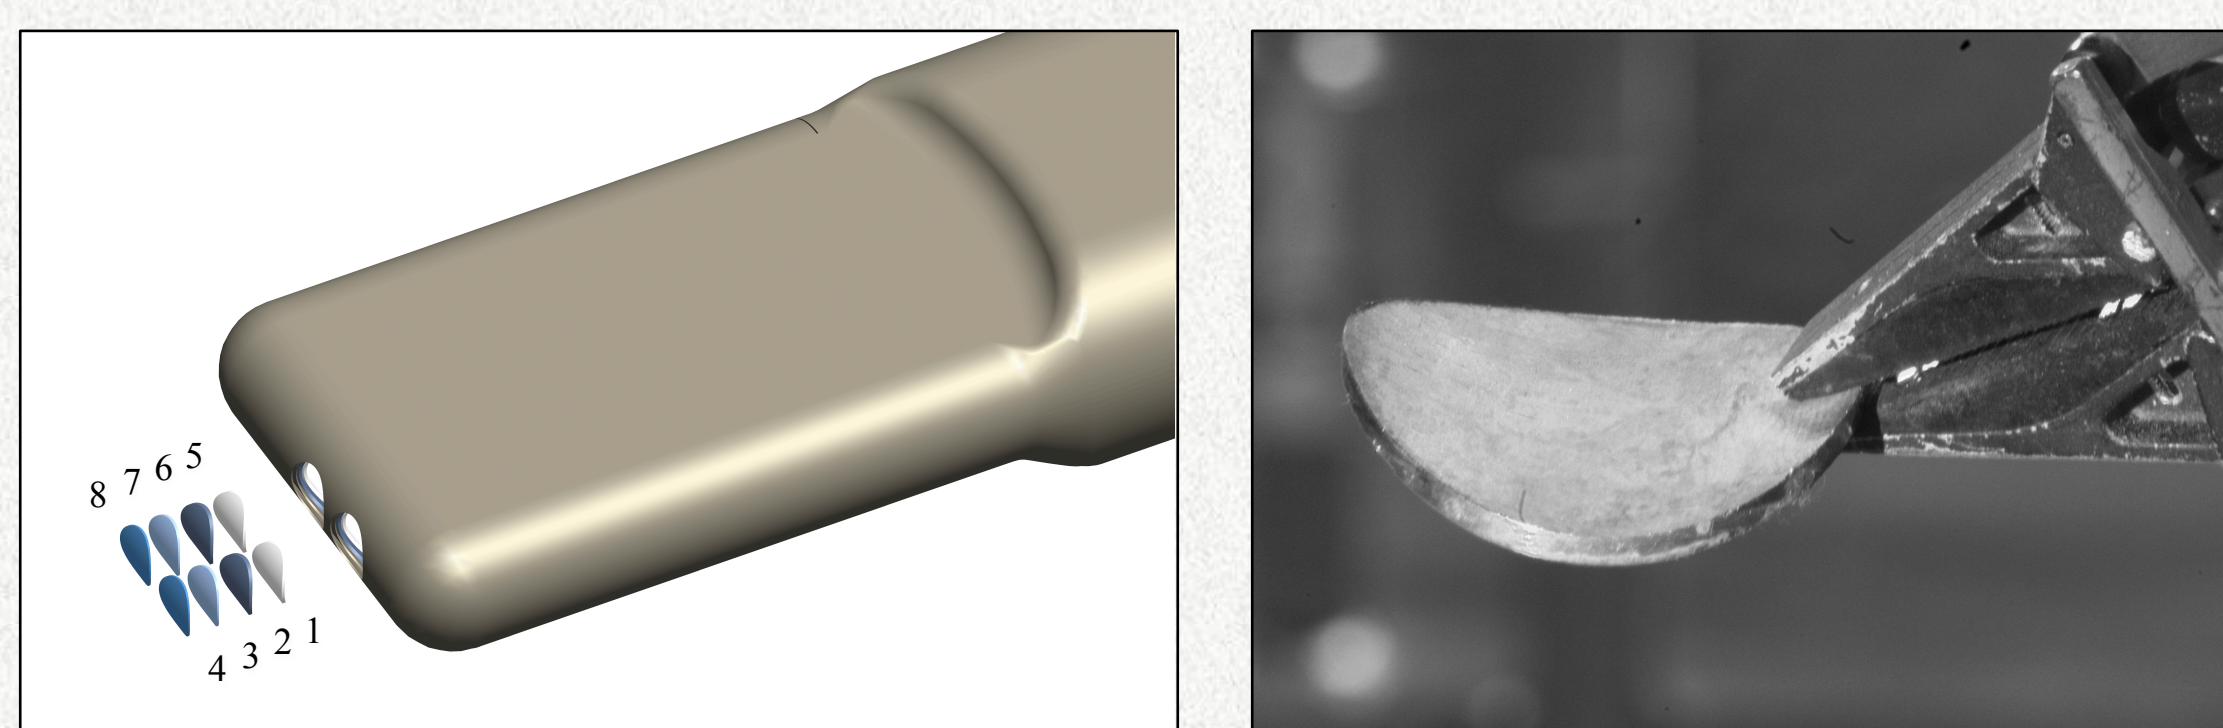
Disk-shaped samples, shown in Figure 2, were removed from the beam entrance region of SNS Targets 8 and 9 using annular cutters after removal from service.

Figure 2. Diagram of specimens removed from beam entrance region of SNS targets and an example of disk-shaped sample from target vessel.

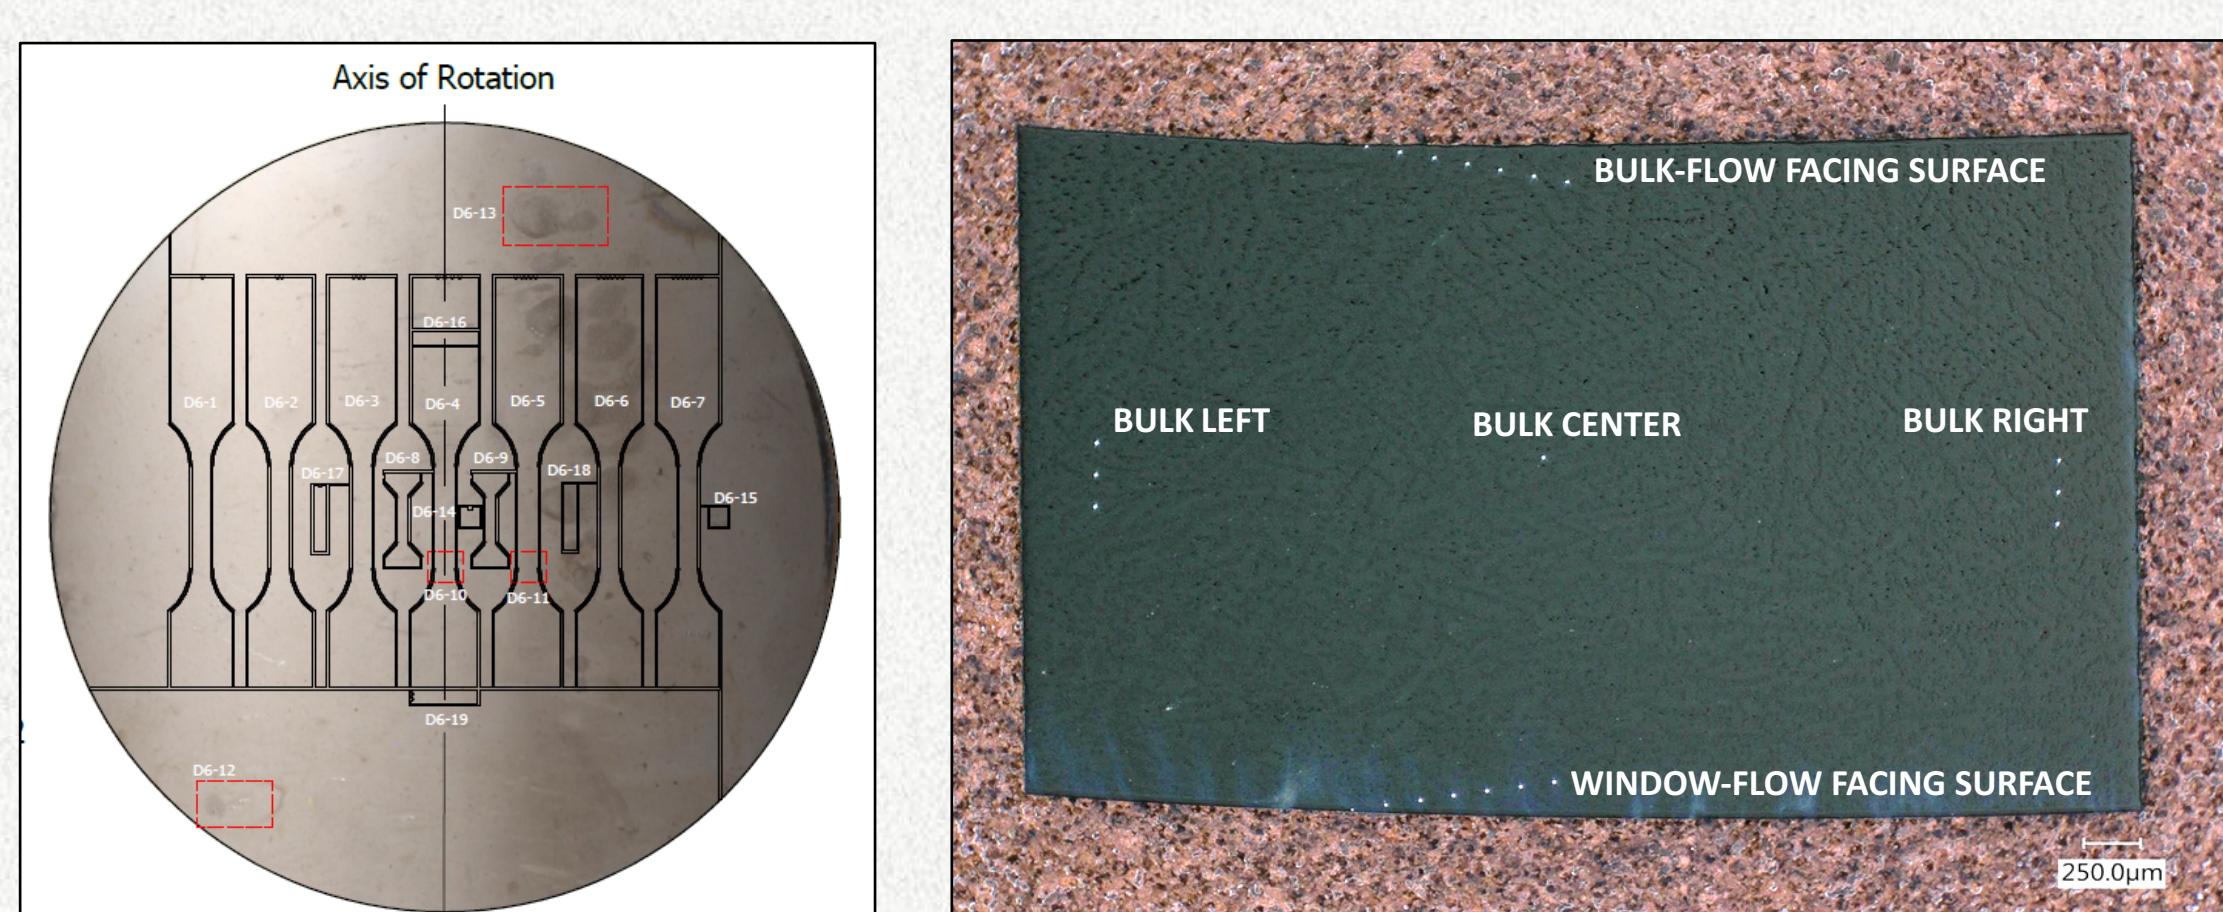
Several different specimen types were machined from the disk-shaped samples by wire electrical discharge machining (EDM), as shown in Figure 3. The specimens from microhardness testing were mounted such that the cross section of the disk is viewed after grinding and polishing.

Figure 3. Machining map for SNS target disk-shaped specimen (left) and indentations on hardness specimen D6-19 from Target 9 (right).

The Vickers microhardness of the K-layer and bulk material was measured using a Wilson[®] Tukon 2500 with a 50 g load. Indentations to characterize the hardness of the K-layer were performed in a closely spaced staggered pattern of seven indentations near the vessel surface, as shown on a specimen in Figure 3. The bulk material hardness was also characterized with a series of indentations. The manufacturer recommended dwell time of 15 s was used for indentations.
